# **LAKE LAND** **C O L L E G E**

## **Facilities Master Plan**

DECEMBER 2022  
LLC FACILITY CONDITION ASSESSMENT  
BAILEY EDWARD PROJ. NO. 022072

## LAKE LAND COLLEGE FACILITY CONDITION ASSESSMENT REPORT

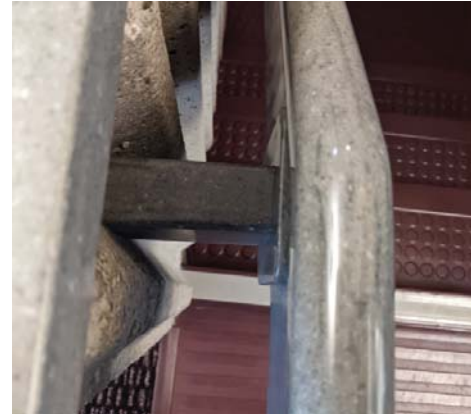
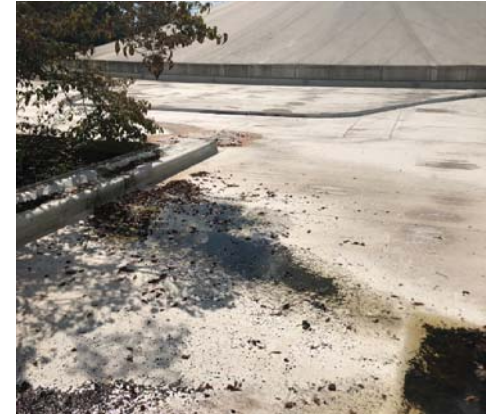
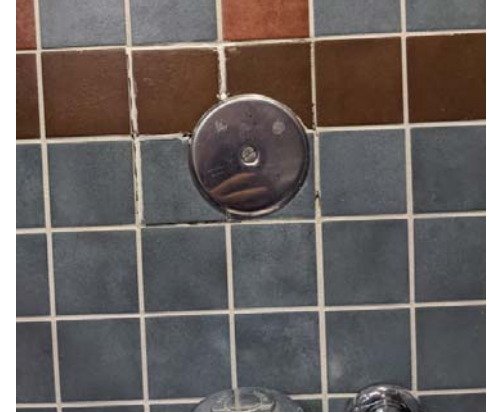
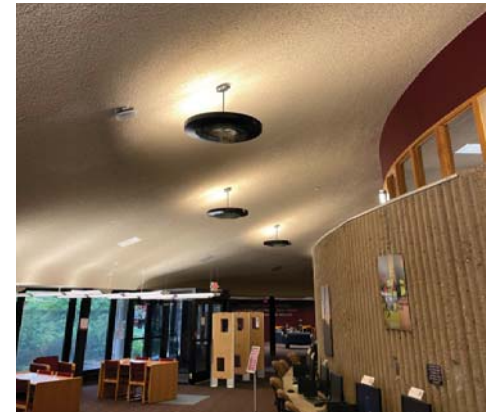
- Seepage at basement
- Roof warranty expired 2016
- Storefront past service life
- Access control upgrade needed
- Broadloom carpet past service life
- Leakage issues also in Offices 062, 063 and 064 at basement coming through the wall base and floor
- Stair handrails need to be replaced
- Exterior wall packs past service life
- Interior lighting is past service life
- Basement has multiple conduits due for repair or replacement

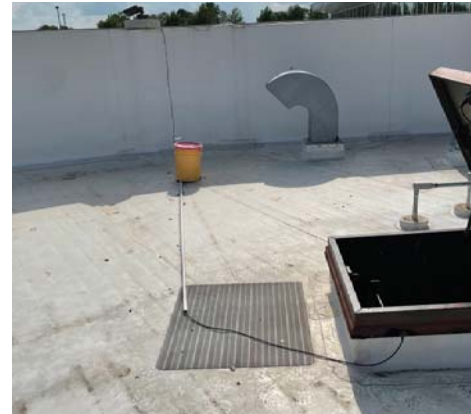
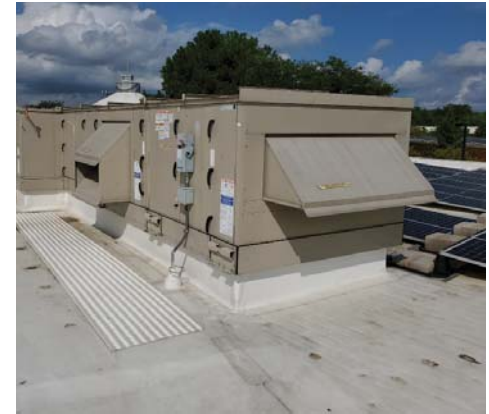
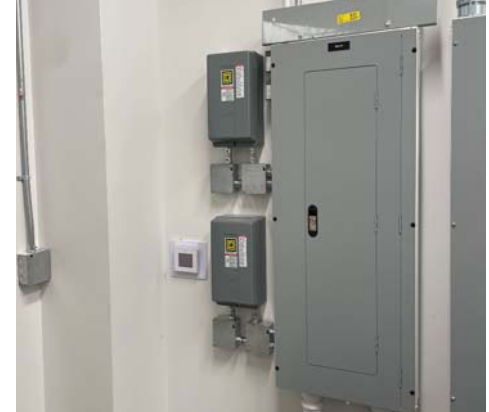
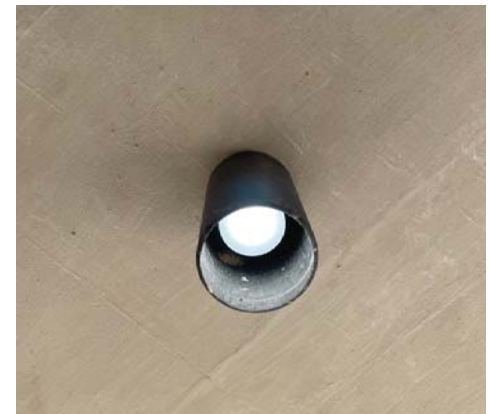
- Roof at connector and leading up to roof is in poor condition
- Roof above Theater must be replaced
- The building is newly renovated but the Auditorium was never updated. It is in dire need of a full renovation. The roof was not renovated so there is water infiltration. It needs a new ceiling. It needs new finishes. It smells of water and mold. The Auditorium was last updated in the 1990's.
- Ground fault meter was found in an electrical room and was detecting a ground fault. Ground fault study should be observed.
- Exterior local over current protection are past their service life.

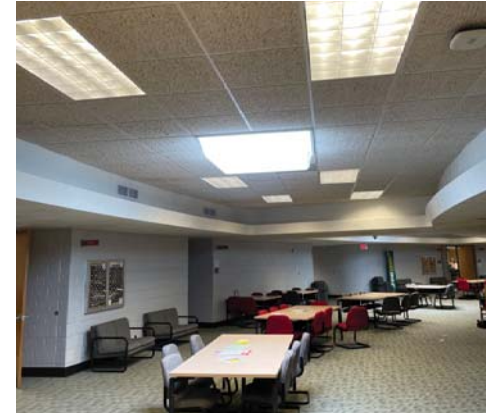
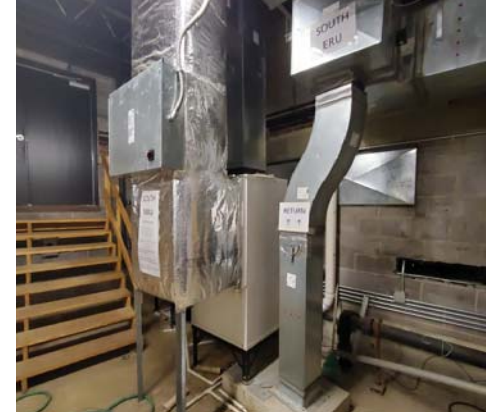
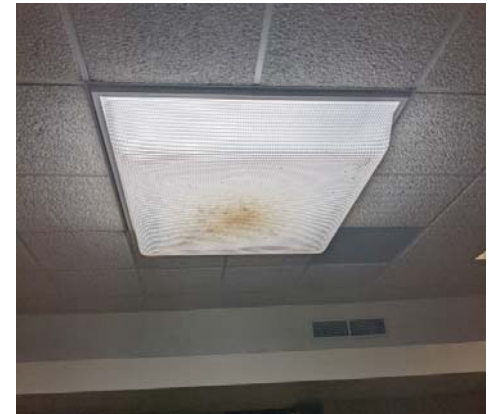
- Roof warranty expired 2001
- Water infiltration at light wells
- Water infiltration at clerestory windows
- Entry storefronts past their useful service life
- Access control upgrade needed
- Sealant at control joints clearly past its service life.
- Water stains at ceilings
- DEFERRED MAINTENANCE REQUEST ISSUED 11/04/2021
- Broadloom carpet past service life
- Mechanical equipment its past service life

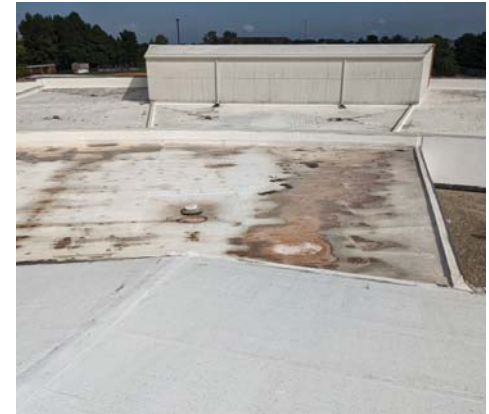
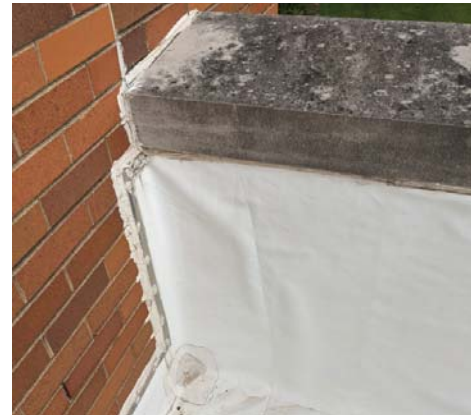
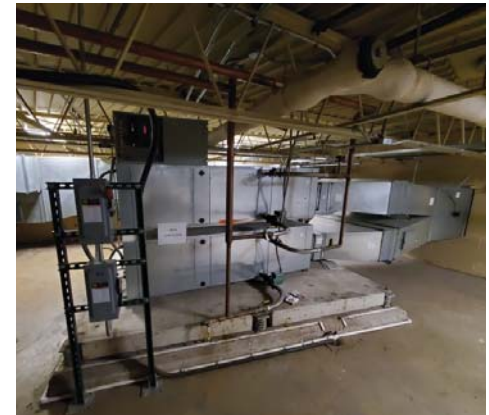
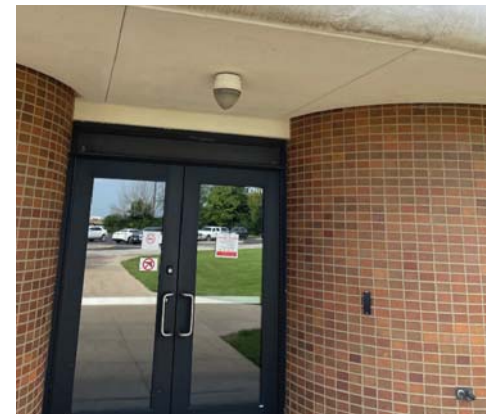
- Roof warranty expired 2005-06
- Storefront past service life
- Access control upgrade needed
- DEFERRED MAINTENANCE REQUEST ISSUED 11/04/2021
- 7500 square feet of ceiling replacement is scheduled for 2023
- Four locker rooms and their walls are scheduled to be renovated in 2023
- Many areas around the building are scheduled to have new flooring installed including Entry 040, Classrooms 104, 105, 108, 109, 110, 111, and the Fitness Center as well as several of the existing corridors. There is a new basketball floor installed. All together, this comprises roughly 70% of the building's floors.
- Storefront and glazing on original building are past their useful service life
- Interior and exterior lighting is past it's service life.
- Panel boards located around the gym floor are past their service life.
- Panel board relays in mezzanine are not functions.

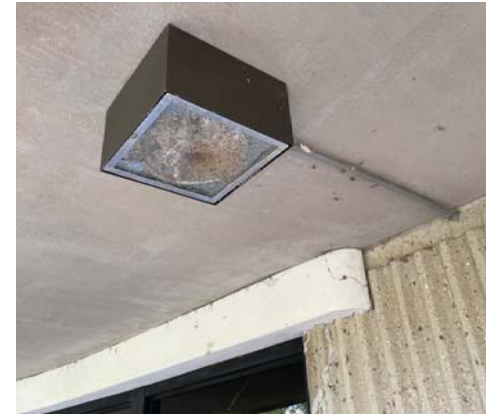
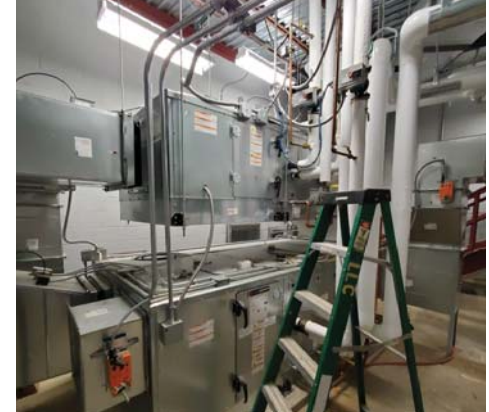
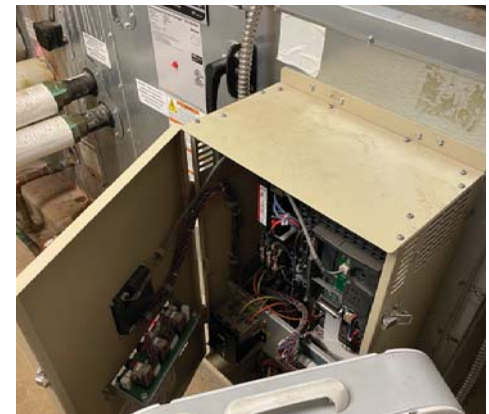
- Water infiltration at MEP Penthouse
- Water infiltration at clerestory windows at interior circular corridor
- Storefront past service life
- Access control upgrade needed
- Roof warranty good till 2032
- Sealant at control joints clearly past its service life.
- DEFERRED MAINTENANCE REQUEST ISSUED June 13, 2022
- Exterior doors and storefront past useful service life
- Interior and exterior luminaires past service life
- VFD's and Solid State drives associated with HVAC equipment appears to be past useful service life
- Solar inverters may be undersized or equipment is not properly grounded

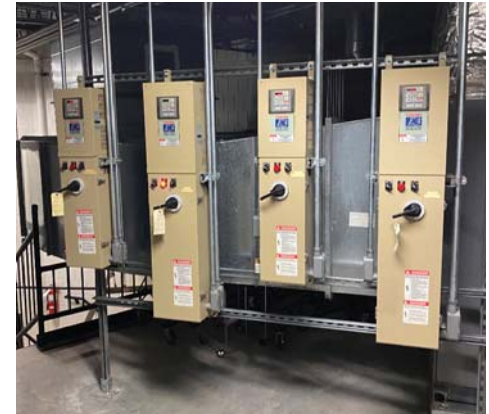
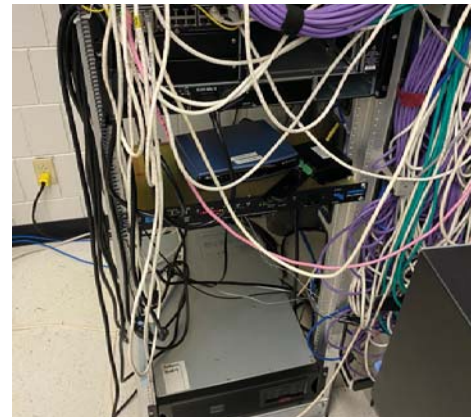
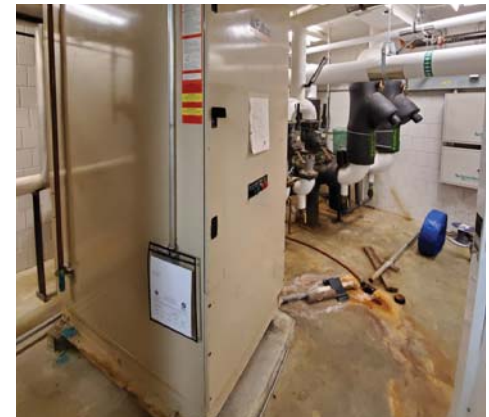
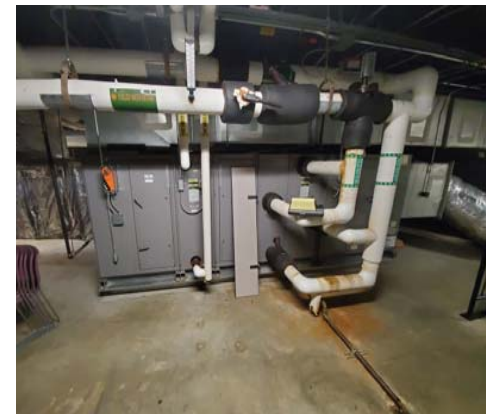
- Roof warranty expires in 2040
- Windows scheduled to be repaired
- Sealant at cladding past service life
- Most ceilings and floor finishes scheduled to be replaced in 2023
- Most walls scheduled to be refinished and painted in 2023
- Metal ladder to roof is in need of repair
- Interior lighting is past service life and scheduled to be replaced
- Data infrastructure is outdated and being updated soon
- Mechanical equipment over current protection devices are due for replacement

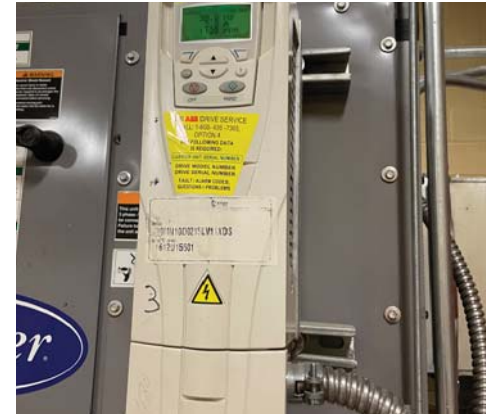
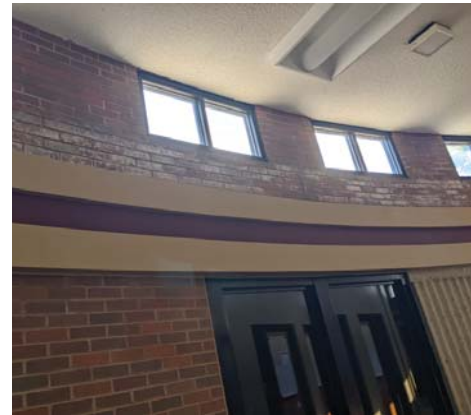
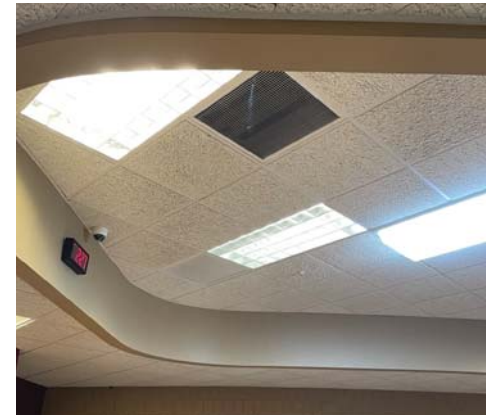
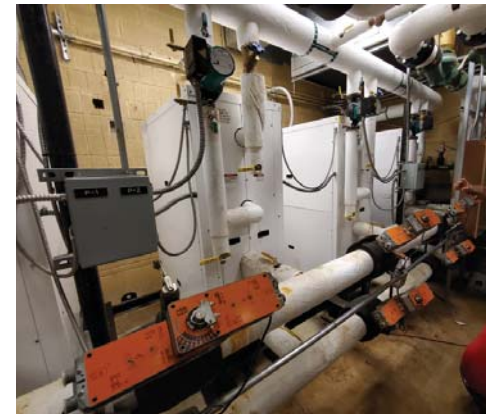
- Step crack at south corner suggests foundation settlement or heave
- Roof warranty expired 2018 for roughly 70 squares
- Roof warranty good till early 2030's
- Efflorescence at clerestory windows
- Storefront past service life
- Access control upgrade needed
- Sealant past service life
- Ceiling over 20 years old
- Interior and exterior luminaires past service life
- VFD's and Solid State drives associated with HVAC equipment appears to be past useful service life.
- Solar inverters may be undersized or equipment is not properly grounded.

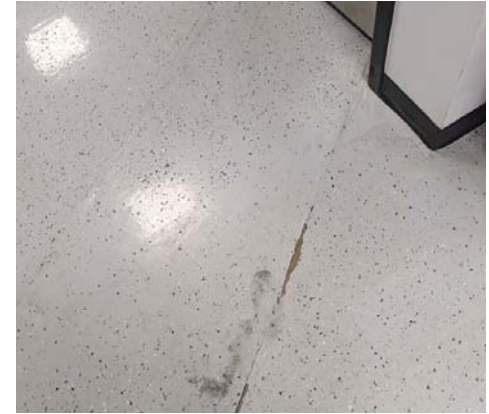
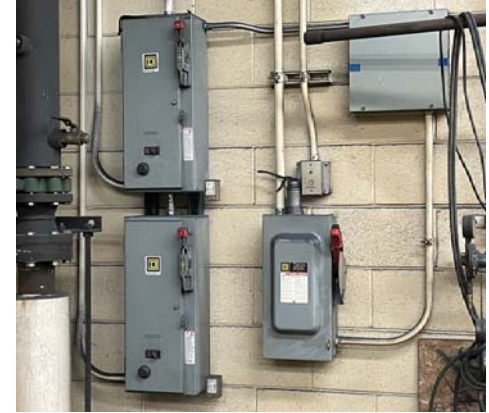
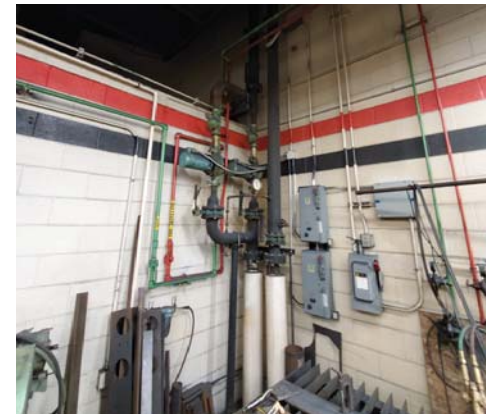
- Grass growing on roof. Roof drains clogged. Roof scuttle is dangerous
- Programmatic constraints with teachers sharing an office.
- Epoxy floors were a DIY fix and are at the end of their service life.
- Noise issue in the building between the shop and the classrooms.
- Metal roof ladder and scuttle are a safety concern
- A few vehicle exhaust fan were noted to not be functioning and are due for replacement and will need a new electrical circuit and means of disconnect.
- Parking lot lighting should be considered for replacement.

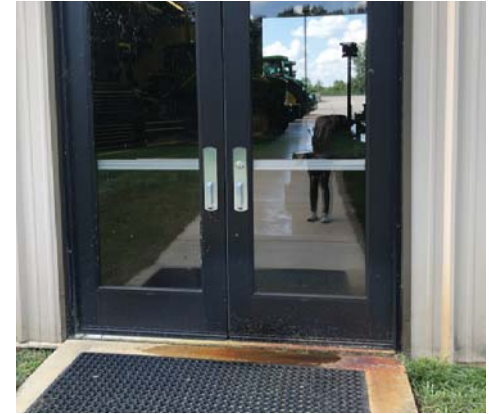
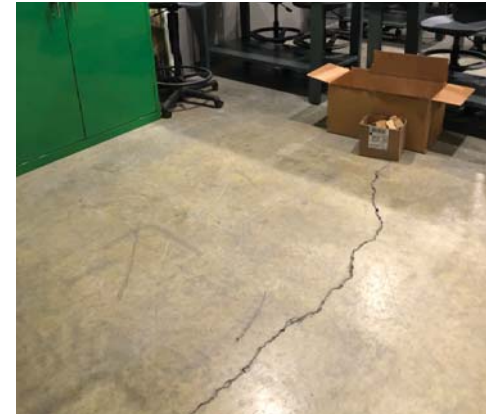
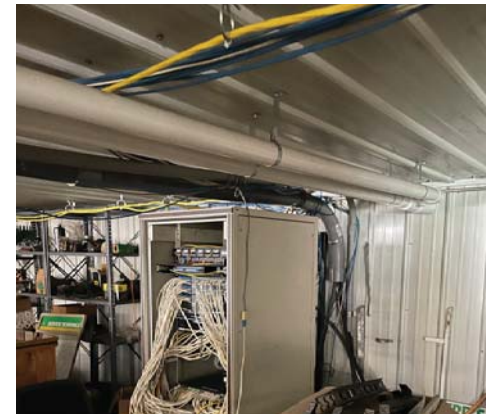
- Seepage present in NE corner of Room 106.
- Restrooms need to be refreshed–new partitions, specialties, and finishes.
- Offices need to be refreshed–new casework and finishes.
- Original Doors to the building. They should be studied in detail in conjunction with a campus-wide access/access control project
- Interior and exterior lighting is past it's service life.
- Data racks are not in a dedicated closet.
- Exiting lighting and exterior pedestrian lighting appears to not be present.

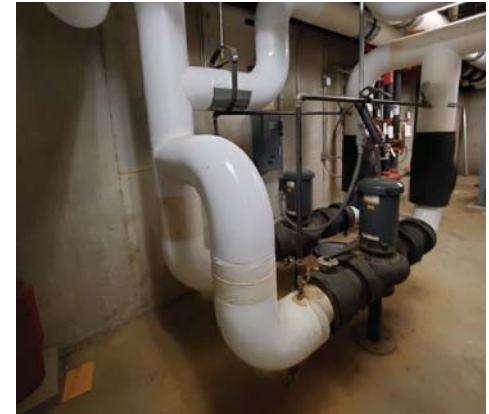
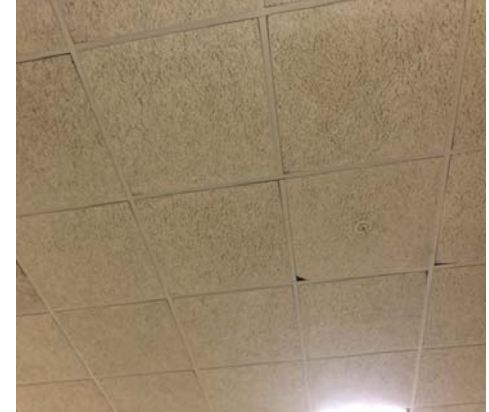
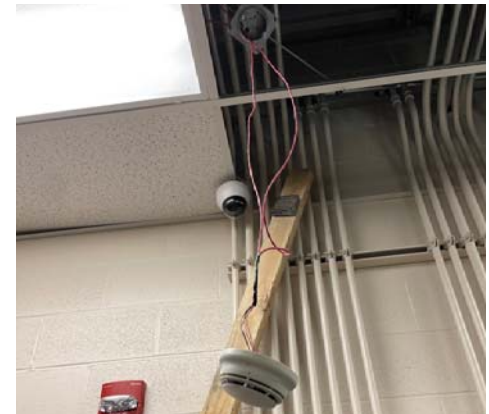
- Trip hazard at top of stairs leading to Mechanical Basement.
- This building had a transformer short circuit and the grounding associated with the main electrical equipment should be investigated.

- Interior and exterior luminaires past service life
- VFD's and local over current protection associated with HVAC equipment needs updated

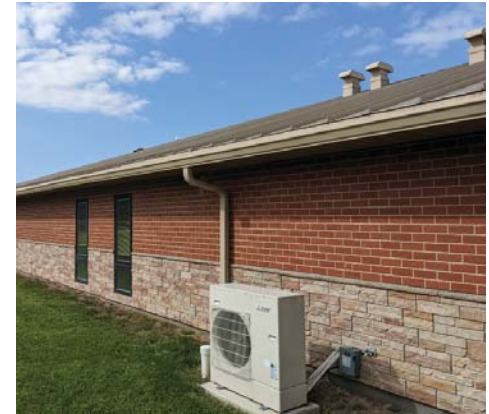
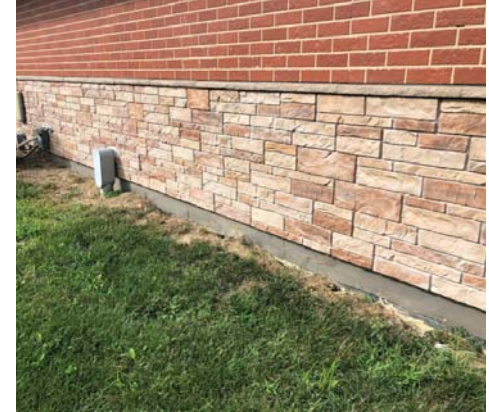
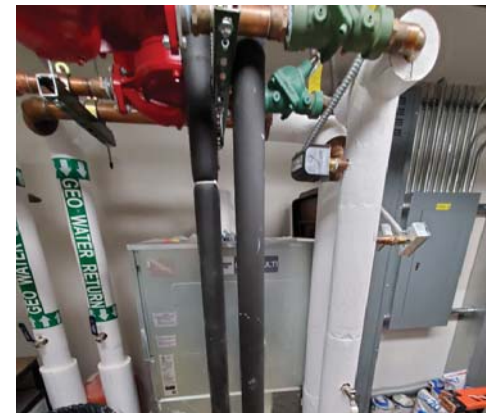
- The roof is too heavy for the structure it is sitting on.
- The ceilings are deflecting because a standing seam metal roof was put on the original 1988 trusses. You can see the ceiling drywall sagging/flexing every sixteen inches where it is fastened to the joist side of the trusses.
- The users report high sound transfer between offices. Sound batts or white-noise machine are recommended
- General electrical maintenance throughout the building

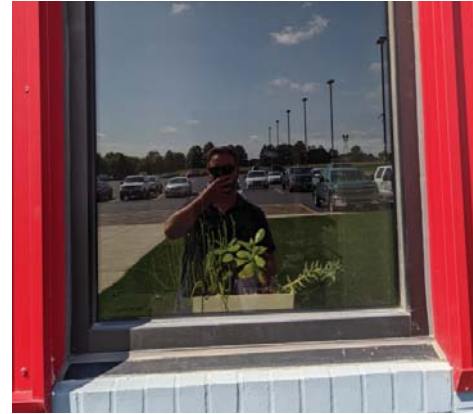
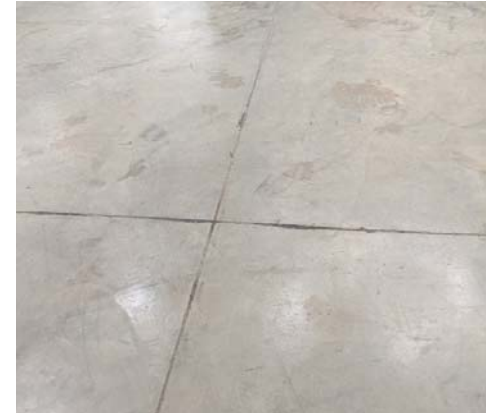
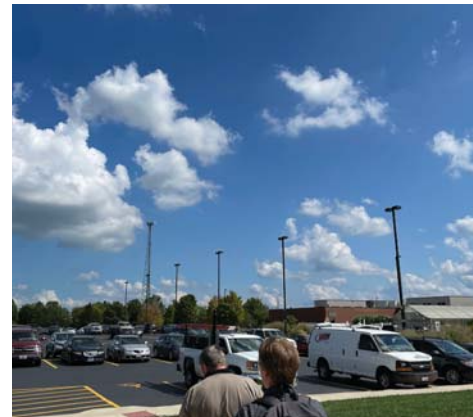
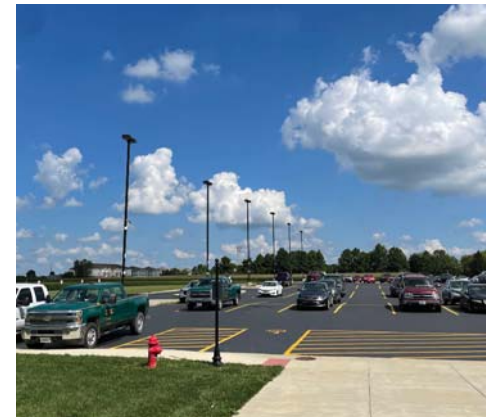
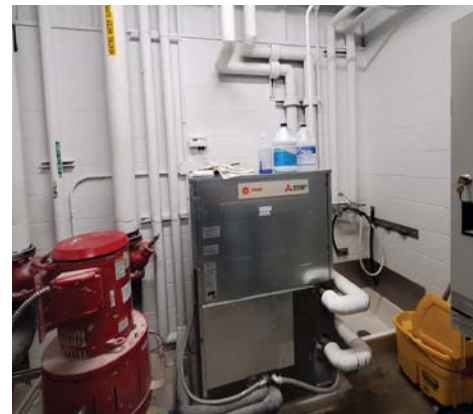
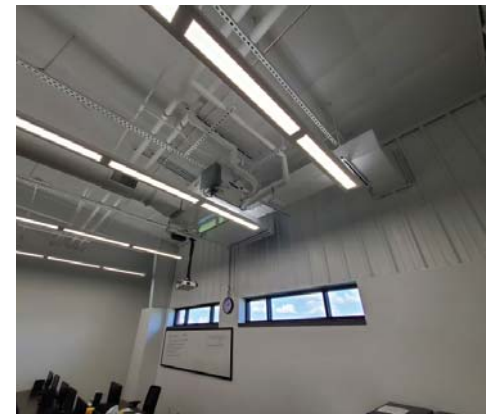
- Some concern about birds nesting at entry
- Some concern about the color of concrete in the building
- Parking lot lighting should be considered for replacement

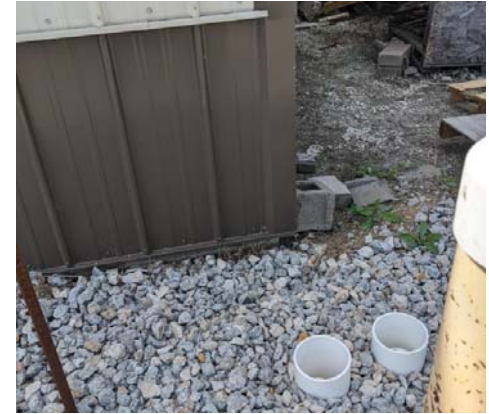
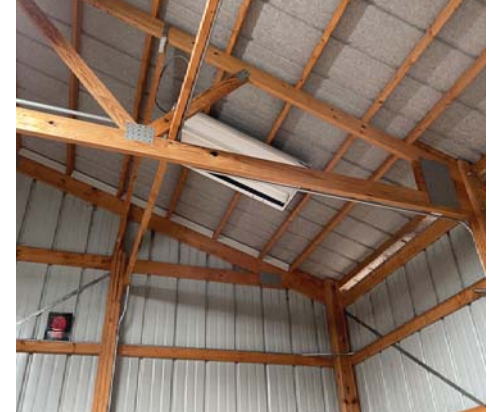
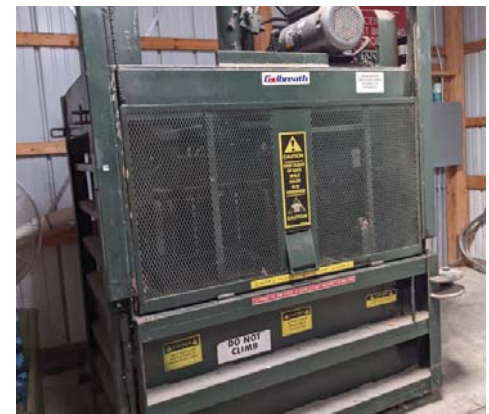
- Building is in overall good condition
- Typical routine and maintenance are needed
- Interior lighting fixtures are in need of upgrades or replacement
- Exterior lighting wall packs are in need of replacement

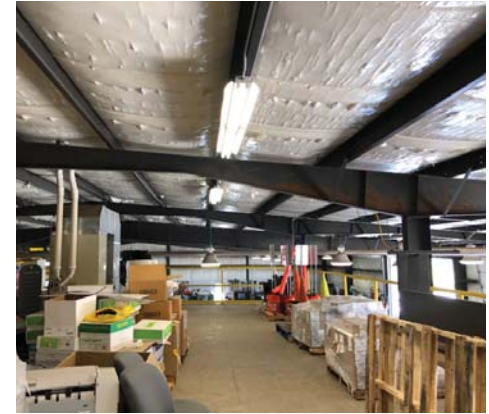
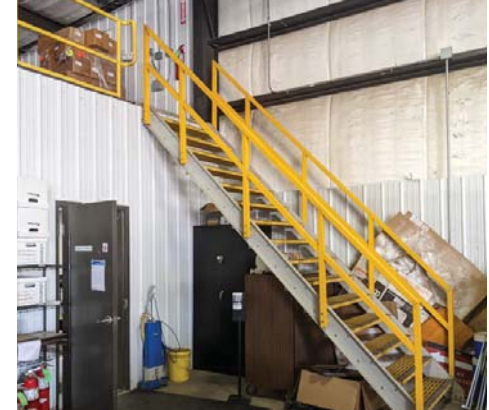
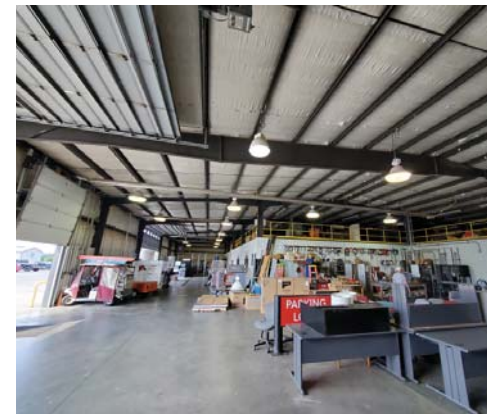
- There is a roof truss that is below 6'-8" at the mezzanine. It needs to be marked for safety.
- Vinyl ceiling is tearing at several areas
- Interior and exterior lighting is past it's service life.
- Exterior local over current protection for HVAC equipment is passed it's intended service life.

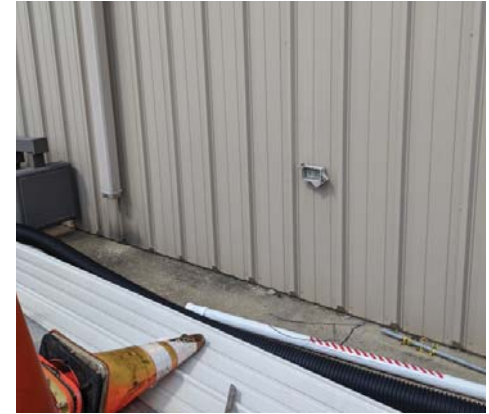
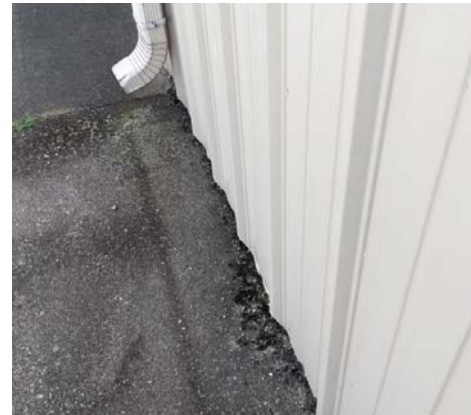
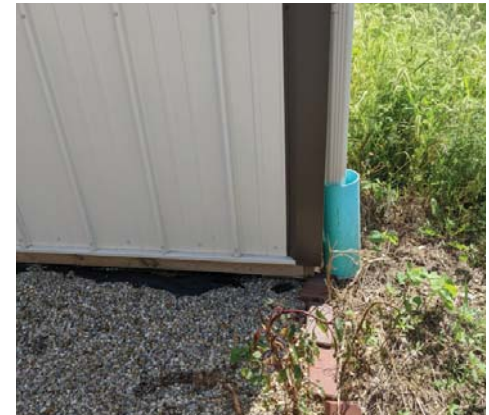
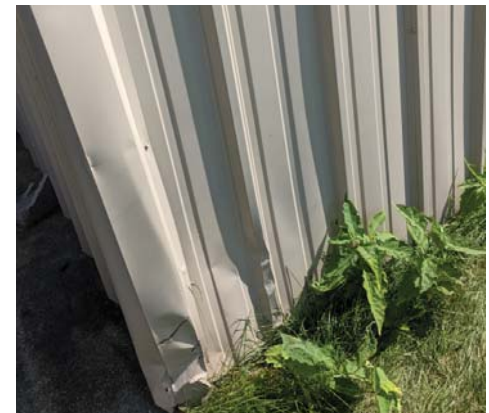
- Some cladding damaged at base
- Interior and exterior lighting is past it's service life
- Building in overall good condition
- Typical routine and maintenance are needed

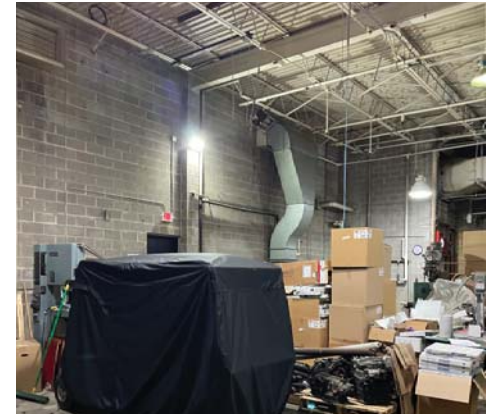
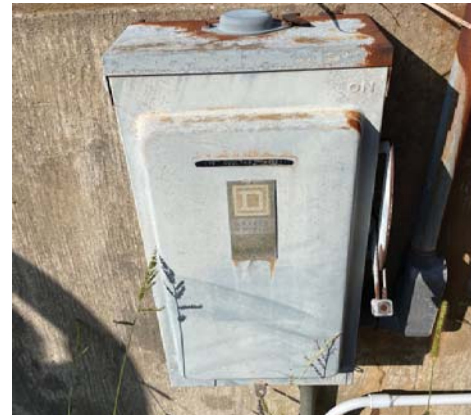
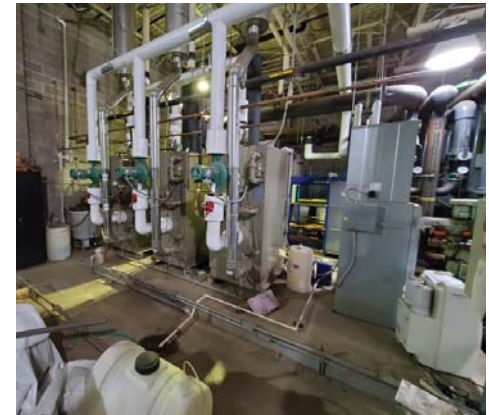
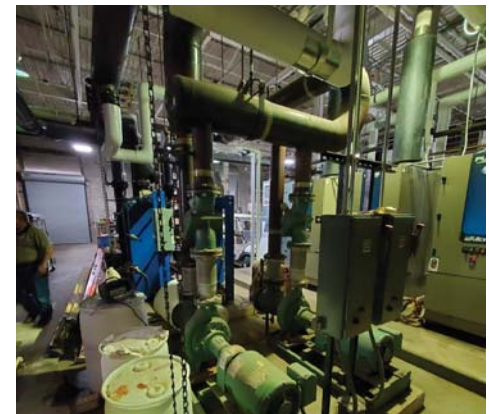
- Leaks at NW and at existing pipe penetrations that are abandoned.
- Trip Hazard at the top of the stairs at the exit door.
- Efflorescence at walls
- Interior and exterior lighting is past it's service life.
- Switchgear is reaching it's expected service life.
- Capacitor bank is not functioning.
