LAKE LAND COLLEGE

Facilities Master Plan

DECEMBER 2022
LLC FACILITY CONDITION ASSESSMENT
BAILEY EDWARD PROJ. NO. 022072

LAKE LAND COLLEGE FACILITY CONDITION ASSESSMENT REPORT

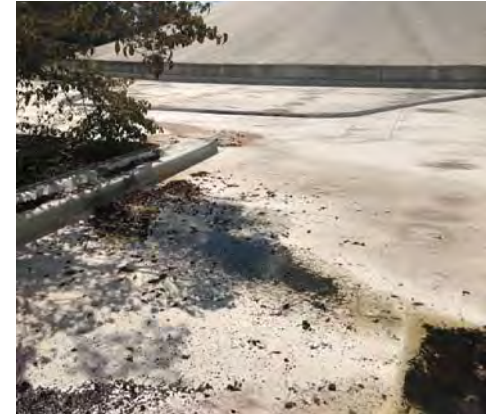
- Seepage at basement
- Roof warranty expired 2016
- Storefront past service life
- Access control upgrade needed
- Broadloom carpet past service life
- Leakage issues also in Offices 062, 063 and 064 at basement coming through the wall base and floor
- Stair handrails need to be replaced
- Exterior wall packs past service life
- Interior lighting is past service life
- Basement has multiple conduits due for repair or replacement

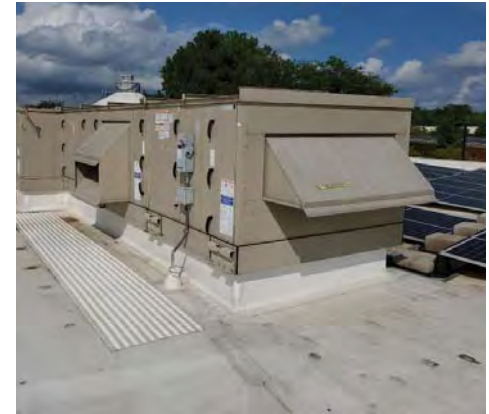
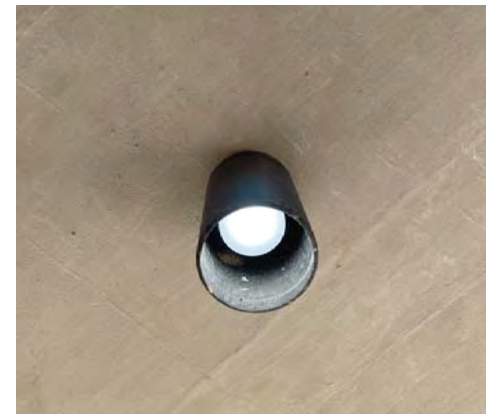
- Roof at connector and leading up to roof is in poor condition
- Roof above Theater must be replaced
- The building is newly renovated but the Auditorium was never updated. It is in dire need of a full renovation. The roof was not renovated so there is water infiltration. It needs a new ceiling. It needs new finishes. It smells of water and mold. The Auditorium was last updated in the 1990's.
- Ground fault meter was found in an electrical room and was detecting a ground fault. Ground fault study should be observed.
- Exterior local over current protection are past their service life.

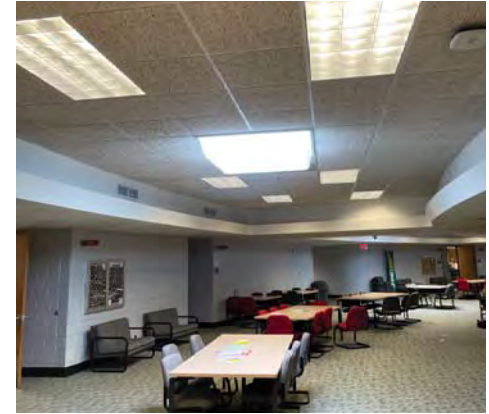
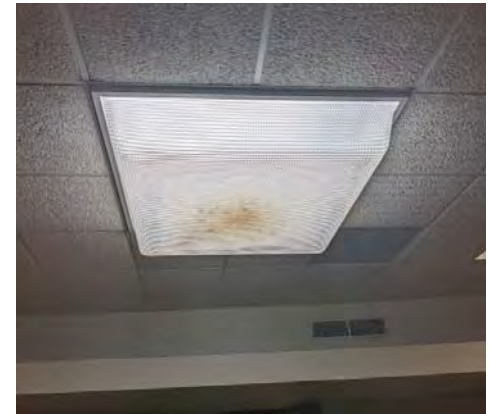
- Roof warranty expired 2001
- Water infiltration at light wells
- Water infiltration at clerestory windows
- Entry storefronts past their useful service life
- Access control upgrade needed
- Sealant at control joints clearly past its service life.
- Water stains at ceilings
- DEFERRED MAINTENANCE REQUEST ISSUED 11/04/2021
- Broadloom carpet past service life
- Mechanical equipment its past service life

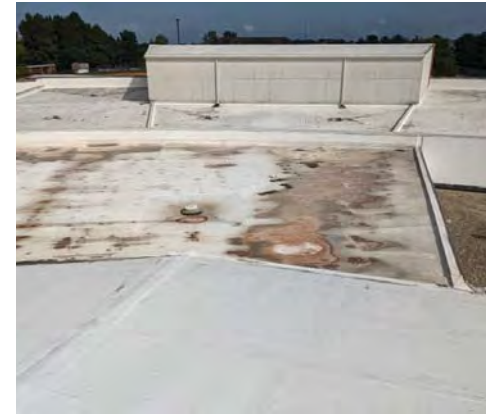
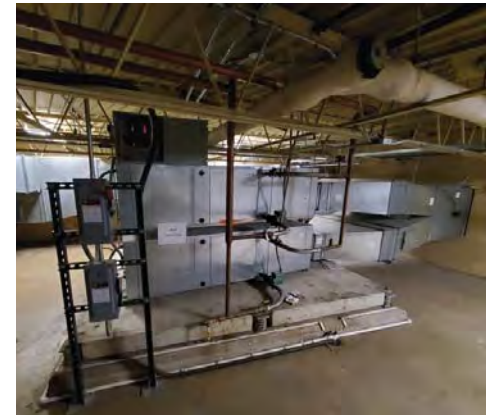
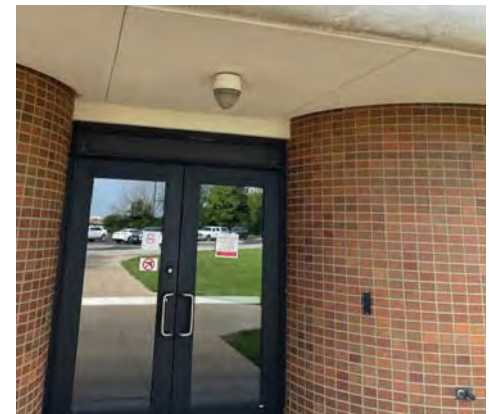
- Roof warranty expired 2005-06
- Storefront past service life
- Access control upgrade needed
- DEFERRED MAINTENANCE REQUEST ISSUED 11/04/2021
- 7500 square feet of ceiling replacement is scheduled for 2023
- Four locker rooms and their walls are scheduled to be renovated in 2023
- Many areas around the building are scheduled to have new flooring installed including Entry 040, Classrooms 104, 105, 108, 109, 110, 111, and the Fitness Center as well as several of the existing corridors. There is a new basketball floor installed. All together, this comprises roughly 70% of the building's floors.
- Storefront and glazing on original building are past their useful service life
- Interior and exterior lighting is past it's service life.
- Panel boards located around the gym floor are past their service life.
- Panel board relays in mezzanine are not functions.

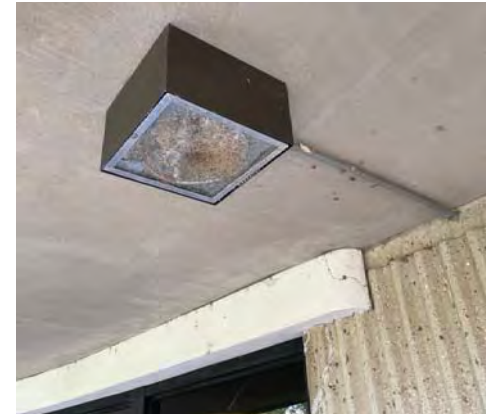
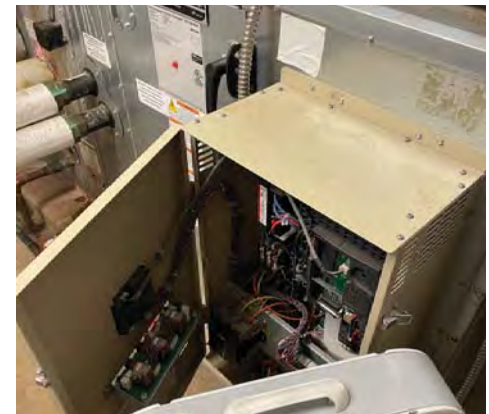
- Water infiltration at MEP Penthouse
- Water infiltration at clerestory windows at interior circular corridor
- Storefront past service life
- Access control upgrade needed
- Roof warranty good till 2032
- Sealant at control joints clearly past its service life.
- DEFERRED MAINTENANCE REQUEST ISSUED June 13, 2022
- Exterior doors and storefront past useful service life
- Interior and exterior luminaires past service life
- VFD's and Solid State drives associated with HVAC equipment appears to be past useful service life
- Solar inverters may be undersized or equipment is not properly grounded

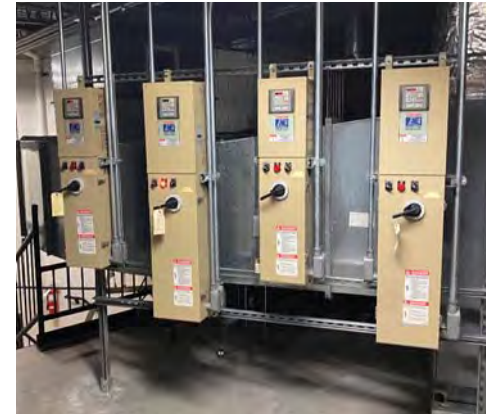
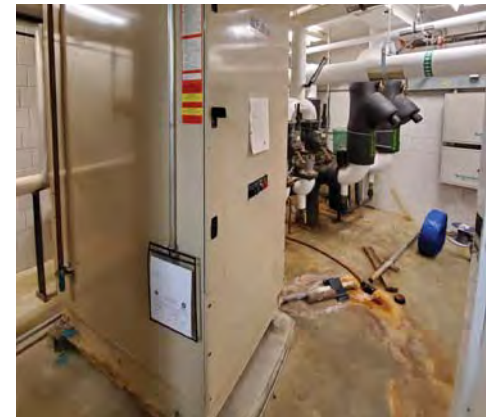
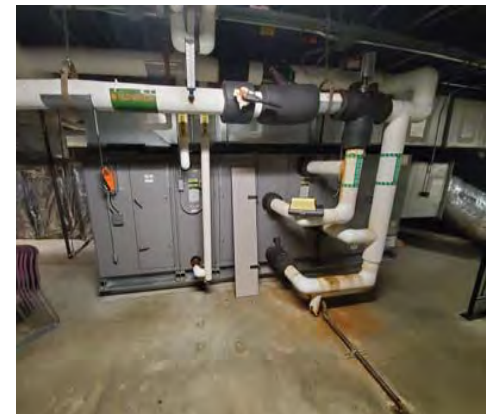
- Roof warranty expires in 2040
- Windows scheduled to be repaired
- Sealant at cladding past service life
- Most ceilings and floor finishes scheduled to be replaced in 2023
- Most walls scheduled to be refinished and painted in 2023
- Metal ladder to roof is in need of repair
- Interior lighting is past service life and scheduled to be replaced
- Data infrastructure is outdated and being updated soon
- Mechanical equipment over current protection devices are due for replacement

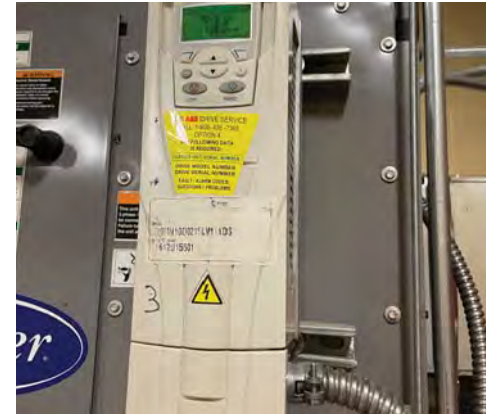
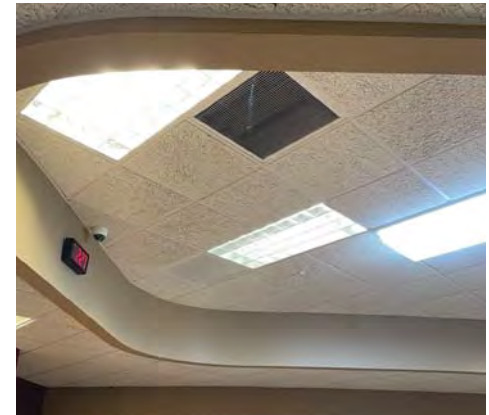
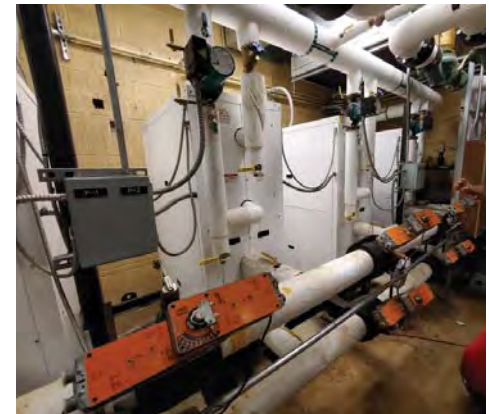
- Step crack at south corner suggests foundation settlement or heave
- Roof warranty expired 2018 for roughly 70 squares
- Roof warranty good till early 2030's
- Efflorescence at clerestory windows
- Storefront past service life
- Access control upgrade needed
- Sealant past service life
- Ceiling over 20 years old
- Interior and exterior luminaires past service life
- VFD's and Solid State drives associated with HVAC equipment appears to be past useful service life.
- Solar inverters may be undersized or equipment is not properly grounded.

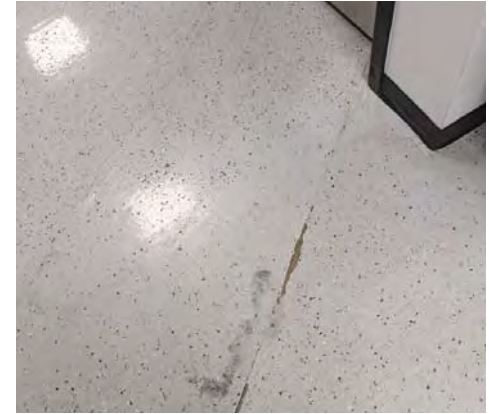
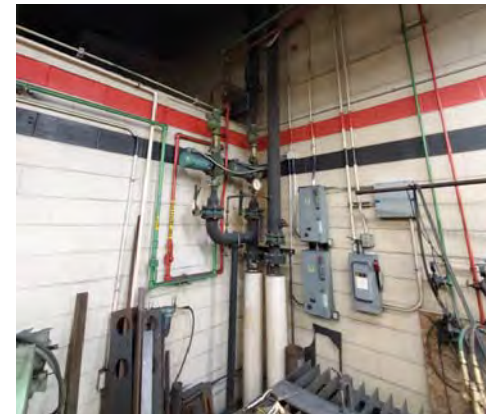
- Grass growing on roof. Roof drains clogged. Roof scuttle is dangerous
- Programmatic constraints with teachers sharing an office.
- Epoxy floors were a DIY fix and are at the end of their service life.
- Noise issue in the building between the shop and the classrooms.
- Metal roof ladder and scuttle are a safety concern
- A few vehicle exhaust fan were noted to not be functioning and are due for replacement and will need a new electrical circuit and means of disconnect.
- Parking lot lighting should be considered for replacement.

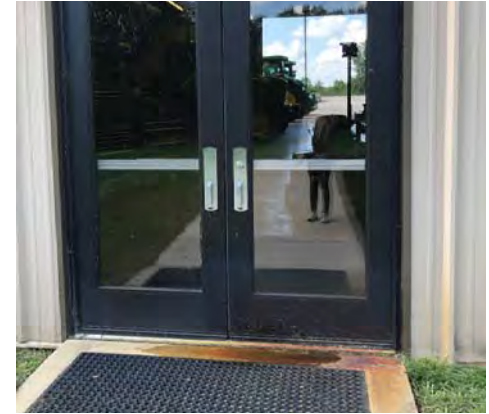
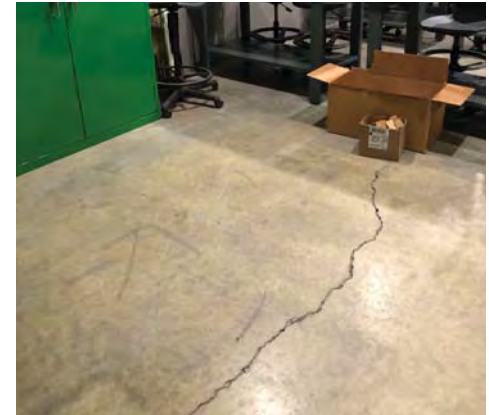
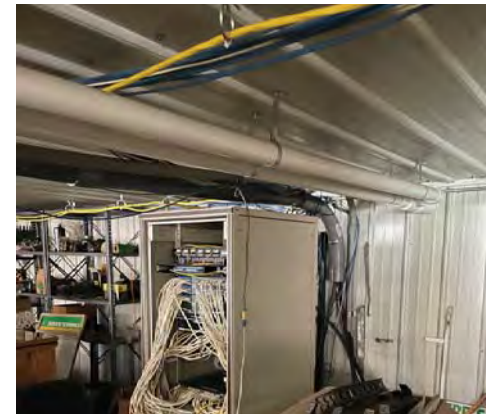
- Seepage present in NE corner of Room 106.
- Restrooms need to be refreshed—new partitions, specialties, and finishes.
- Offices need to be refreshed—new casework and finishes.
- Original Doors to the building. They should be studied in detail in conjunction with a campus-wide access/access control project
- Interior and exterior lighting is past it's service life.
- Data racks are not in a dedicated closet.
- Exiting lighting and exterior pedestrian lighting appears to not be present.

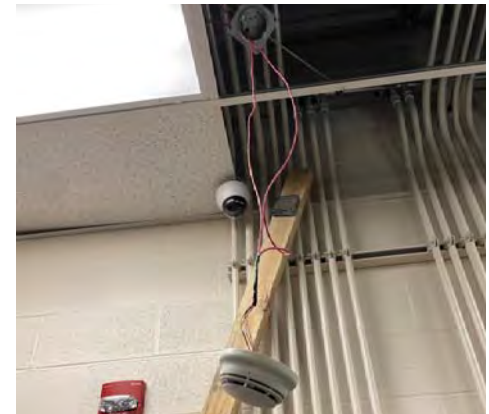
- Interior and exterior luminaires past service life
- VFD's and local over current protection associated with HVAC equipment needs updated

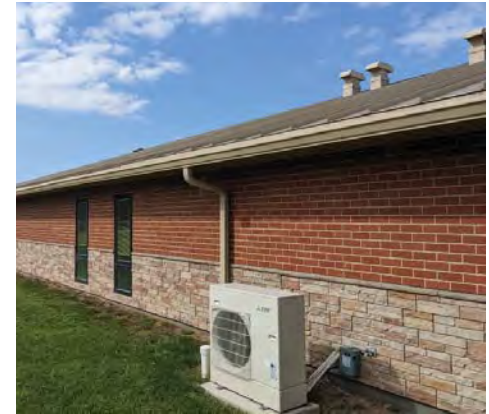
- The roof is too heavy for the structure it is sitting on.
- The ceilings are deflecting because a standing seam metal roof was put on the original 1988 trusses. You can see the ceiling drywall sagging/flexing every sixteen inches where it is fastened to the joist side of the trusses.
- The users report high sound transfer between offices. Sound batts or white-noise machine are recommended
- General electrical maintenance throughout the building

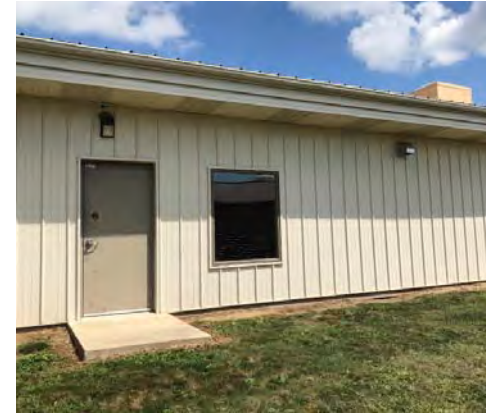
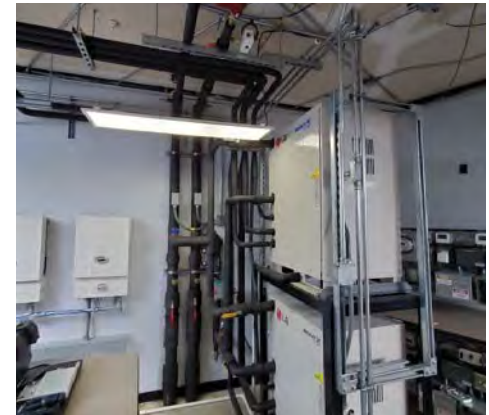
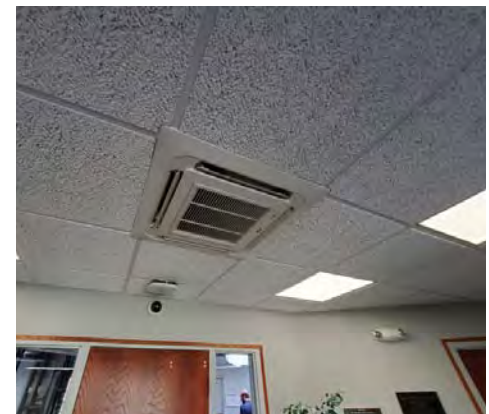
- Thin brick may not be a fifty-year system
- Small issue at stone veneer cladding
- Parking lot lighting should be considered for replacement.
- Lighting controls are not modern energy saving lighting controls

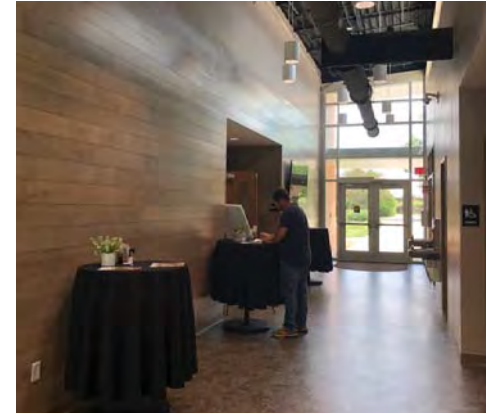
- Building in overall good condition
- Typical routine and maintenance are needed
- Typical electrical maintenance throughout the building needed

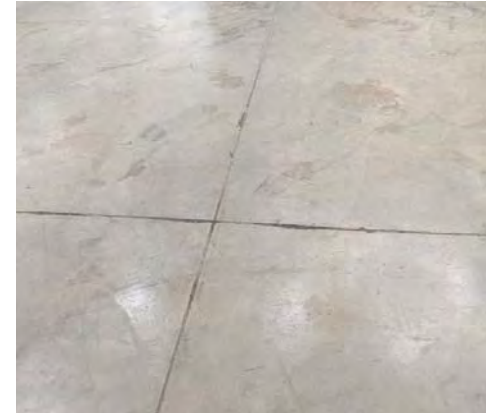
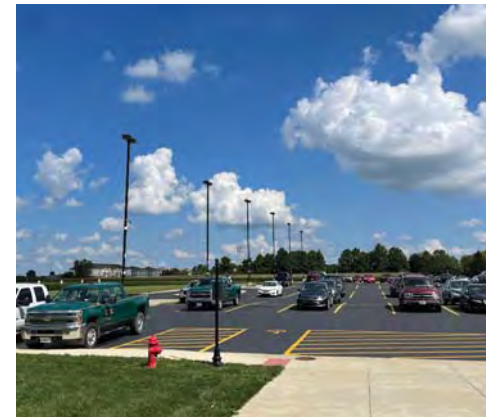
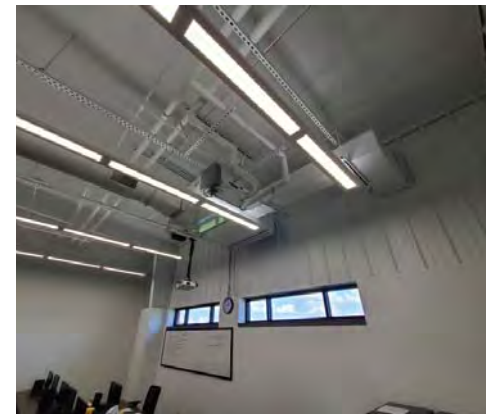
- Some concern about birds nesting at entry
- Some concern about the color of concrete in the building
- Parking lot lighting should be considered for replacement

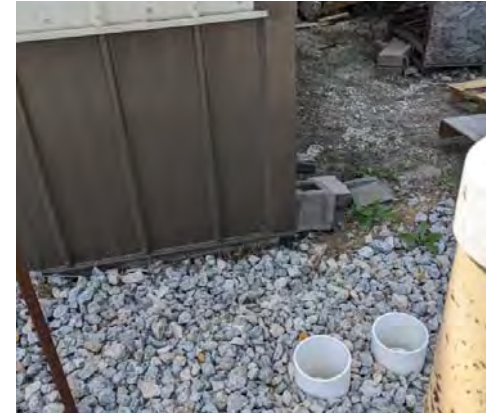
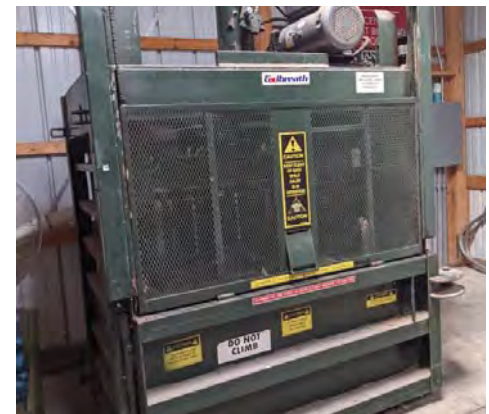
- Building is in overall good condition
- Typical routine and maintenance are needed
- Interior lighting fixtures are in need of upgrades or replacement
- Exterior lighting wall packs are in need of replacement

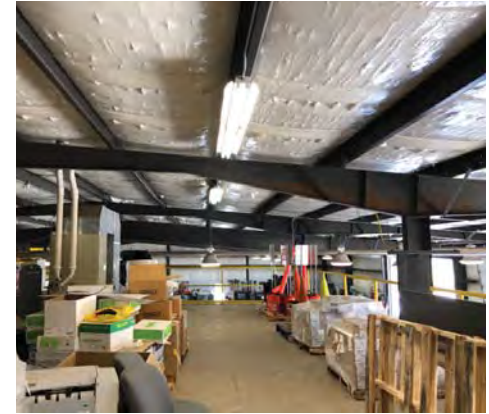
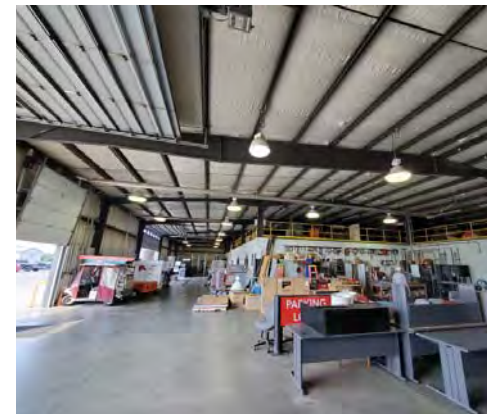
- There is a roof truss that is below 6'-8" at the mezzanine. It needs to be marked for safety.
- Vinyl ceiling is tearing at several areas
- Interior and exterior lighting is past it's service life.
- Exterior local over current protection for HVAC equipment is passed it's intended service life.

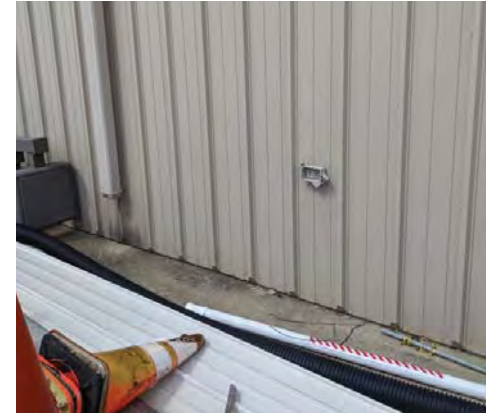
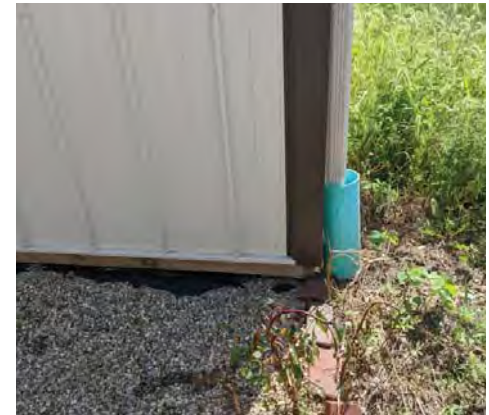
- Some cladding damaged at base
- Interior and exterior lighting is past it's service life
- Building in overall good condition
- Typical routine and maintenance are needed

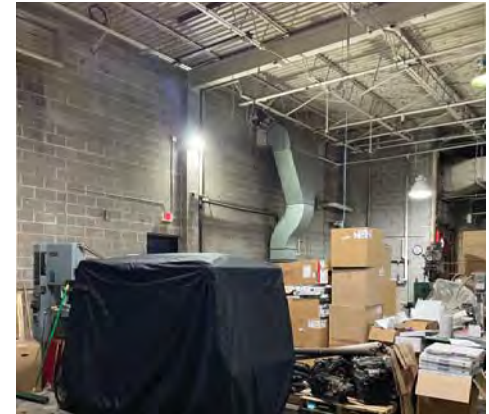
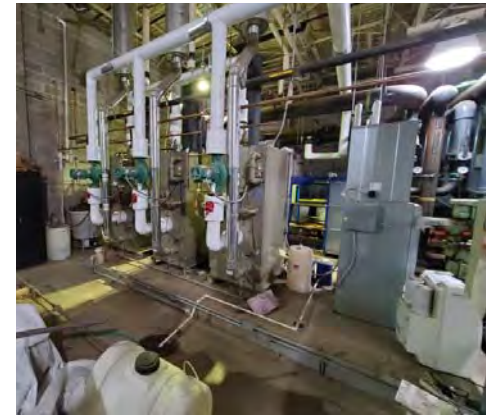
- Leaks at NW and at existing pipe penetrations that are abandoned.
- Trip Hazard at the top of the stairs at the exit door.
- Efflorescence at walls
- Interior and exterior lighting is past it's service life.
- Switchgear is reaching it's expected service life.
- Capacitor bank is not functioning.
