# **LAKE LAND** **C O L L E G E**

## **Facilities Master Plan**

DECEMBER 2022  
LLC FACILITY CONDITION ASSESSMENT  
BAILEY EDWARD PROJ. NO. 022072

## LAKE LAND COLLEGE FACILITY CONDITION ASSESSMENT REPORT

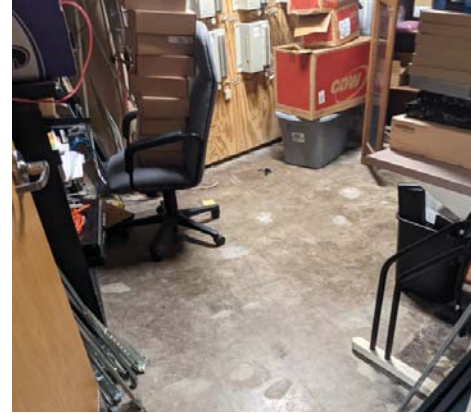
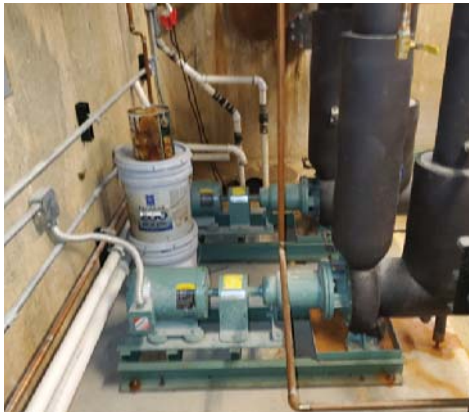
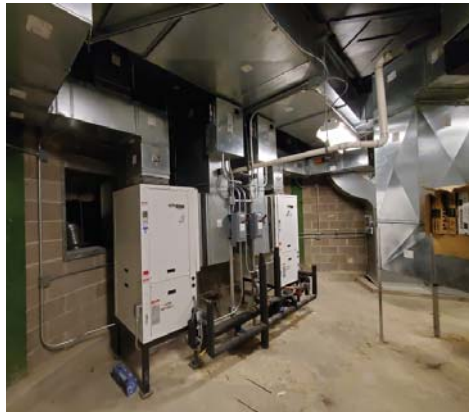
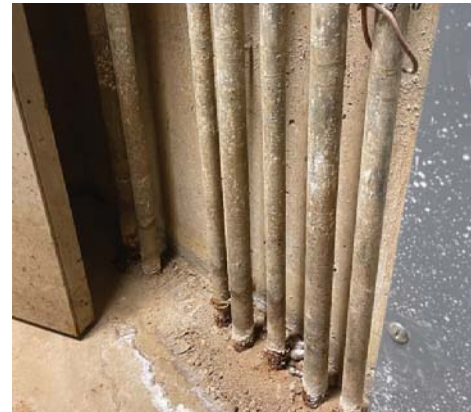
- Seepage at basement
- Roof warranty expired 2016
- Storefront past service life
- Access control upgrade needed
- Broadloom carpet past service life
- Leakage issues also in Offices 062, 063 and 064 at basement coming through the wall base and floor
- Stair handrails need to be replaced
- Exterior wall packs past service life
- Interior lighting is past service life
- Basement has multiple conduits due for repair or replacement

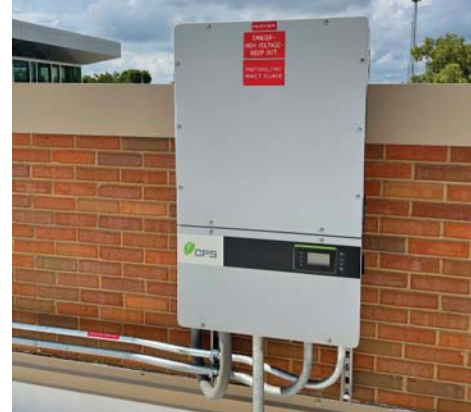
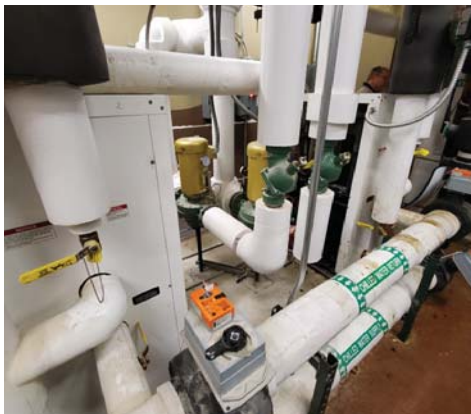
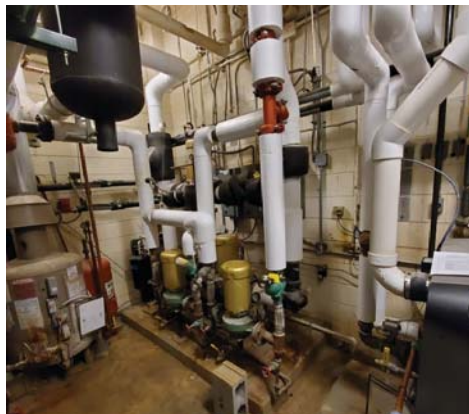
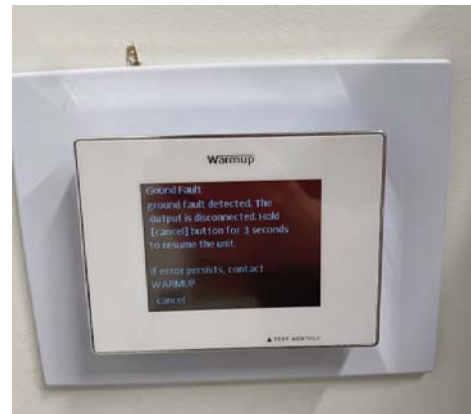
- Roof at connector and leading up to roof is in poor condition
- Roof above Theater must be replaced
- The building is newly renovated but the Auditorium was never updated. It is in dire need of a full renovation. The roof was not renovated so there is water infiltration. It needs a new ceiling. It needs new finishes. It smells of water and mold. The Auditorium was last updated in the 1990's.
- Ground fault meter was found in an electrical room and was detecting a ground fault. Ground fault study should be observed.
- Exterior local over current protection are past their service life.

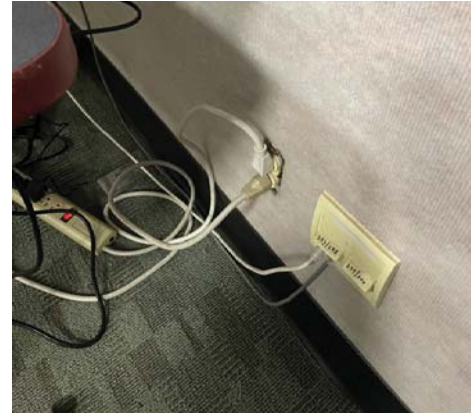
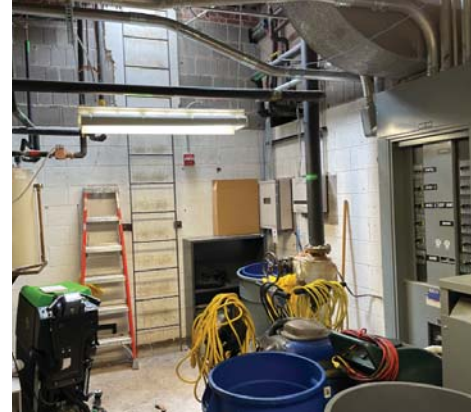
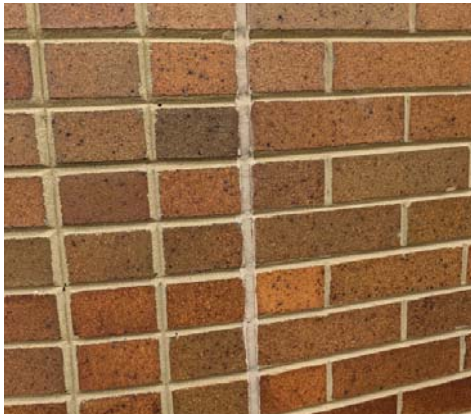
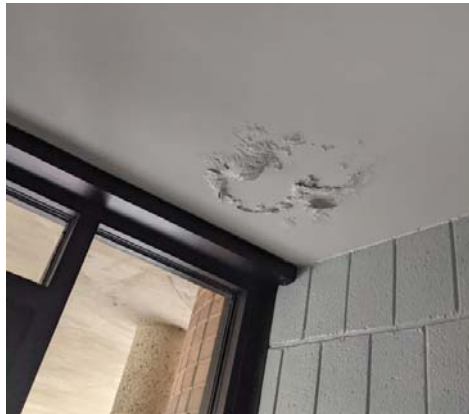
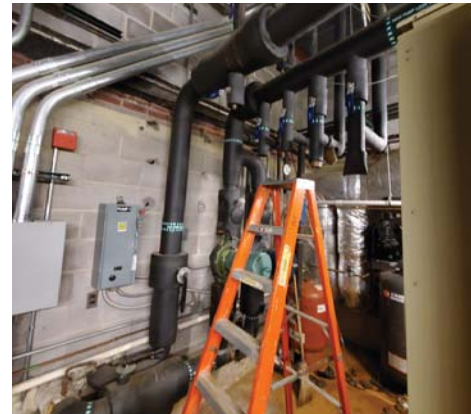
- Roof warranty expired 2001
- Water infiltration at light wells
- Water infiltration at clerestory windows
- Entry storefronts past their useful service life
- Access control upgrade needed
- Sealant at control joints clearly past its service life.
- Water stains at ceilings
- DEFERRED MAINTENANCE REQUEST ISSUED 11/04/2021
- Broadloom carpet past service life
- Mechanical equipment its past service life

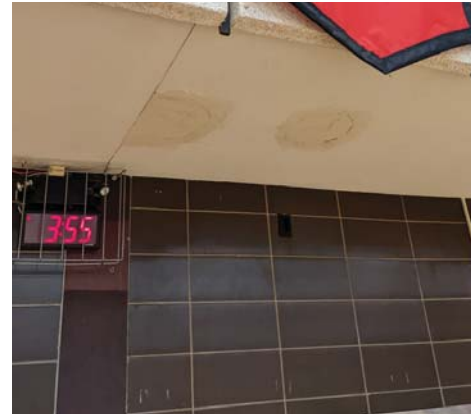
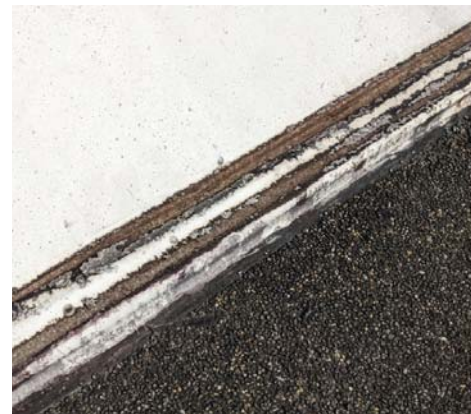
- Roof warranty expired 2005-06
- Storefront past service life
- Access control upgrade needed
- DEFERRED MAINTENANCE REQUEST ISSUED 11/04/2021
- 7500 square feet of ceiling replacement is scheduled for 2023
- Four locker rooms and their walls are scheduled to be renovated in 2023
- Many areas around the building are scheduled to have new flooring installed including Entry 040, Classrooms 104, 105, 108, 109, 110, 111, and the Fitness Center as well as several of the existing corridors. There is a new basketball floor installed. All together, this comprises roughly 70% of the building's floors.
- Storefront and glazing on original building are past their useful service life
- Interior and exterior lighting is past it's service life.
- Panel boards located around the gym floor are past their service life.
- Panel board relays in mezzanine are not functions.

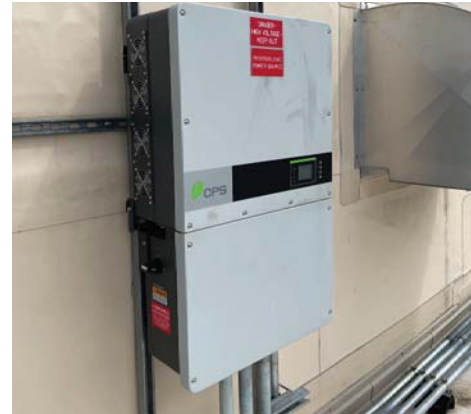
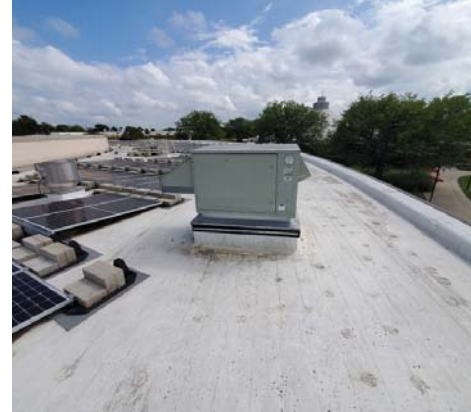
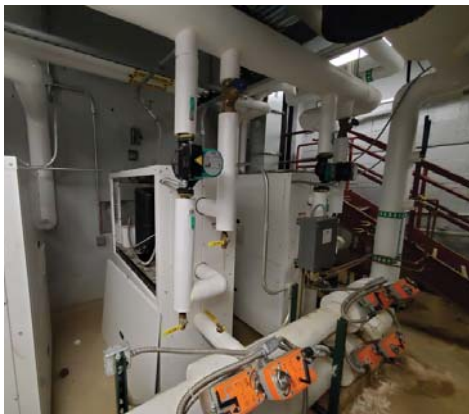
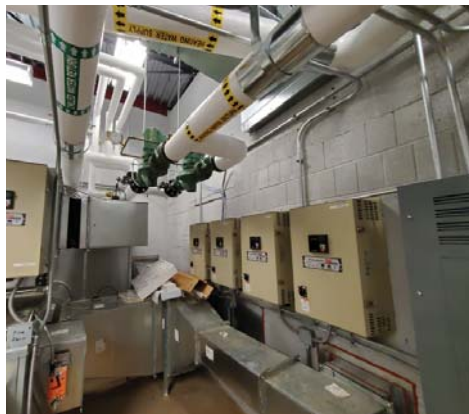
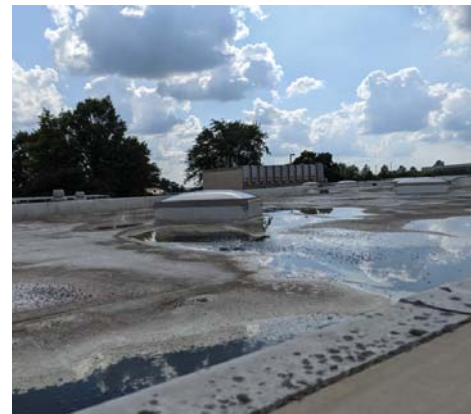
- Water infiltration at MEP Penthouse
- Water infiltration at clerestory windows at interior circular corridor
- Storefront past service life
- Access control upgrade needed
- Roof warranty good till 2032
- Sealant at control joints clearly past its service life.
- DEFERRED MAINTENANCE REQUEST ISSUED June 13, 2022
- Exterior doors and storefront past useful service life
- Interior and exterior luminaires past service life
- VFD's and Solid State drives associated with HVAC equipment appears to be past useful service life
- Solar inverters may be undersized or equipment is not properly grounded

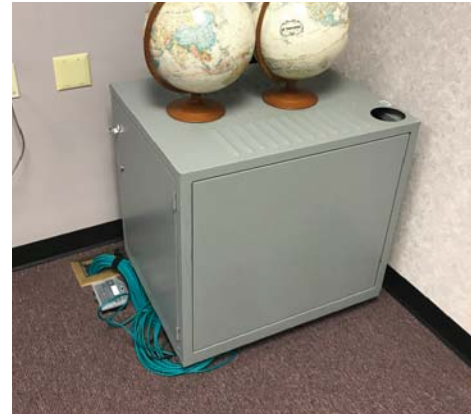
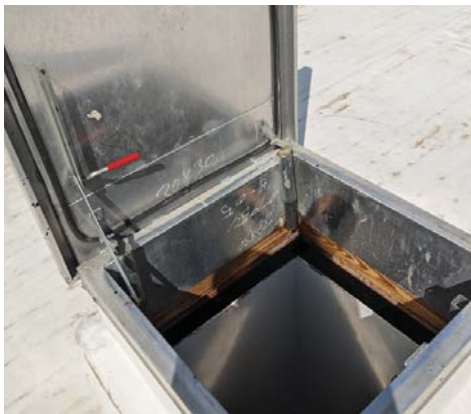
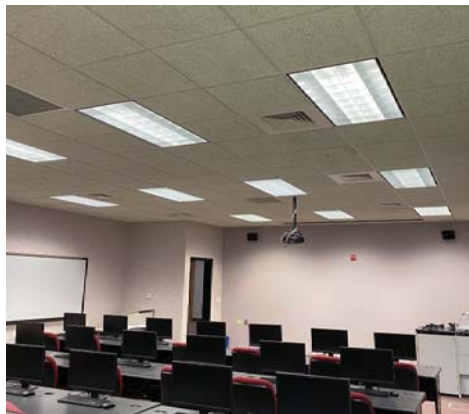
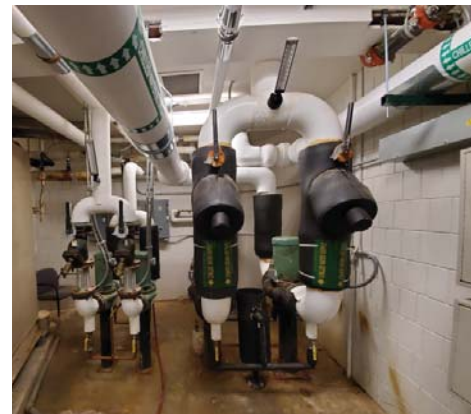
- Roof warranty expires in 2040
- Windows scheduled to be repaired
- Sealant at cladding past service life
- Most ceilings and floor finishes scheduled to be replaced in 2023
- Most walls scheduled to be refinished and painted in 2023
- Metal ladder to roof is in need of repair
- Interior lighting is past service life and scheduled to be replaced
- Data infrastructure is outdated and being updated soon
- Mechanical equipment over current protection devices are due for replacement

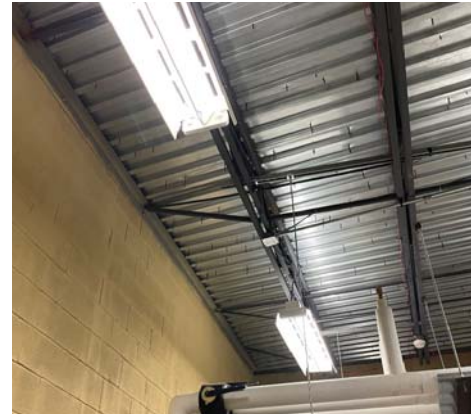
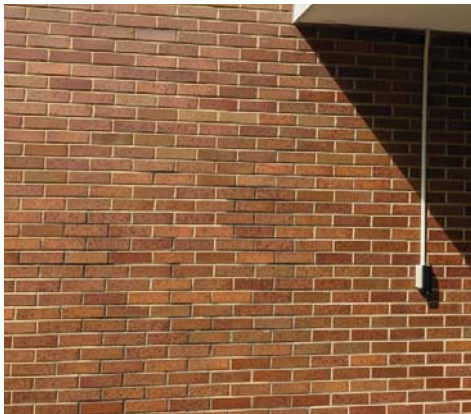
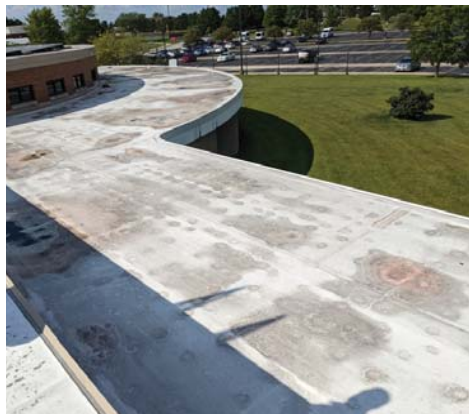
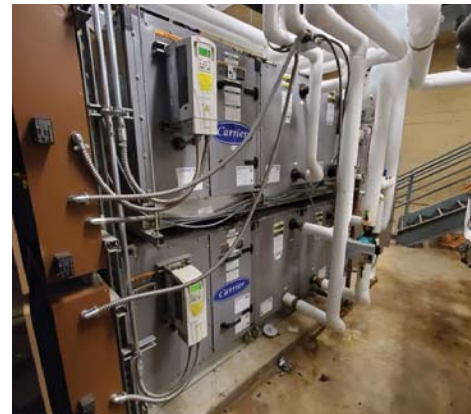
- Step crack at south corner suggests foundation settlement or heave
- Roof warranty expired 2018 for roughly 70 squares
- Roof warranty good till early 2030's
- Efflorescence at clerestory windows
- Storefront past service life
- Access control upgrade needed
- Sealant past service life
- Ceiling over 20 years old
- Interior and exterior luminaires past service life
- VFD's and Solid State drives associated with HVAC equipment appears to be past useful service life.
- Solar inverters may be undersized or equipment is not properly grounded.

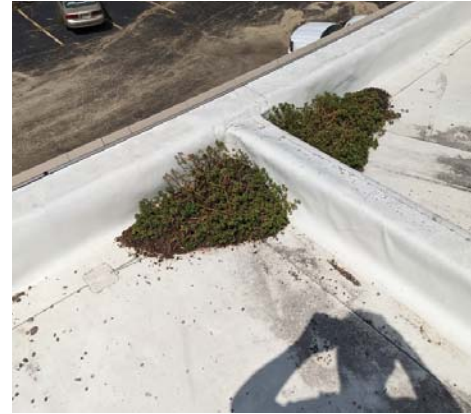
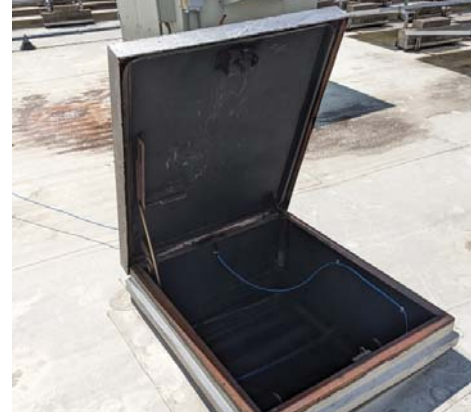
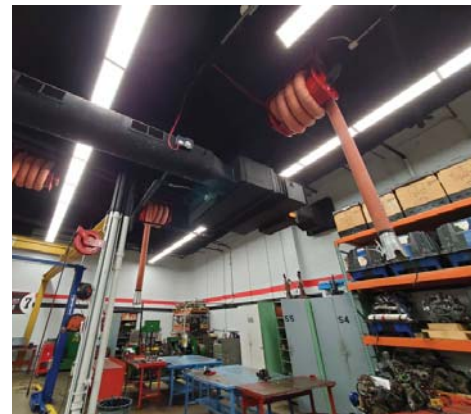
- Grass growing on roof. Roof drains clogged. Roof scuttle is dangerous
- Programmatic constraints with teachers sharing an office.
- Epoxy floors were a DIY fix and are at the end of their service life.
- Noise issue in the building between the shop and the classrooms.
- Metal roof ladder and scuttle are a safety concern
- A few vehicle exhaust fan were noted to not be functioning and are due for replacement and will need a new electrical circuit and means of disconnect.
- Parking lot lighting should be considered for replacement.

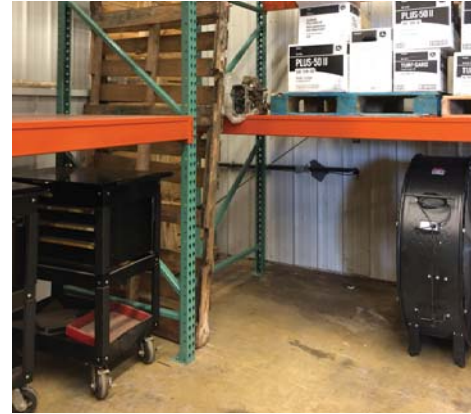
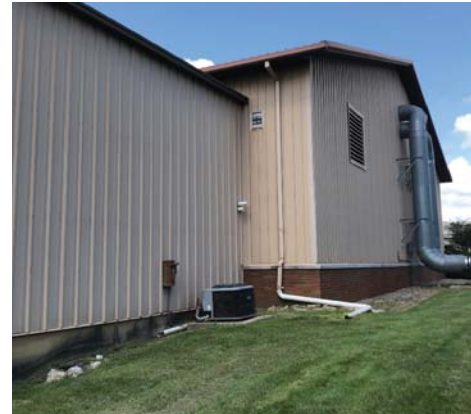
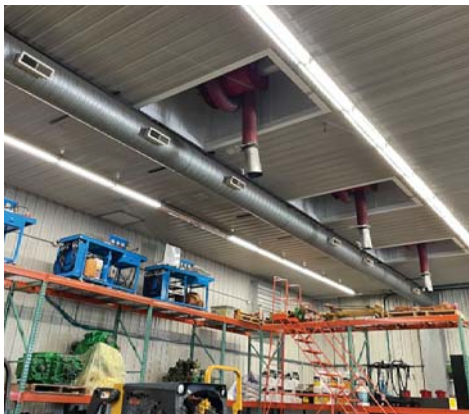
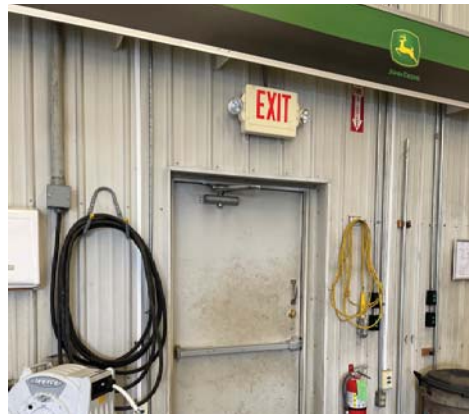
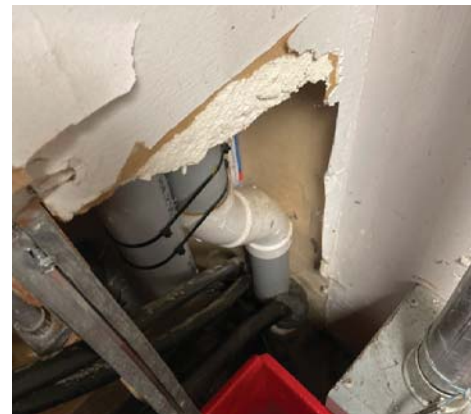
- Seepage present in NE corner of Room 106.
- Restrooms need to be refreshed–new partitions, specialties, and finishes.
- Offices need to be refreshed–new casework and finishes.
- Original Doors to the building. They should be studied in detail in conjunction with a campus-wide access/access control project
- Interior and exterior lighting is past it's service life.
- Data racks are not in a dedicated closet.
- Exiting lighting and exterior pedestrian lighting appears to not be present.

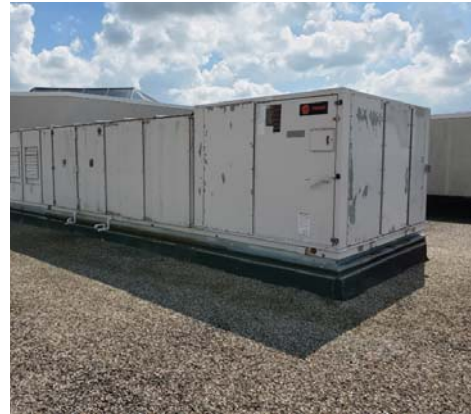
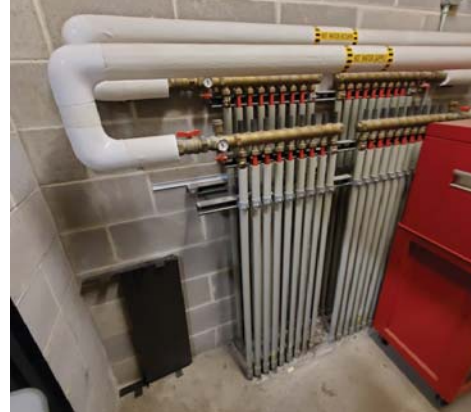
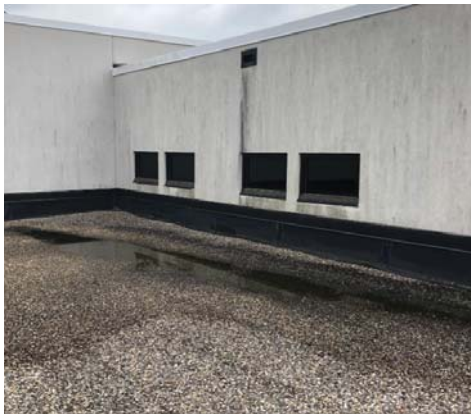
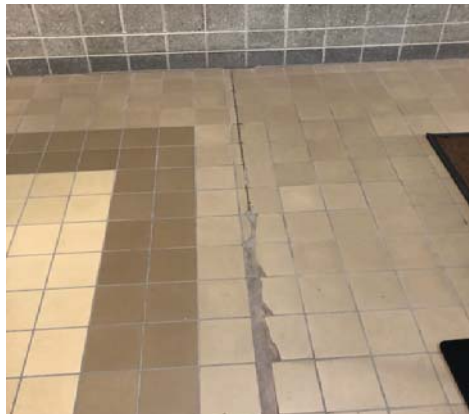
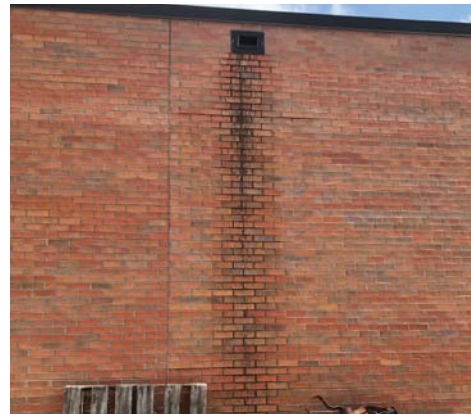
- Roof warranty expired or near expiration
- Water infiltration at the windows
- Masonry wavy and moving differentially to the structure
- The scuppers on the building do not have drip edges. Masonry in these areas is damaged and water stained.

- Water damage in several areas of ceiling tiles
- Several areas of wall are water-damaged, effloresced, or discolored from thermal and moisture intrusion

- Full building expansion joints and control joints cracking in several areas throughout the building.
- Broadloom carpet past service life
- DEFERRED MAINTENANCE REQUEST ISSUED June 13, 2022

- Trip hazard at top of stairs leading to Mechanical Basement.
- This building had a transformer short circuit and the grounding associated with the main electrical equipment should be investigated.

- Interior and exterior luminaires past service life
- VFD's and local over current protection associated with HVAC equipment needs updated

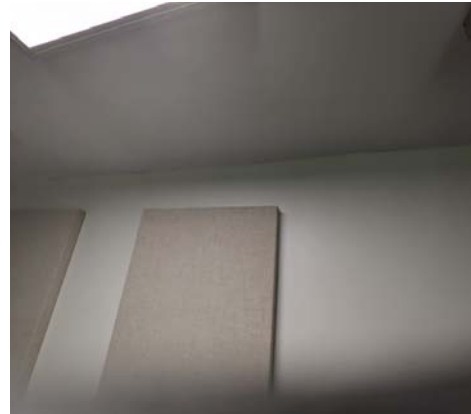
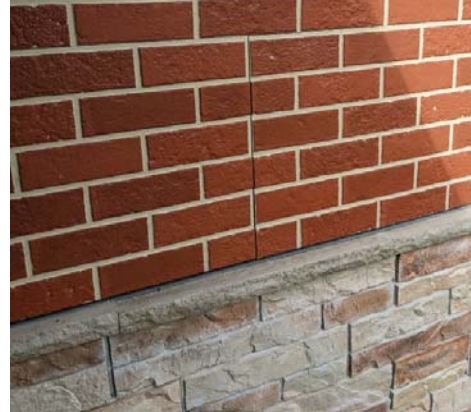
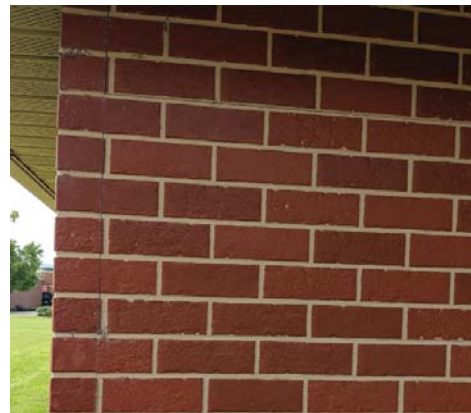
- The roof is too heavy for the structure it is sitting on.
- The ceilings are deflecting because a standing seam metal roof was put on the original 1988 trusses. You can see the ceiling drywall sagging/flexing every sixteen inches where it is fastened to the joist side of the trusses.
- The users report high sound transfer between offices. Sound batts or white-noise machine are recommended
- General electrical maintenance throughout the building

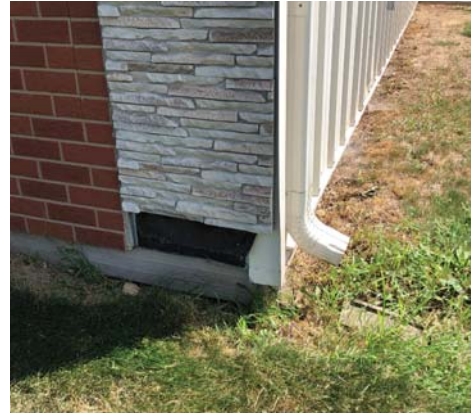
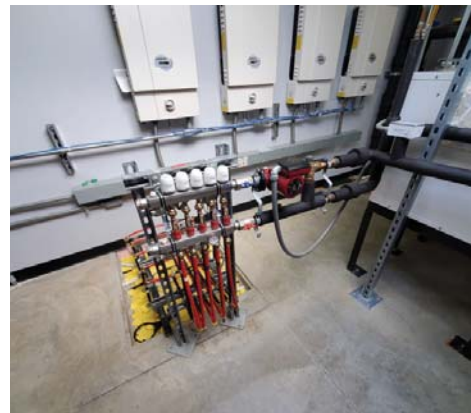
- Thin brick may not be a fifty-year system
- Small issue at stone veneer cladding
- Parking lot lighting should be considered for replacement.
- Lighting controls are not modern energy saving lighting controls

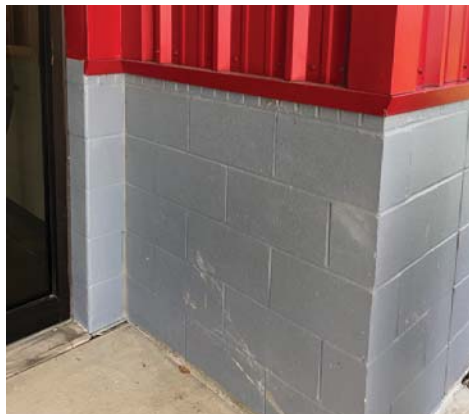
- Some concern about birds nesting at entry
- Some concern about the color of concrete in the building
- Parking lot lighting should be considered for replacement

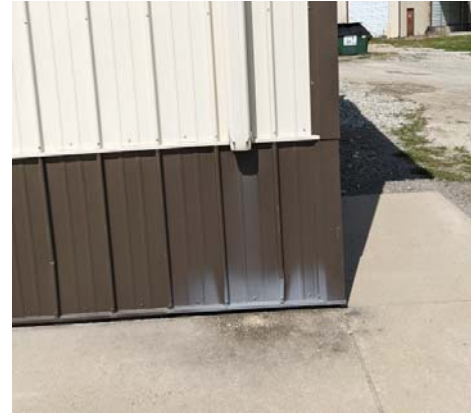
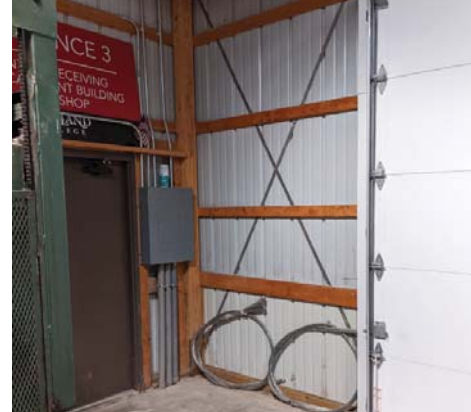
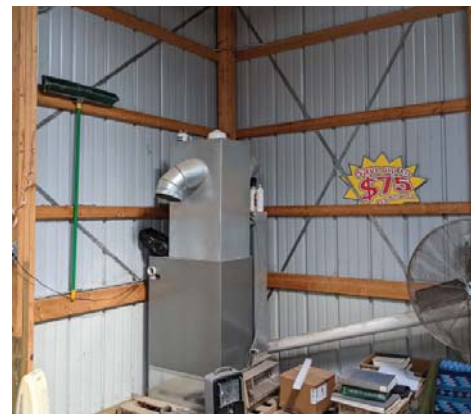
- Building is in overall good condition
- Typical routine and maintenance are needed
- Interior lighting fixtures are in need of upgrades or replacement
- Exterior lighting wall packs are in need of replacement

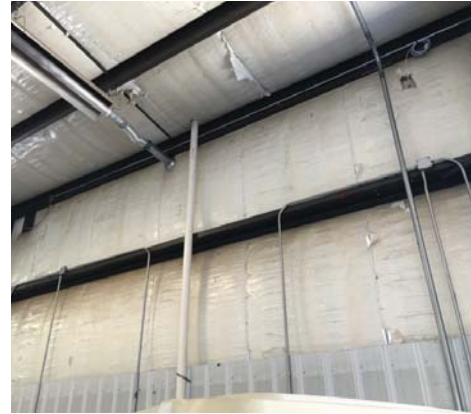
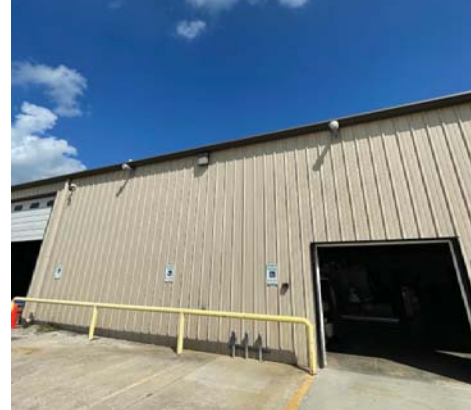
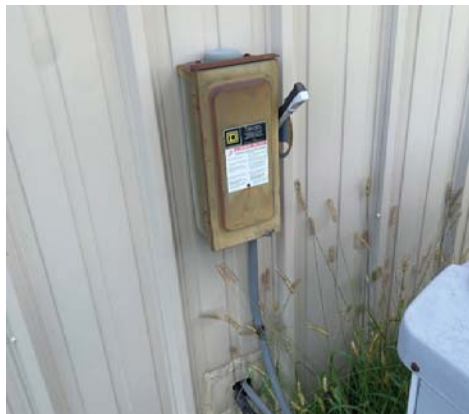
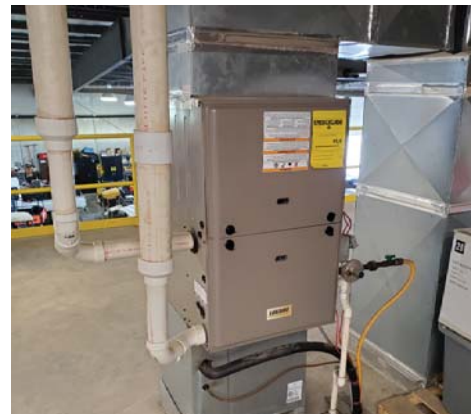
- There is a roof truss that is below 6'-8" at the mezzanine. It needs to be marked for safety.
- Vinyl ceiling is tearing at several areas
- Interior and exterior lighting is past it's service life.
- Exterior local over current protection for HVAC equipment is passed it's intended service life.

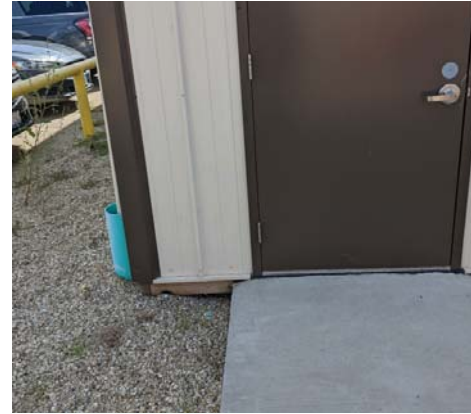
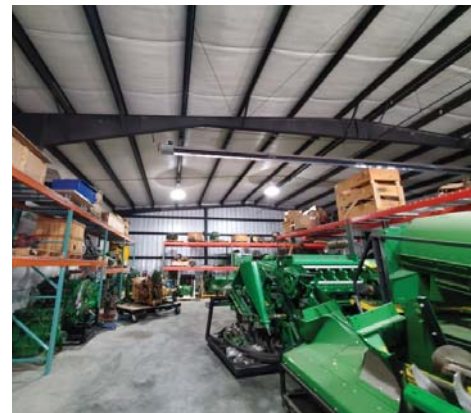
- Some cladding damaged at base
- Interior and exterior lighting is past it's service life
- Building in overall good condition
- Typical routine and maintenance are needed

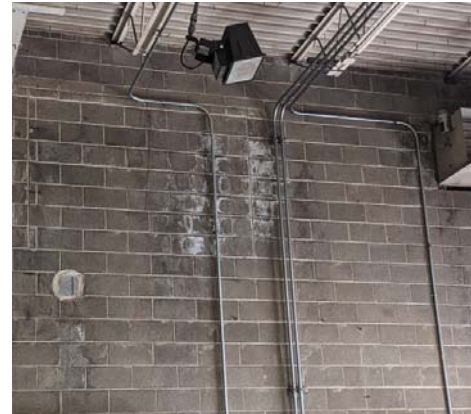
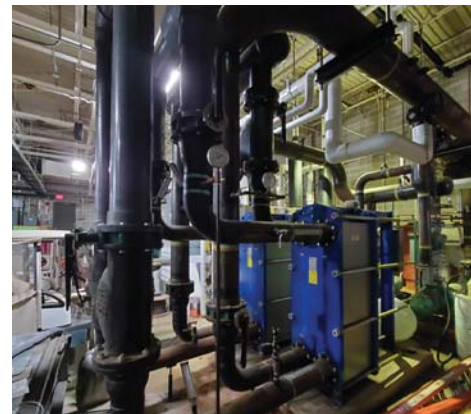
- Leaks at NW and at existing pipe penetrations that are abandoned.
- Trip Hazard at the top of the stairs at the exit door.
- Efflorescence at walls
- Interior and exterior lighting is past it's service life.
- Switchgear is reaching it's expected service life.
- Capacitor bank is not functioning.

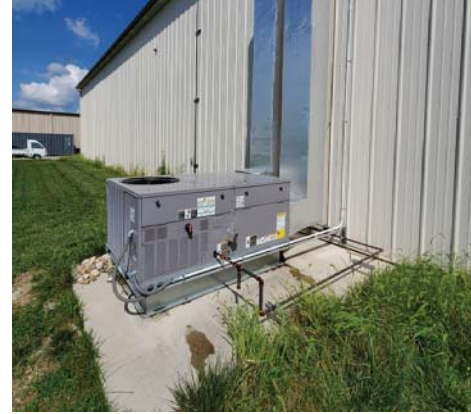
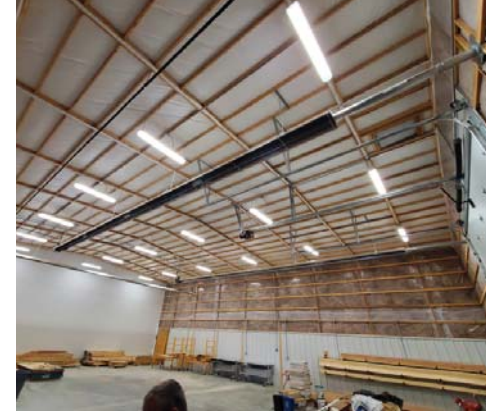
- Building in overall good condition
- Typical routine and maintenance are needed
- General electrical routine maintenance and repair needed
