LAKE LAND COLLEGE

Facilities Master Plan

DECEMBER 2022
LLC FACILITY CONDITION ASSESSMENT
BAILEY EDWARD PROJ. NO. 022072

LAKE LAND COLLEGE FACILITY CONDITION ASSESSMENT REPORT

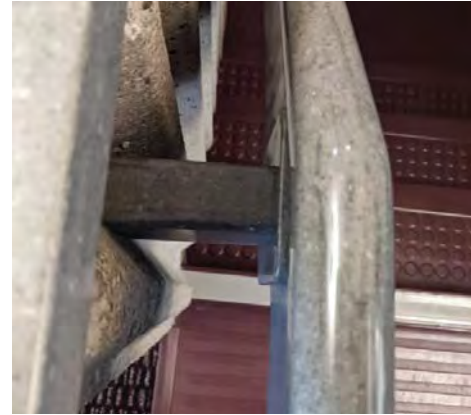
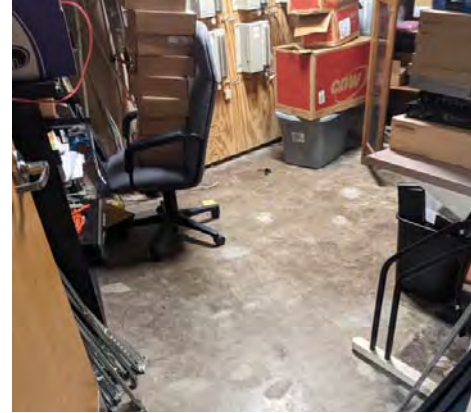
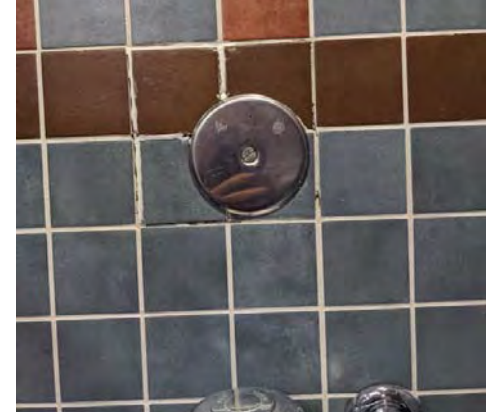
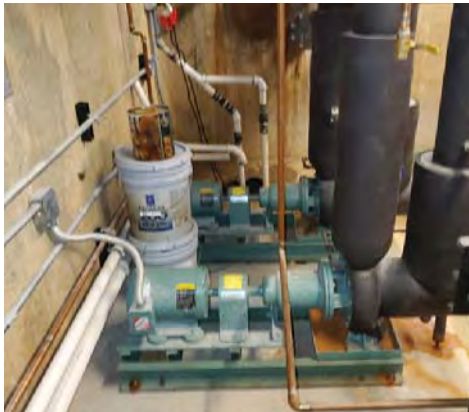
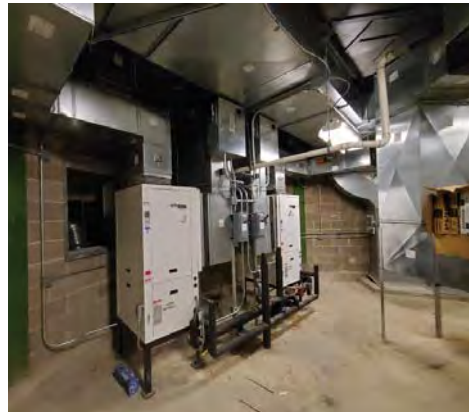
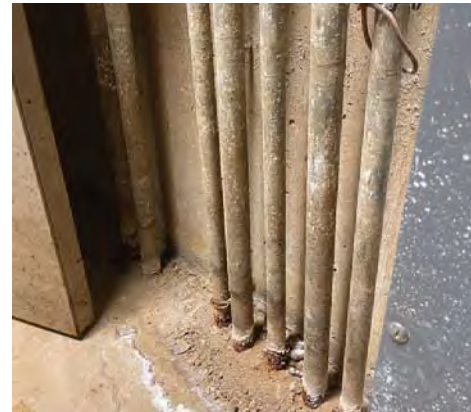
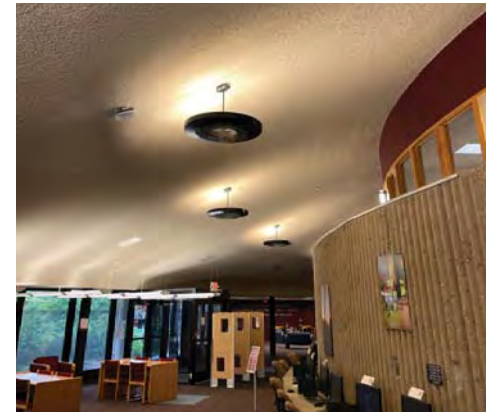
BLDG NO. LL01

- Seepage at basement
- Roof warranty expired 2016
- Storefront past service life
- Access control upgrade needed
- Broadloom carpet past service life
- Leakage issues also in Offices 062, 063 and 064 at basement coming through the wall base and floor
- Stair handrails need to be replaced
- Exterior wall packs past service life
- Interior lighting is past service life
- Basement has multiple conduits due for repair or replacement

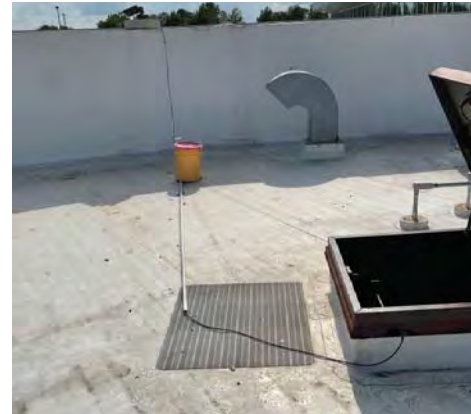
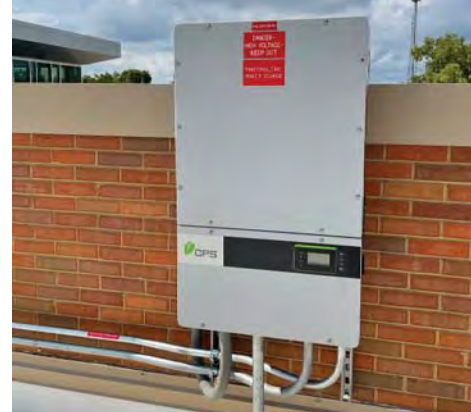
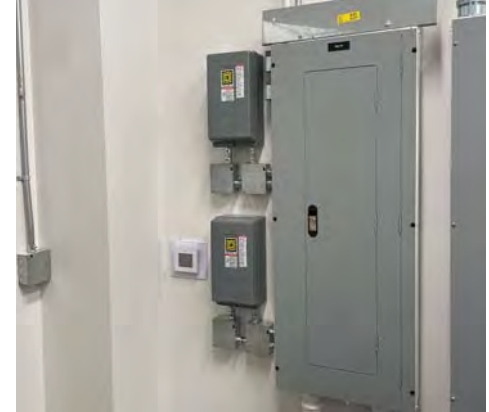
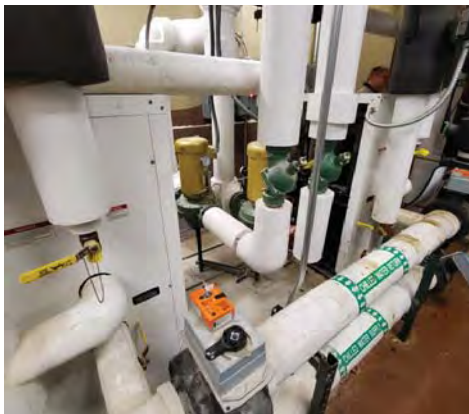
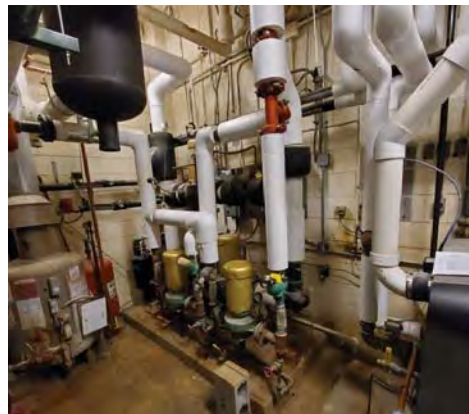
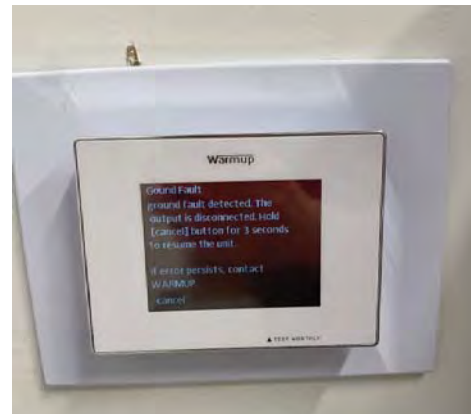
BLDG NO. LL02

- Roof at connector and leading up to roof is in poor condition
- Roof above Theater must be replaced
- The building is newly renovated but the Auditorium was never updated. It is in dire need of a full renovation. The roof was not renovated so there is water infiltration. It needs a new ceiling. It needs new finishes. It smells of water and mold. The Auditorium was last updated in the 1990's.
- Ground fault meter was found in an electrical room and was detecting a ground fault. Ground fault study should be observed.
- Exterior local over current protection are past their service life.

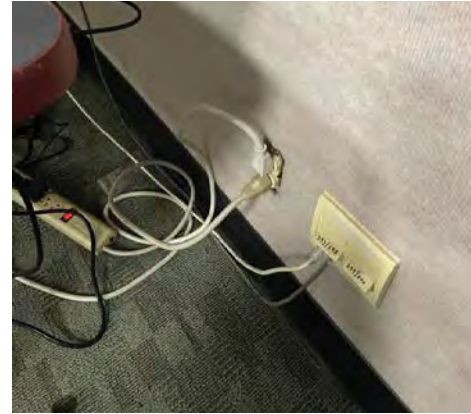
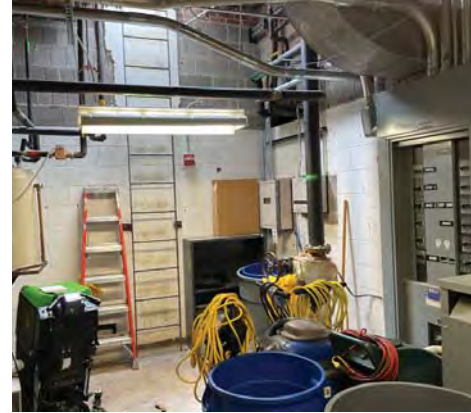
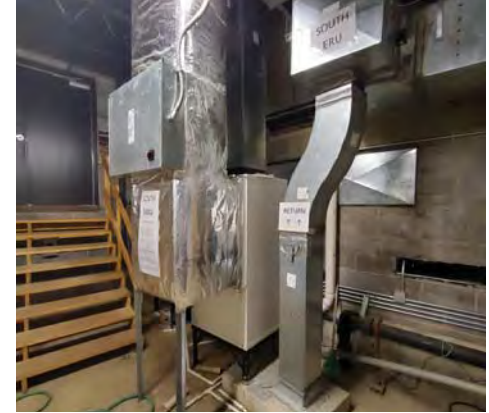
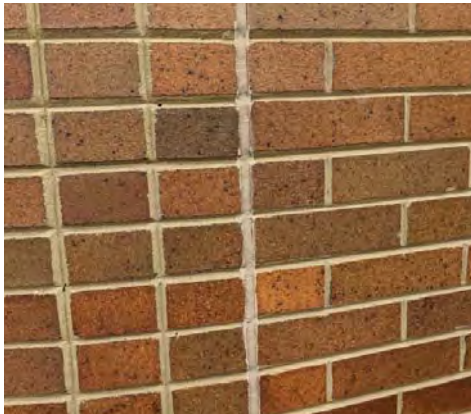
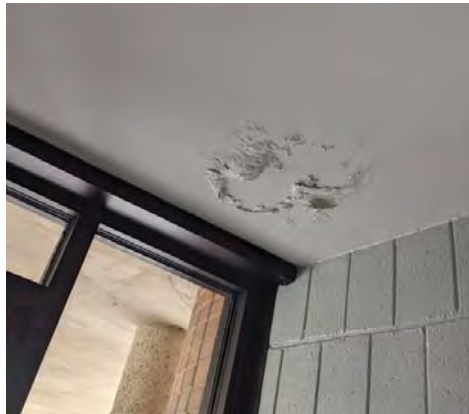
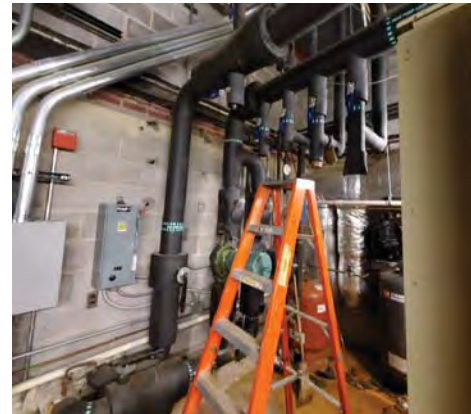
BLDG NO. LL03

- Roof warranty expired 2001
- Water infiltration at light wells
- Water infiltration at clerestory windows
- Entry storefronts past their useful service life
- Access control upgrade needed
- Sealant at control joints clearly past its service life.
- Water stains at ceilings
- DEFERRED MAINTENANCE REQUEST ISSUED 11/04/2021
- Broadloom carpet past service life
- Mechanical equipment its past service life

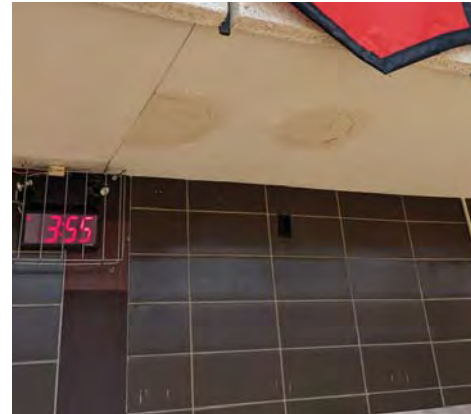
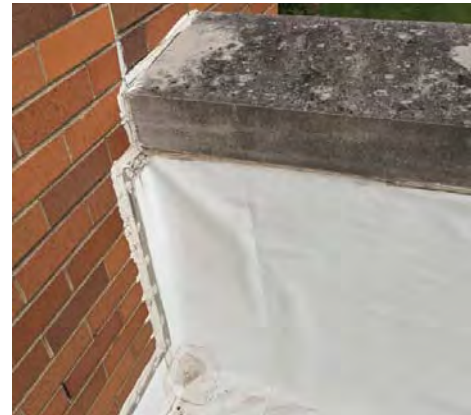
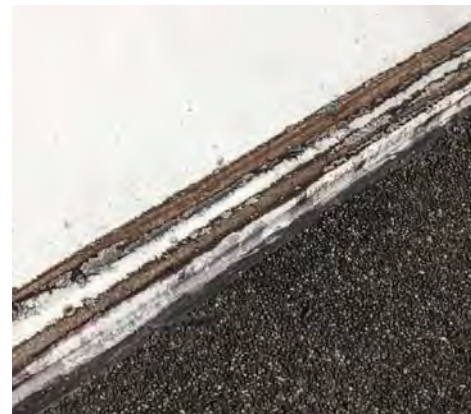
BLDG NO. LL04

- Roof warranty expired 2005-06
- Storefront past service life
- Access control upgrade needed
- DEFERRED MAINTENANCE REQUEST ISSUED 11/04/2021
- 7500 square feet of ceiling replacement is scheduled for 2023
- Four locker rooms and their walls are scheduled to be renovated in 2023
- Many areas around the building are scheduled to have new flooring installed including Entry 040, Classrooms 104, 105, 108, 109, 110, 111, and the Fitness Center as well as several of the existing corridors. There is a new basketball floor installed. All together, this comprises roughly 70% of the building's floors.
- Storefront and glazing on original building are past their useful service life
- Interior and exterior lighting is past it's service life.
- Panel boards located around the gym floor are past their service life.
- Panel board relays in mezzanine are not functions.

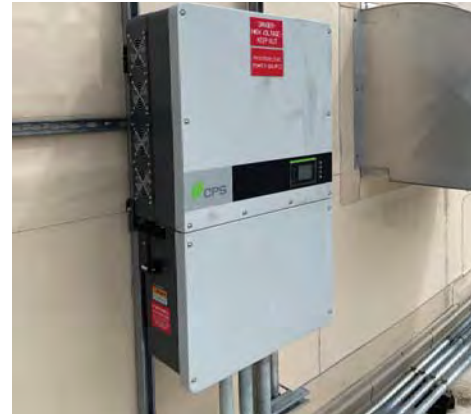
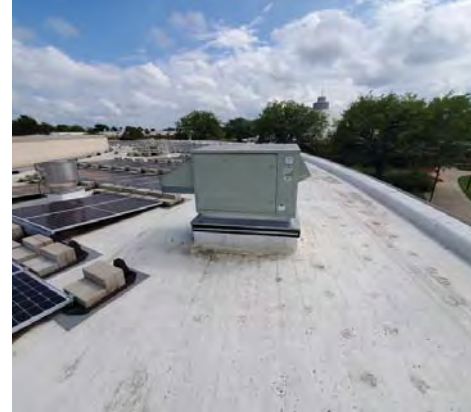
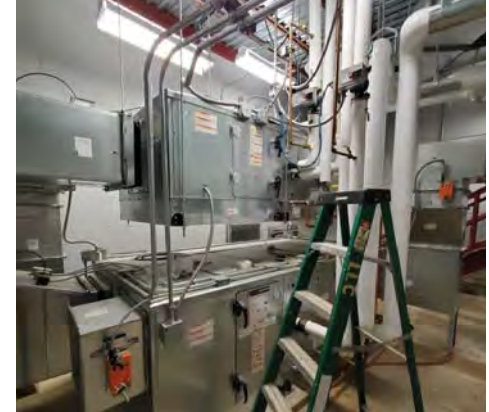
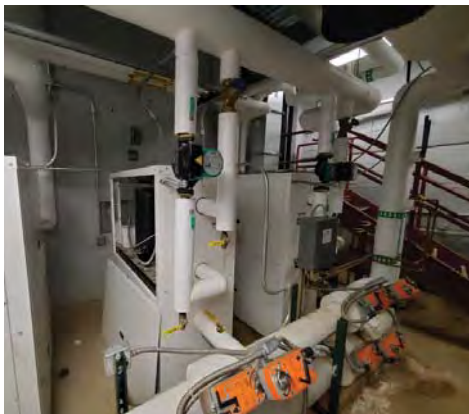
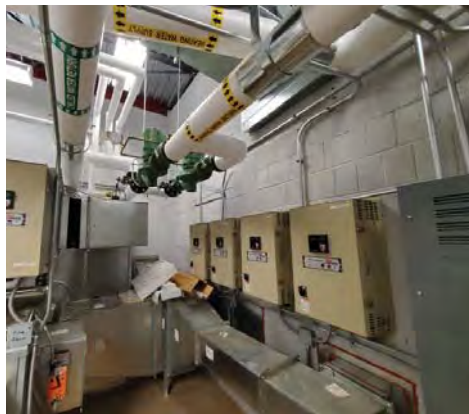
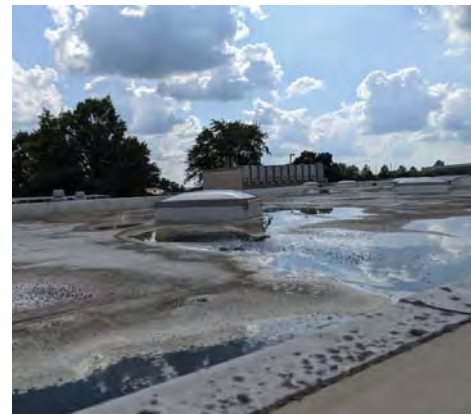
BLDG NO. LL05

- Water infiltration at MEP Penthouse
- Water infiltration at clerestory windows at interior circular corridor
- Storefront past service life
- Access control upgrade needed
- Roof warranty good till 2032
- Sealant at control joints clearly past its service life.
- DEFERRED MAINTENANCE REQUEST ISSUED June 13, 2022
- Exterior doors and storefront past useful service life
- Interior and exterior luminaires past service life
- VFD's and Solid State drives associated with HVAC equipment appears to be past useful service life
- Solar inverters may be undersized or equipment is not properly grounded

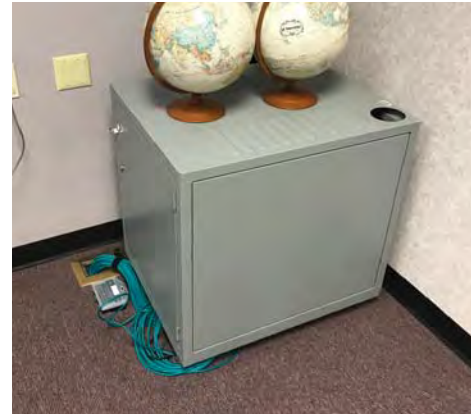
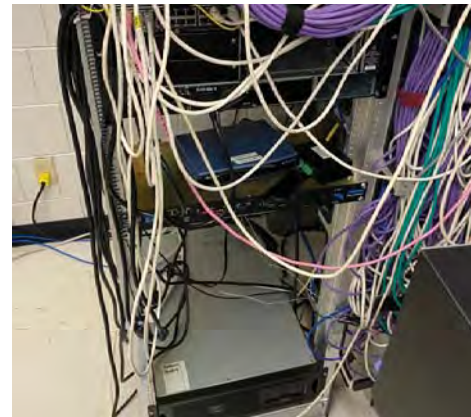
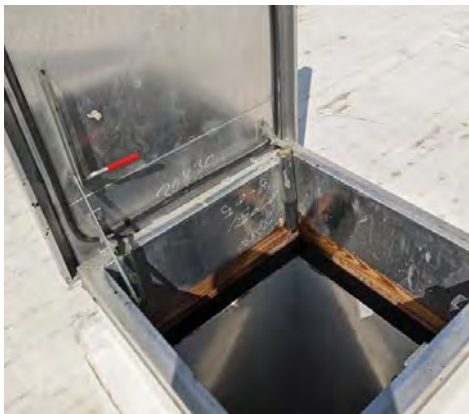
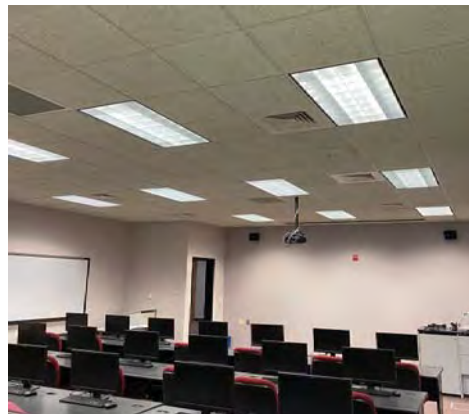
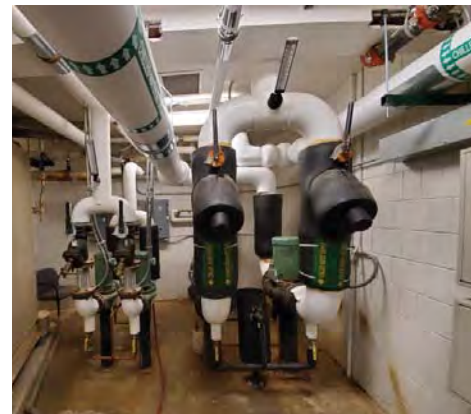
- Roof warranty expires in 2040
- Windows scheduled to be repaired
- Sealant at cladding past service life
- Most ceilings and floor finishes scheduled to be replaced in 2023
- Most walls scheduled to be refinished and painted in 2023
- Metal ladder to roof is in need of repair
- Interior lighting is past service life and scheduled to be replaced
- Data infrastructure is outdated and being updated soon
- Mechanical equipment over current protection devices are due for replacement

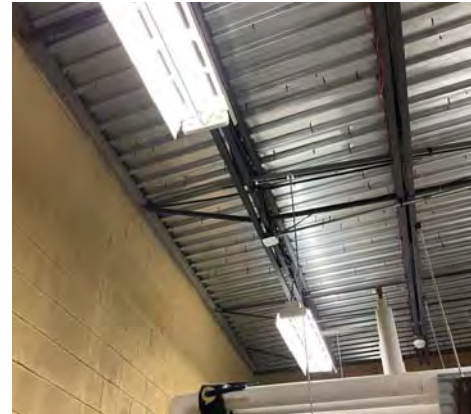
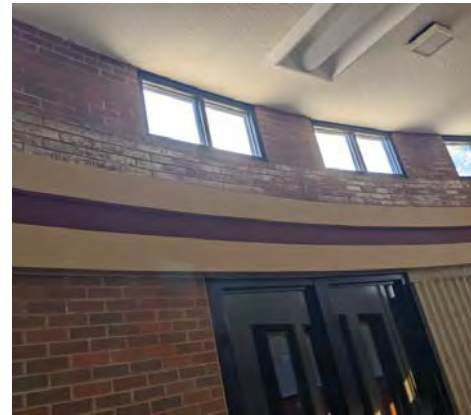
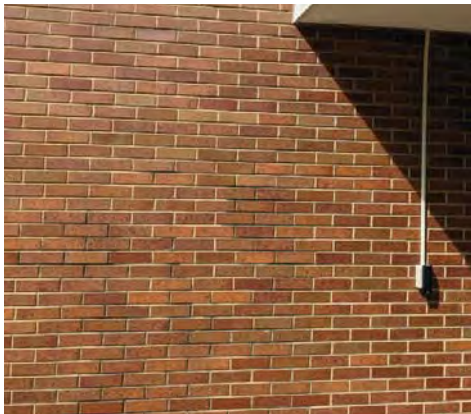
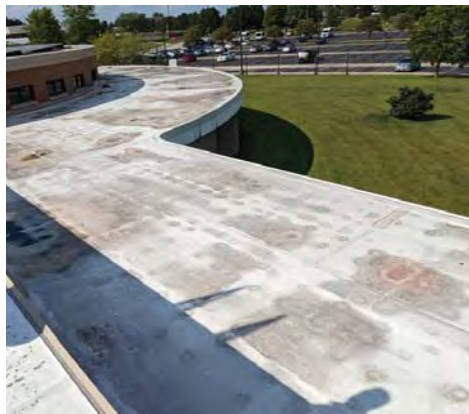
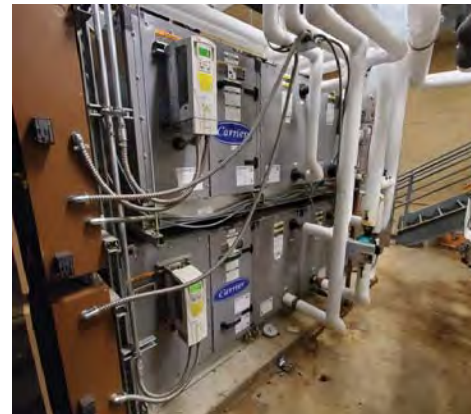
- Step crack at south corner suggests foundation settlement or heave
- Roof warranty expired 2018 for roughly 70 squares
- Roof warranty good till early 2030's
- Efflorescence at clerestory windows
- Storefront past service life
- Access control upgrade needed
- Sealant past service life
- Ceiling over 20 years old
- Interior and exterior luminaires past service life
- VFD's and Solid State drives associated with HVAC equipment appears to be past useful service life.
- Solar inverters may be undersized or equipment is not properly grounded.

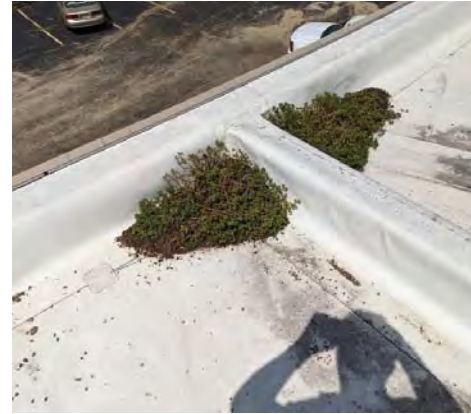
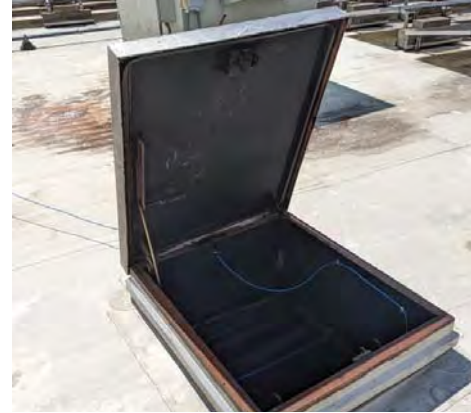
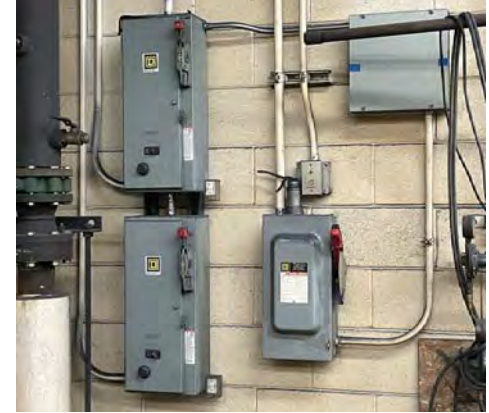
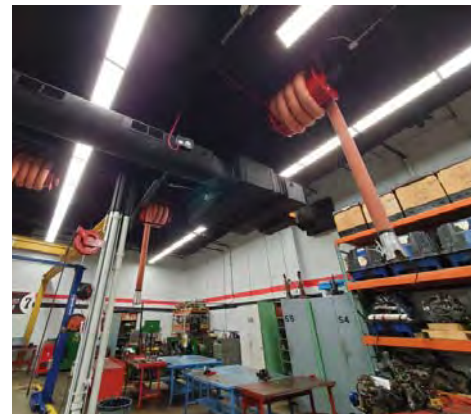
- Grass growing on roof. Roof drains clogged. Roof scuttle is dangerous
- Programmatic constraints with teachers sharing an office.
- Epoxy floors were a DIY fix and are at the end of their service life.
- Noise issue in the building between the shop and the classrooms.
- Metal roof ladder and scuttle are a safety concern
- A few vehicle exhaust fan were noted to not be functioning and are due for replacement and will need a new electrical circuit and means of disconnect.
- Parking lot lighting should be considered for replacement.

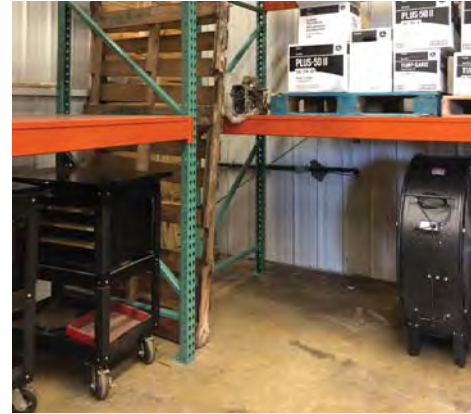
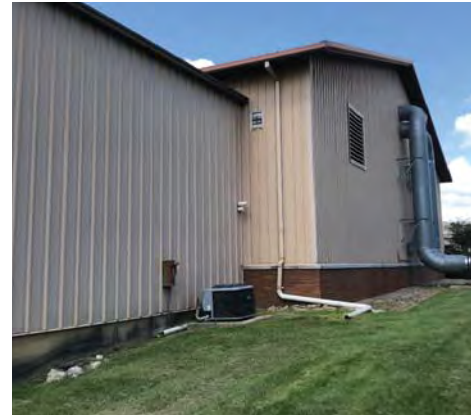
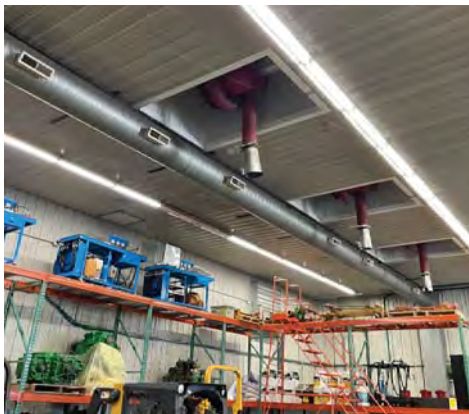
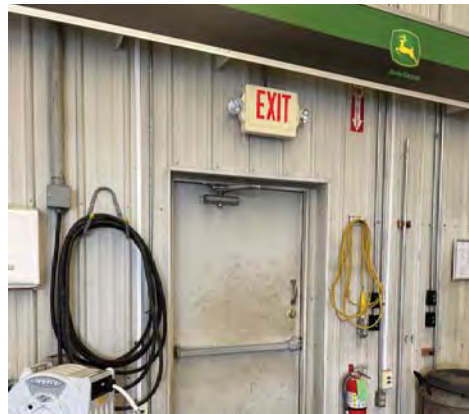
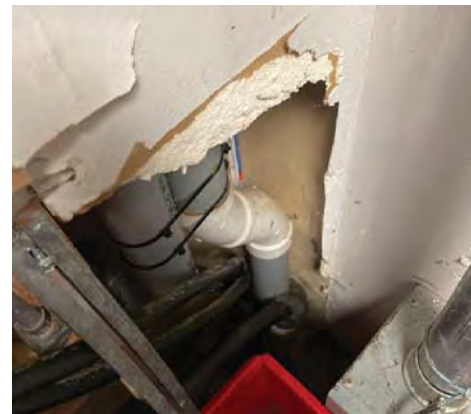
- Seepage present in NE corner of Room 106.
- Restrooms need to be refreshed—new partitions, specialties, and finishes.
- Offices need to be refreshed—new casework and finishes.
- Original Doors to the building. They should be studied in detail in conjunction with a campus-wide access/access control project
- Interior and exterior lighting is past it's service life.
- Data racks are not in a dedicated closet.
- Exiting lighting and exterior pedestrian lighting appears to not be present.

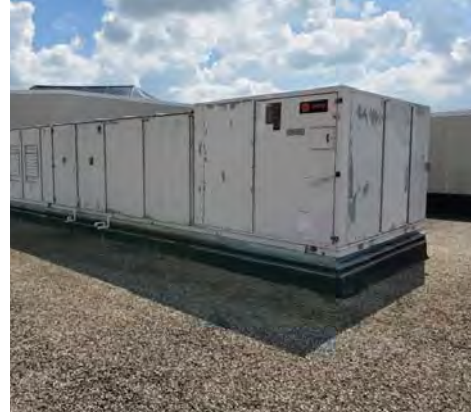
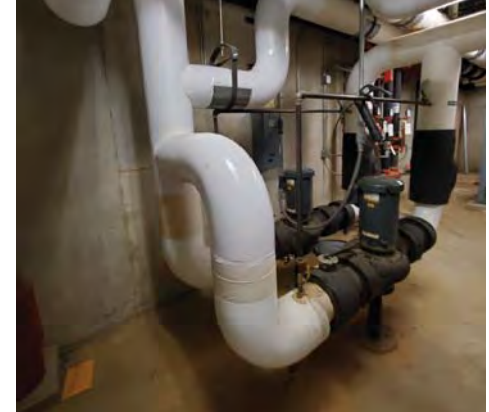
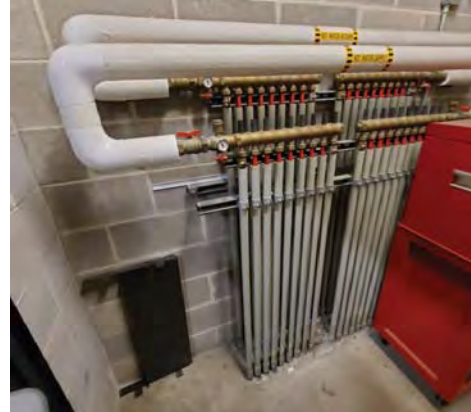
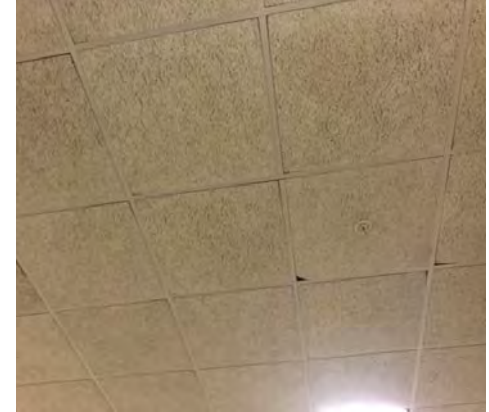
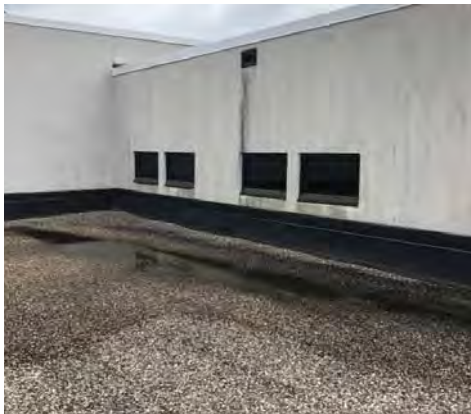
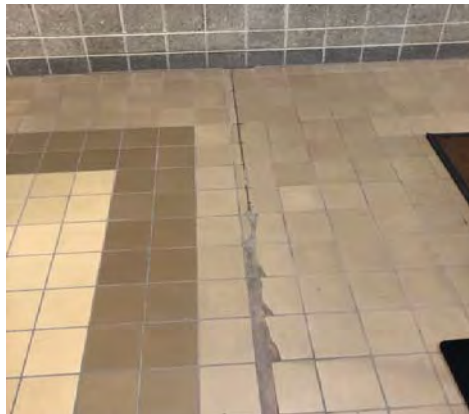
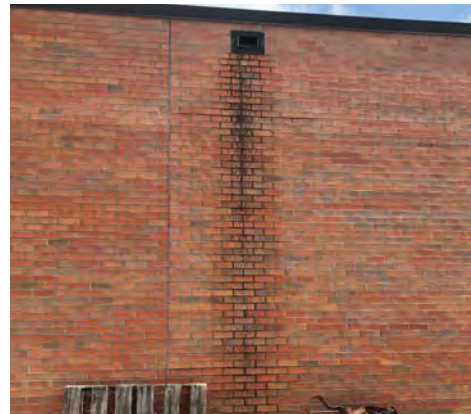
- Roof warranty expired or near expiration
- Water infiltration at the windows
- Masonry wavy and moving differentially to the structure
- The scuppers on the building do not have drip edges. Masonry in these areas is damaged and water stained.

- Water damage in several areas of ceiling tiles
- Several areas of wall are water-damaged, effloresced, or discolored from thermal and moisture intrusion

- Full building expansion joints and control joints cracking in several areas throughout the building.
- Broadloom carpet past service life
- DEFERRED MAINTENANCE REQUEST ISSUED June 13, 2022

- Trip hazard at top of stairs leading to Mechanical Basement.
- This building had a transformer short circuit and the grounding associated with the main electrical equipment should be investigated.

- Interior and exterior luminaires past service life
- VFD's and local over current protection associated with HVAC equipment needs updated

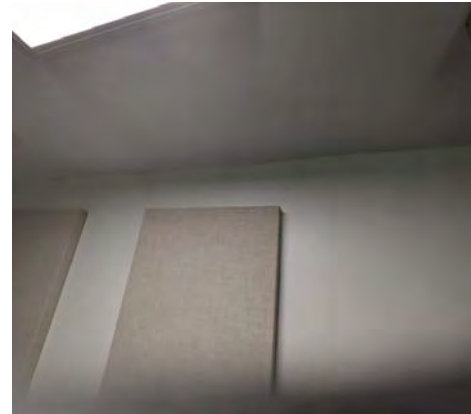
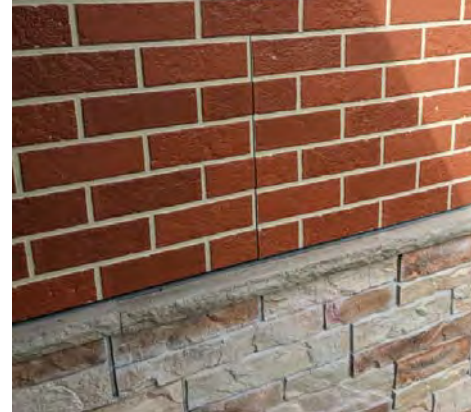
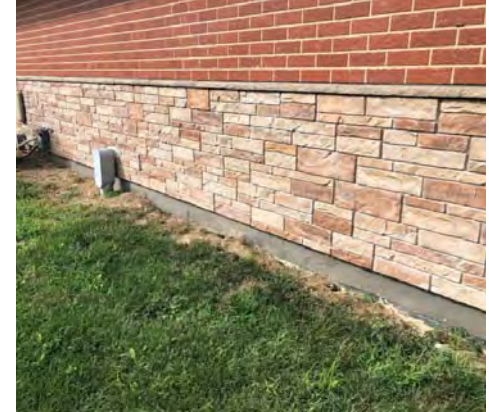
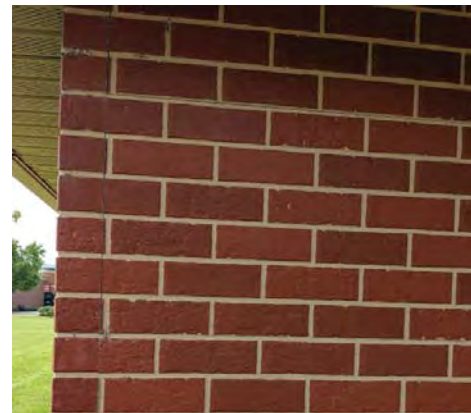
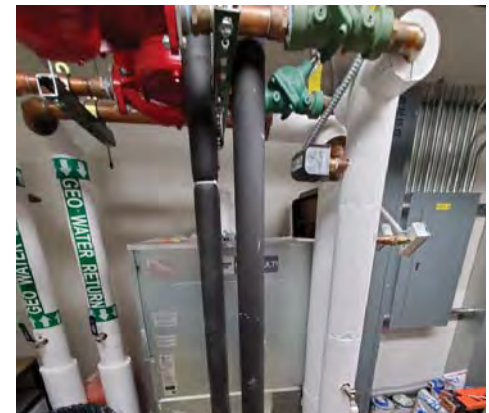
- The roof is too heavy for the structure it is sitting on.
- The ceilings are deflecting because a standing seam metal roof was put on the original 1988 trusses. You can see the ceiling drywall sagging/flexing every sixteen inches where it is fastened to the joist side of the trusses.
- The users report high sound transfer between offices. Sound batts or white-noise machine are recommended
- General electrical maintenance throughout the building

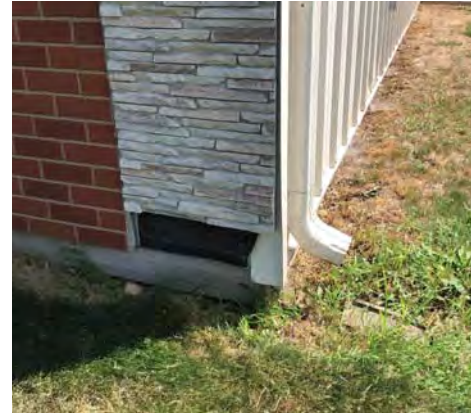
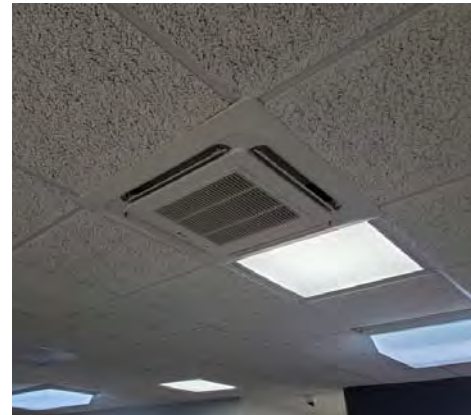
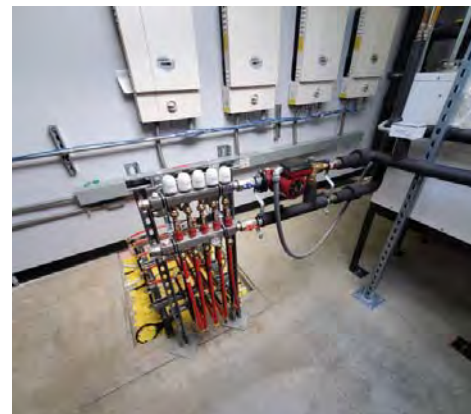
- Thin brick may not be a fifty-year system
- Small issue at stone veneer cladding
- Parking lot lighting should be considered for replacement.
- Lighting controls are not modern energy saving lighting controls

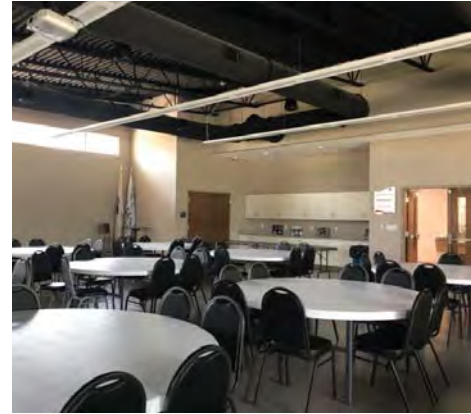
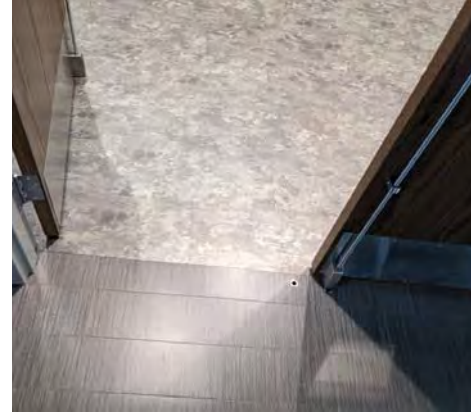
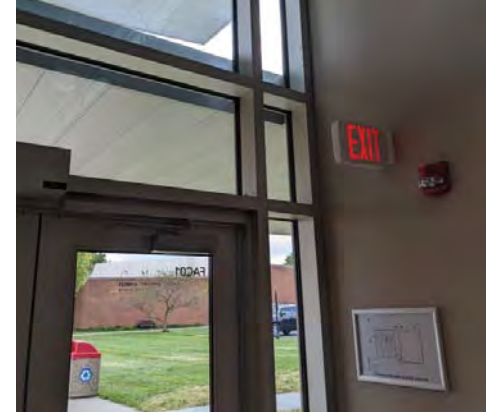
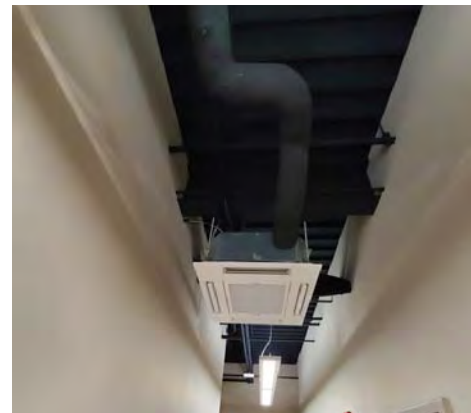
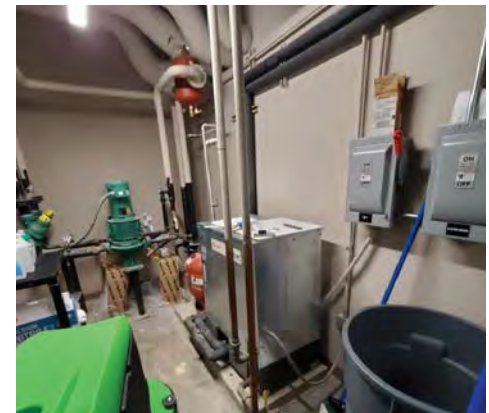
- Building in overall good condition
- Typical routine and maintenance are needed
- Typical electrical maintenance throughout the building needed

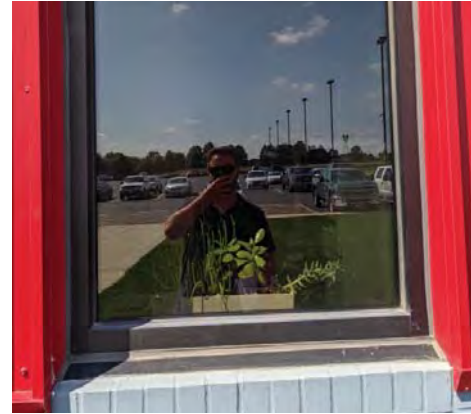
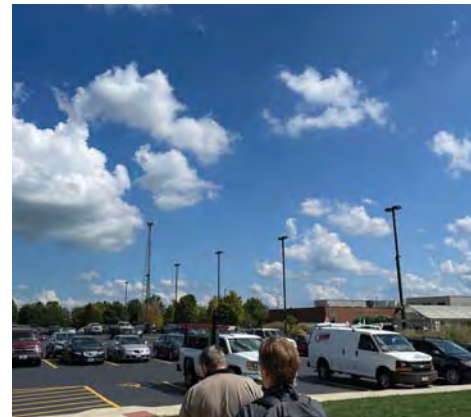
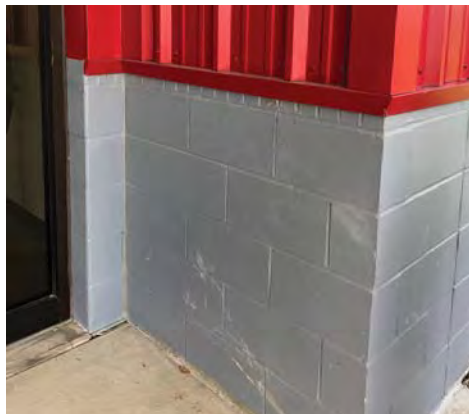
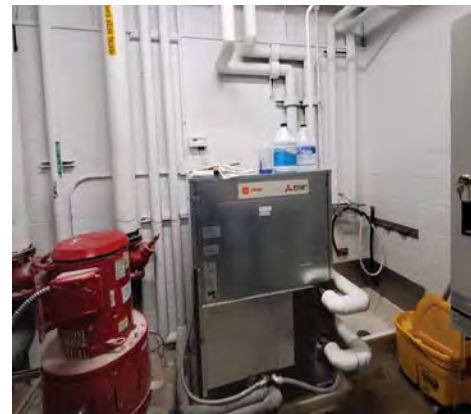
- Some concern about birds nesting at entry
- Some concern about the color of concrete in the building
- Parking lot lighting should be considered for replacement

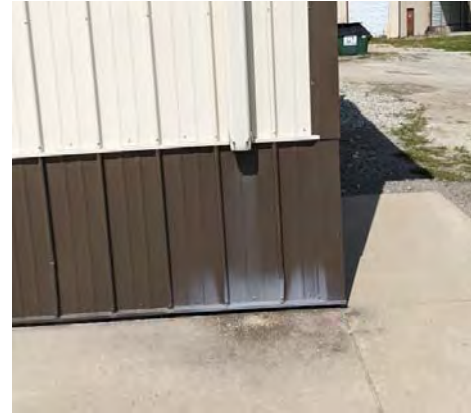
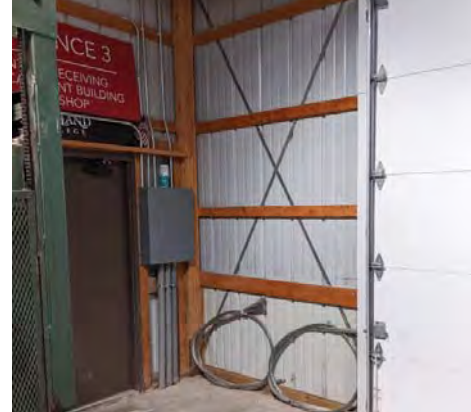
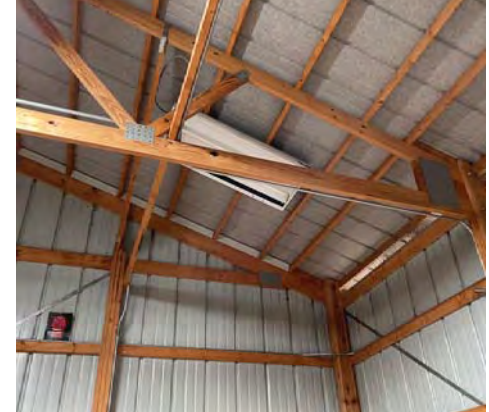
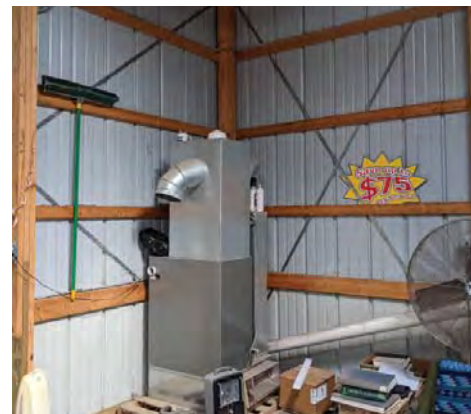
- Building is in overall good condition
- Typical routine and maintenance are needed
- Interior lighting fixtures are in need of upgrades or replacement
- Exterior lighting wall packs are in need of replacement

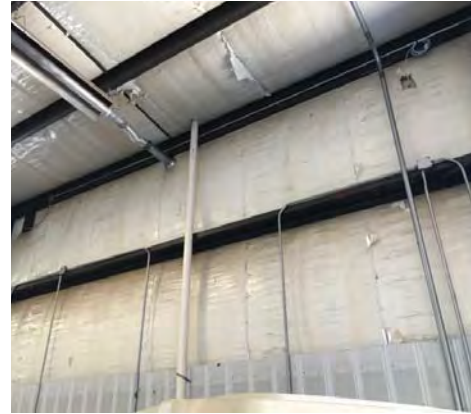
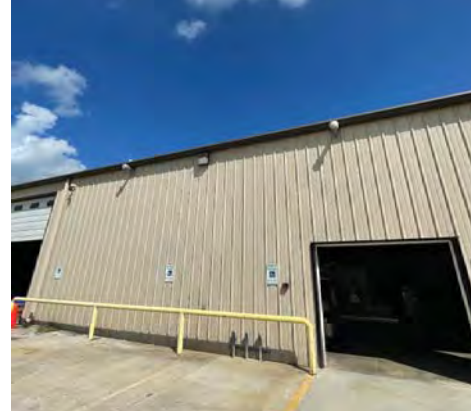
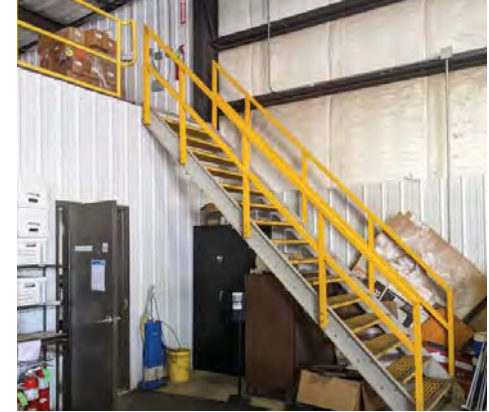
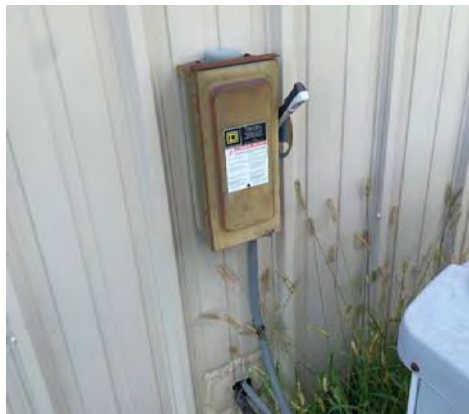
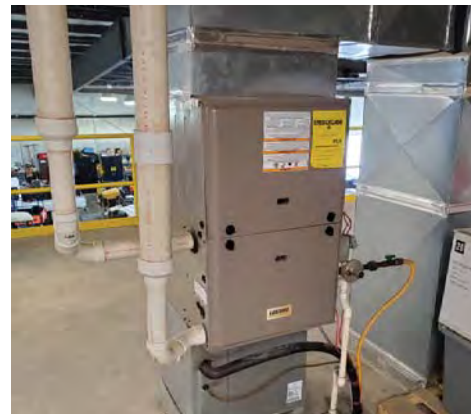
- There is a roof truss that is below 6'-8" at the mezzanine. It needs to be marked for safety.
- Vinyl ceiling is tearing at several areas
- Interior and exterior lighting is past it's service life.
- Exterior local over current protection for HVAC equipment is passed it's intended service life.

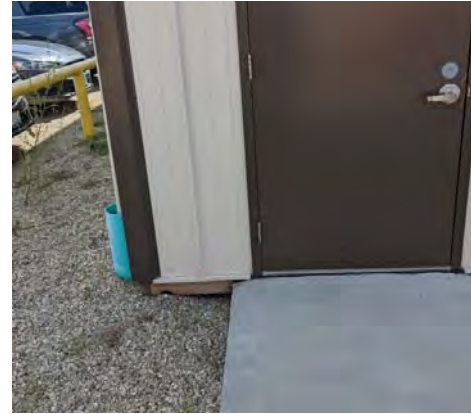
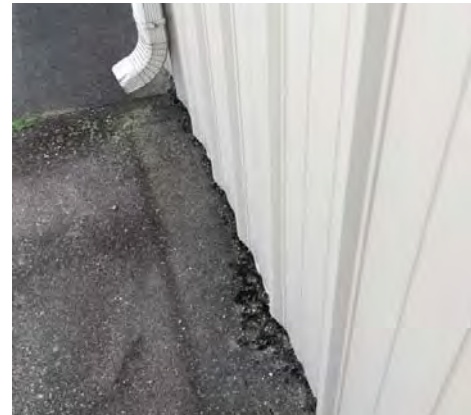
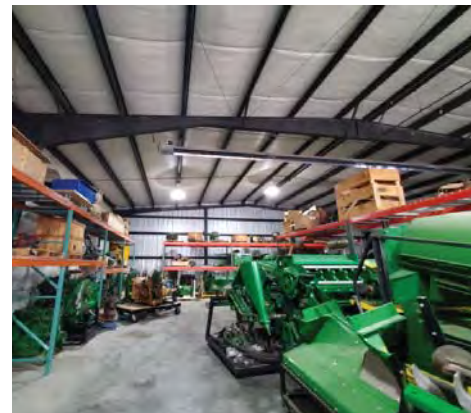
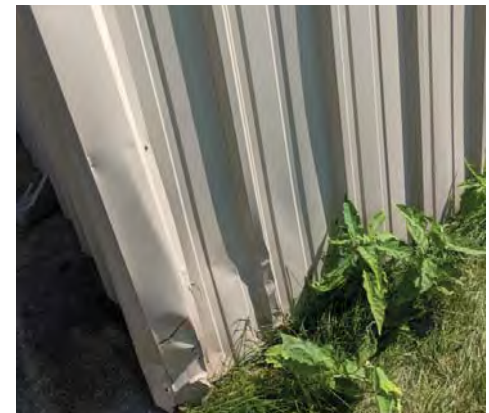
- Some cladding damaged at base
- Interior and exterior lighting is past it's service life
- Building in overall good condition
- Typical routine and maintenance are needed

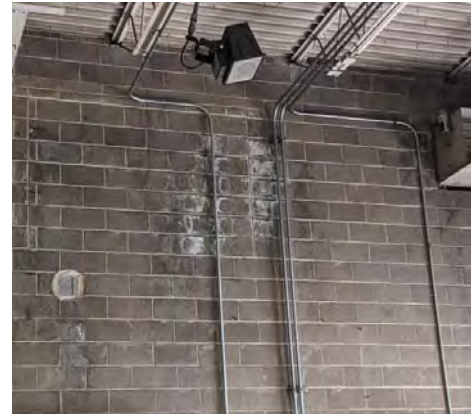
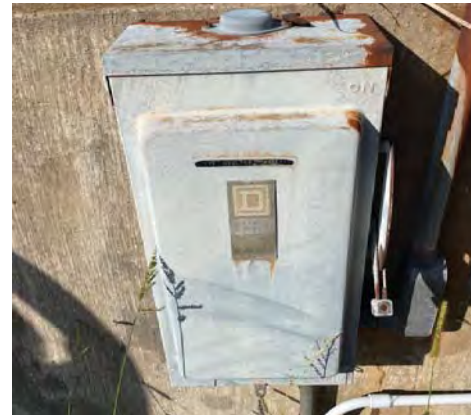
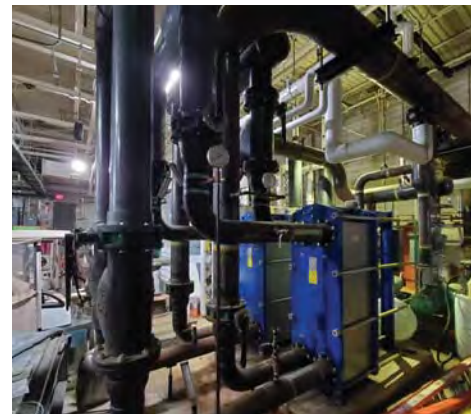
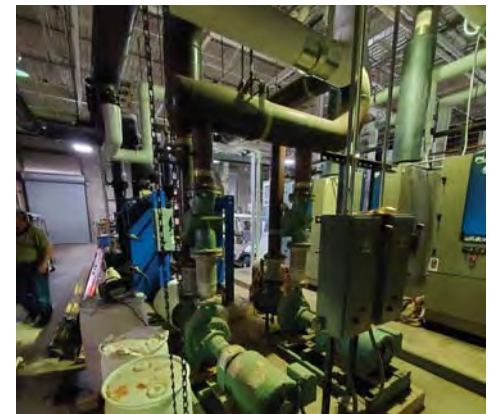
- Leaks at NW and at existing pipe penetrations that are abandoned.
- Trip Hazard at the top of the stairs at the exit door.
- Efflorescence at walls
- Interior and exterior lighting is past it's service life.
- Switchgear is reaching it's expected service life.
- Capacitor bank is not functioning.

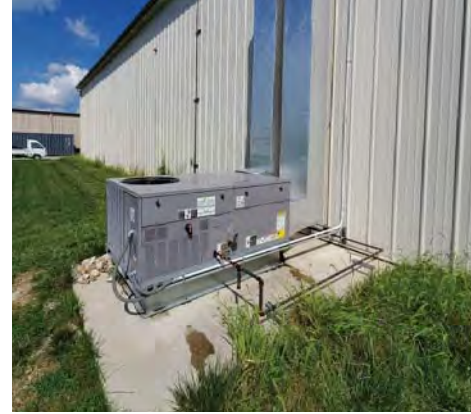
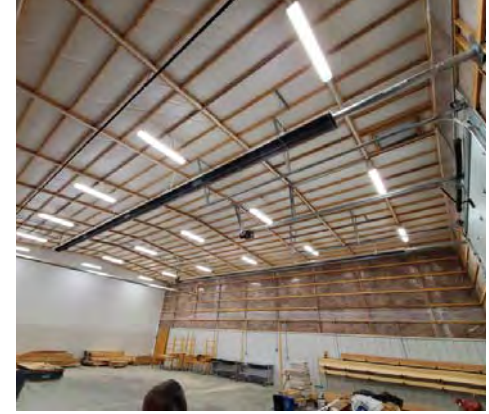
- Building in overall good condition
- Typical routine and maintenance are needed
- General electrical routine maintenance and repair needed

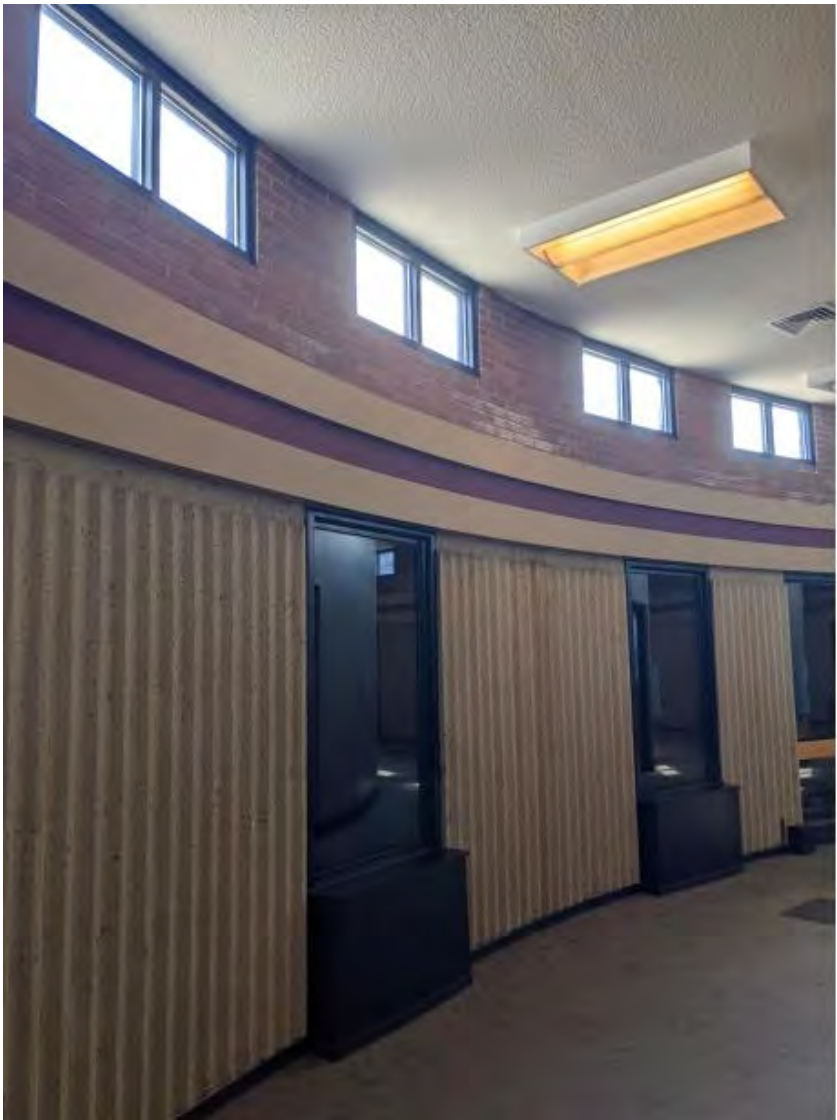
FIGURE 5.6.1 Hallway with windows
