LAKE LAND COLLEGE

Facilities Master Plan

DECEMBER 2022
LLC FACILITY CONDITION ASSESSMENT
BAILEY EDWARD PROJ. NO. 022072

LAKE LAND COLLEGE FACILITY CONDITION ASSESSMENT REPORT

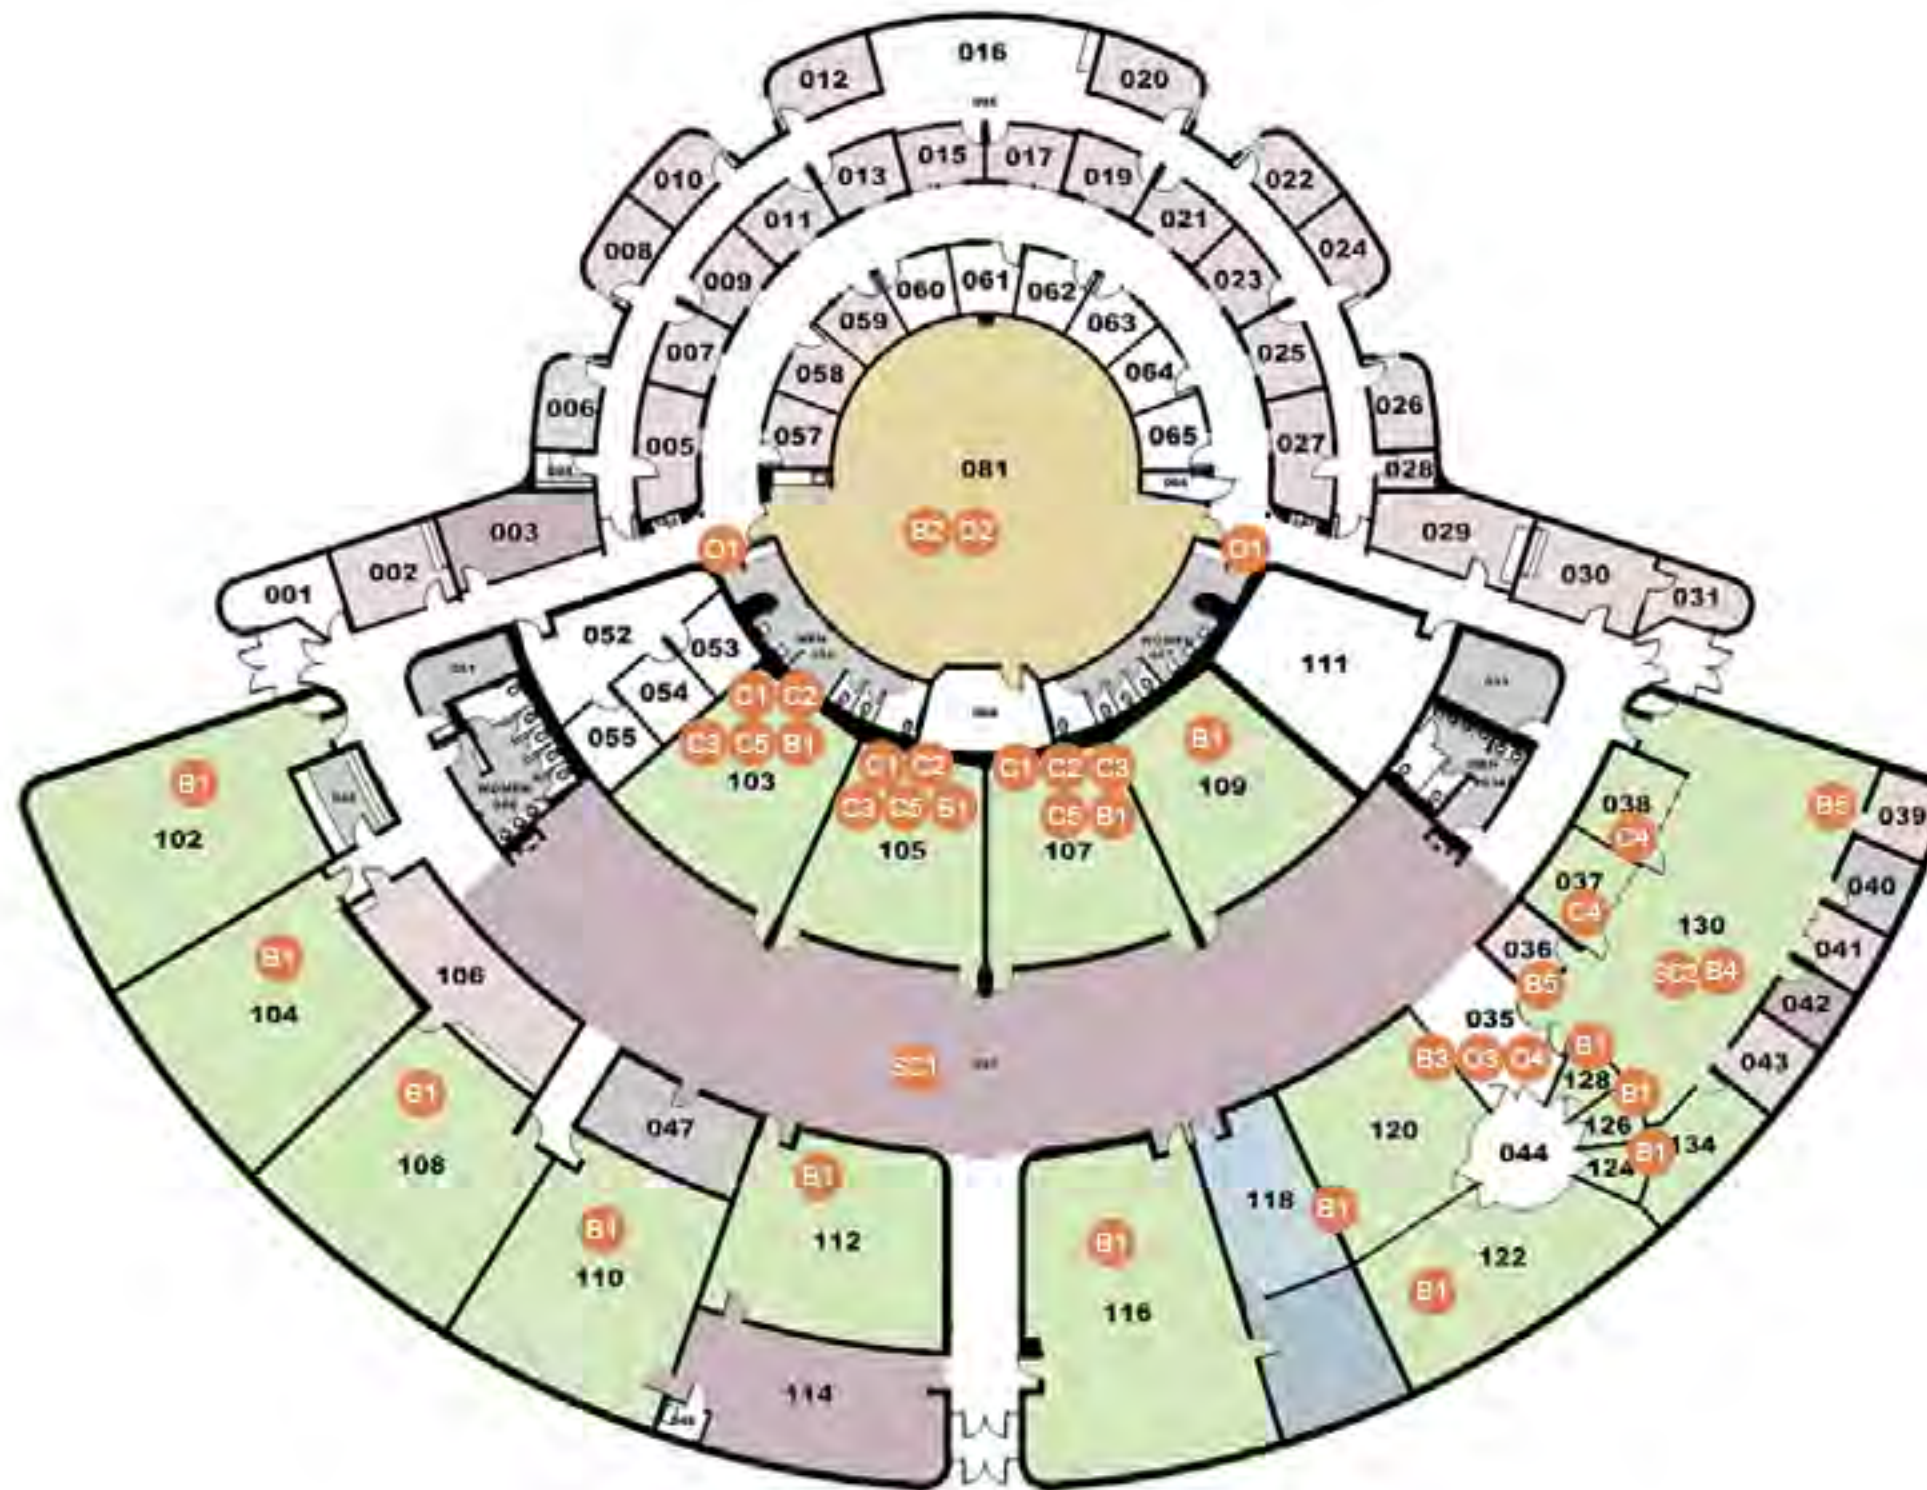
5.6.2 Webb Hall | Challenges

General Challenges

1. Acoustic issues between classrooms
2. Acoustic issues between offices
3. Acoustic issues in tutoring / testing
4. Needs carpet refresh
5. Some lighting issues with levels, zones, sensors
6. Some dental infrastructure is left in place like leaded walls in tutoring area
7. Need a writing lab
8. Need more space for future growth of testing / tutoring
9. Testing / tutoring offices not large enough for meeting with others
10. Would like more group study areas in testing / tutoring

- Q1 Noise travels out from bathrooms due to no door
- Q2 Technology needs to be updated
- Q3 Lockers would be better located in reception area
- Q4 Does not function well

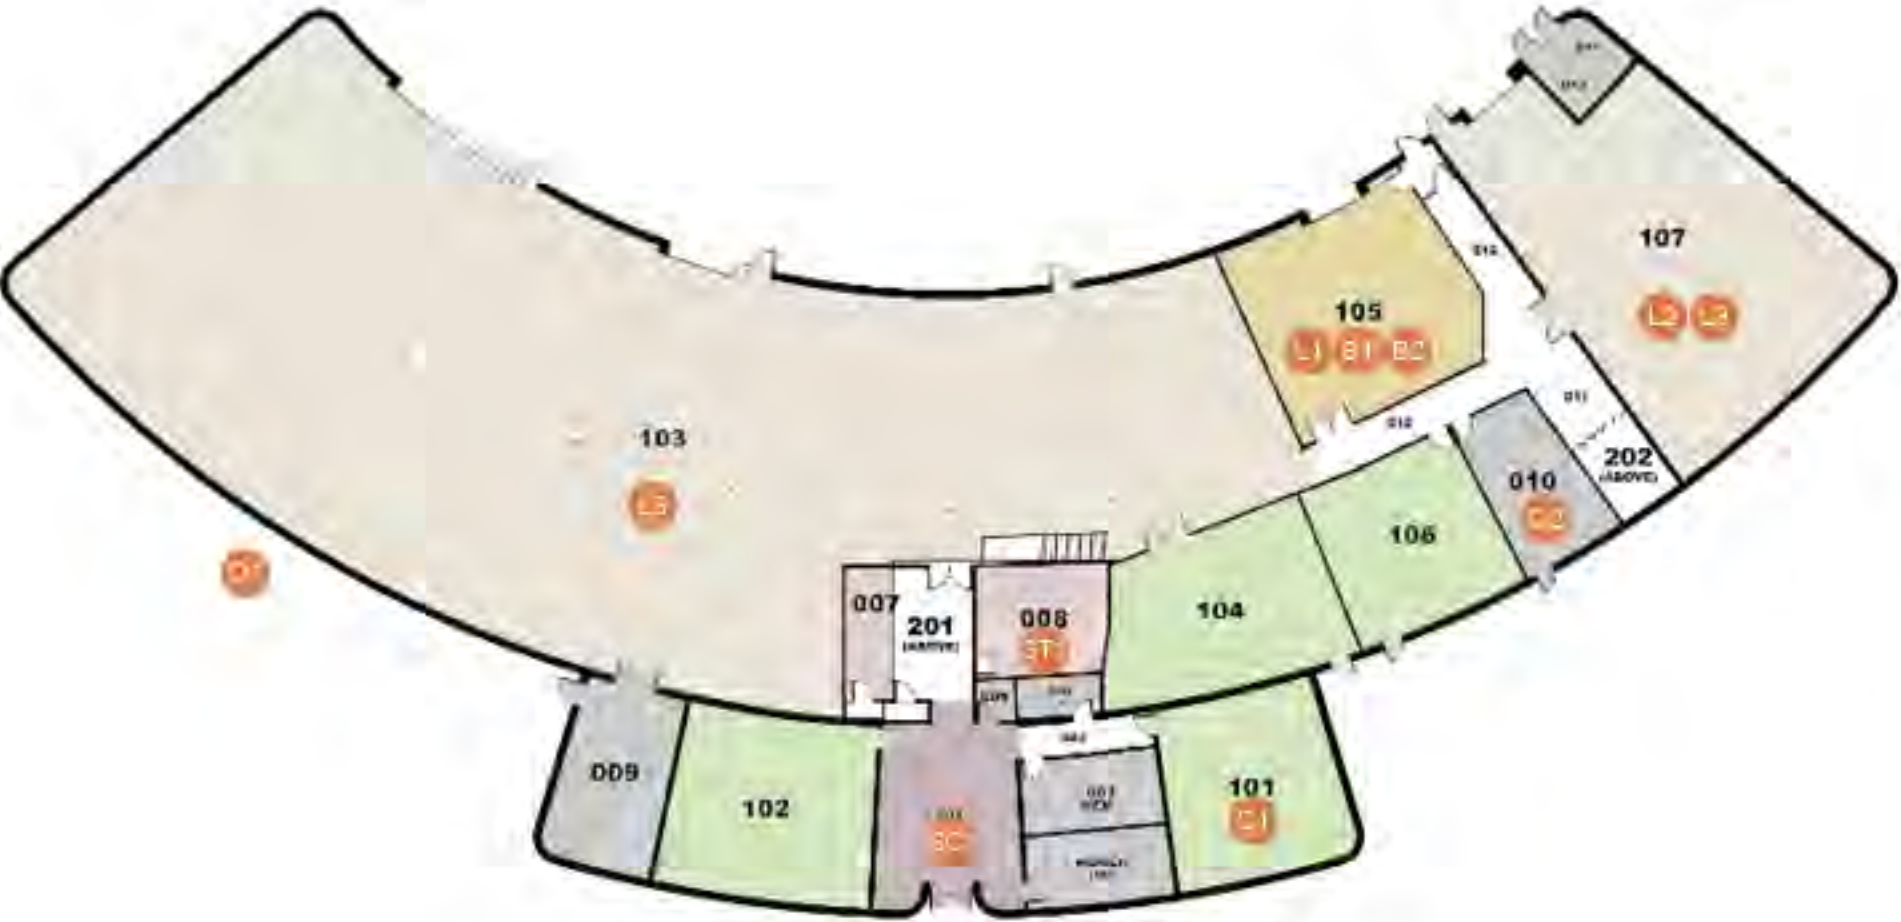
5.7.2 Vo-Tech Building | Challenges

General Challenges

1. Classroom storage needed for samples
2. Outdoor protected secure storage needed for large parts
3. Mezzanine is not ideally utilized
4. Classrooms need more wall storage cabinets for heavy welding samples
5. Classrooms need improved infrastructure for cabling/power/data

- O1 Overhead door is desirable for more flexible vehicle movement
- O2 Storage room could be used for a better function

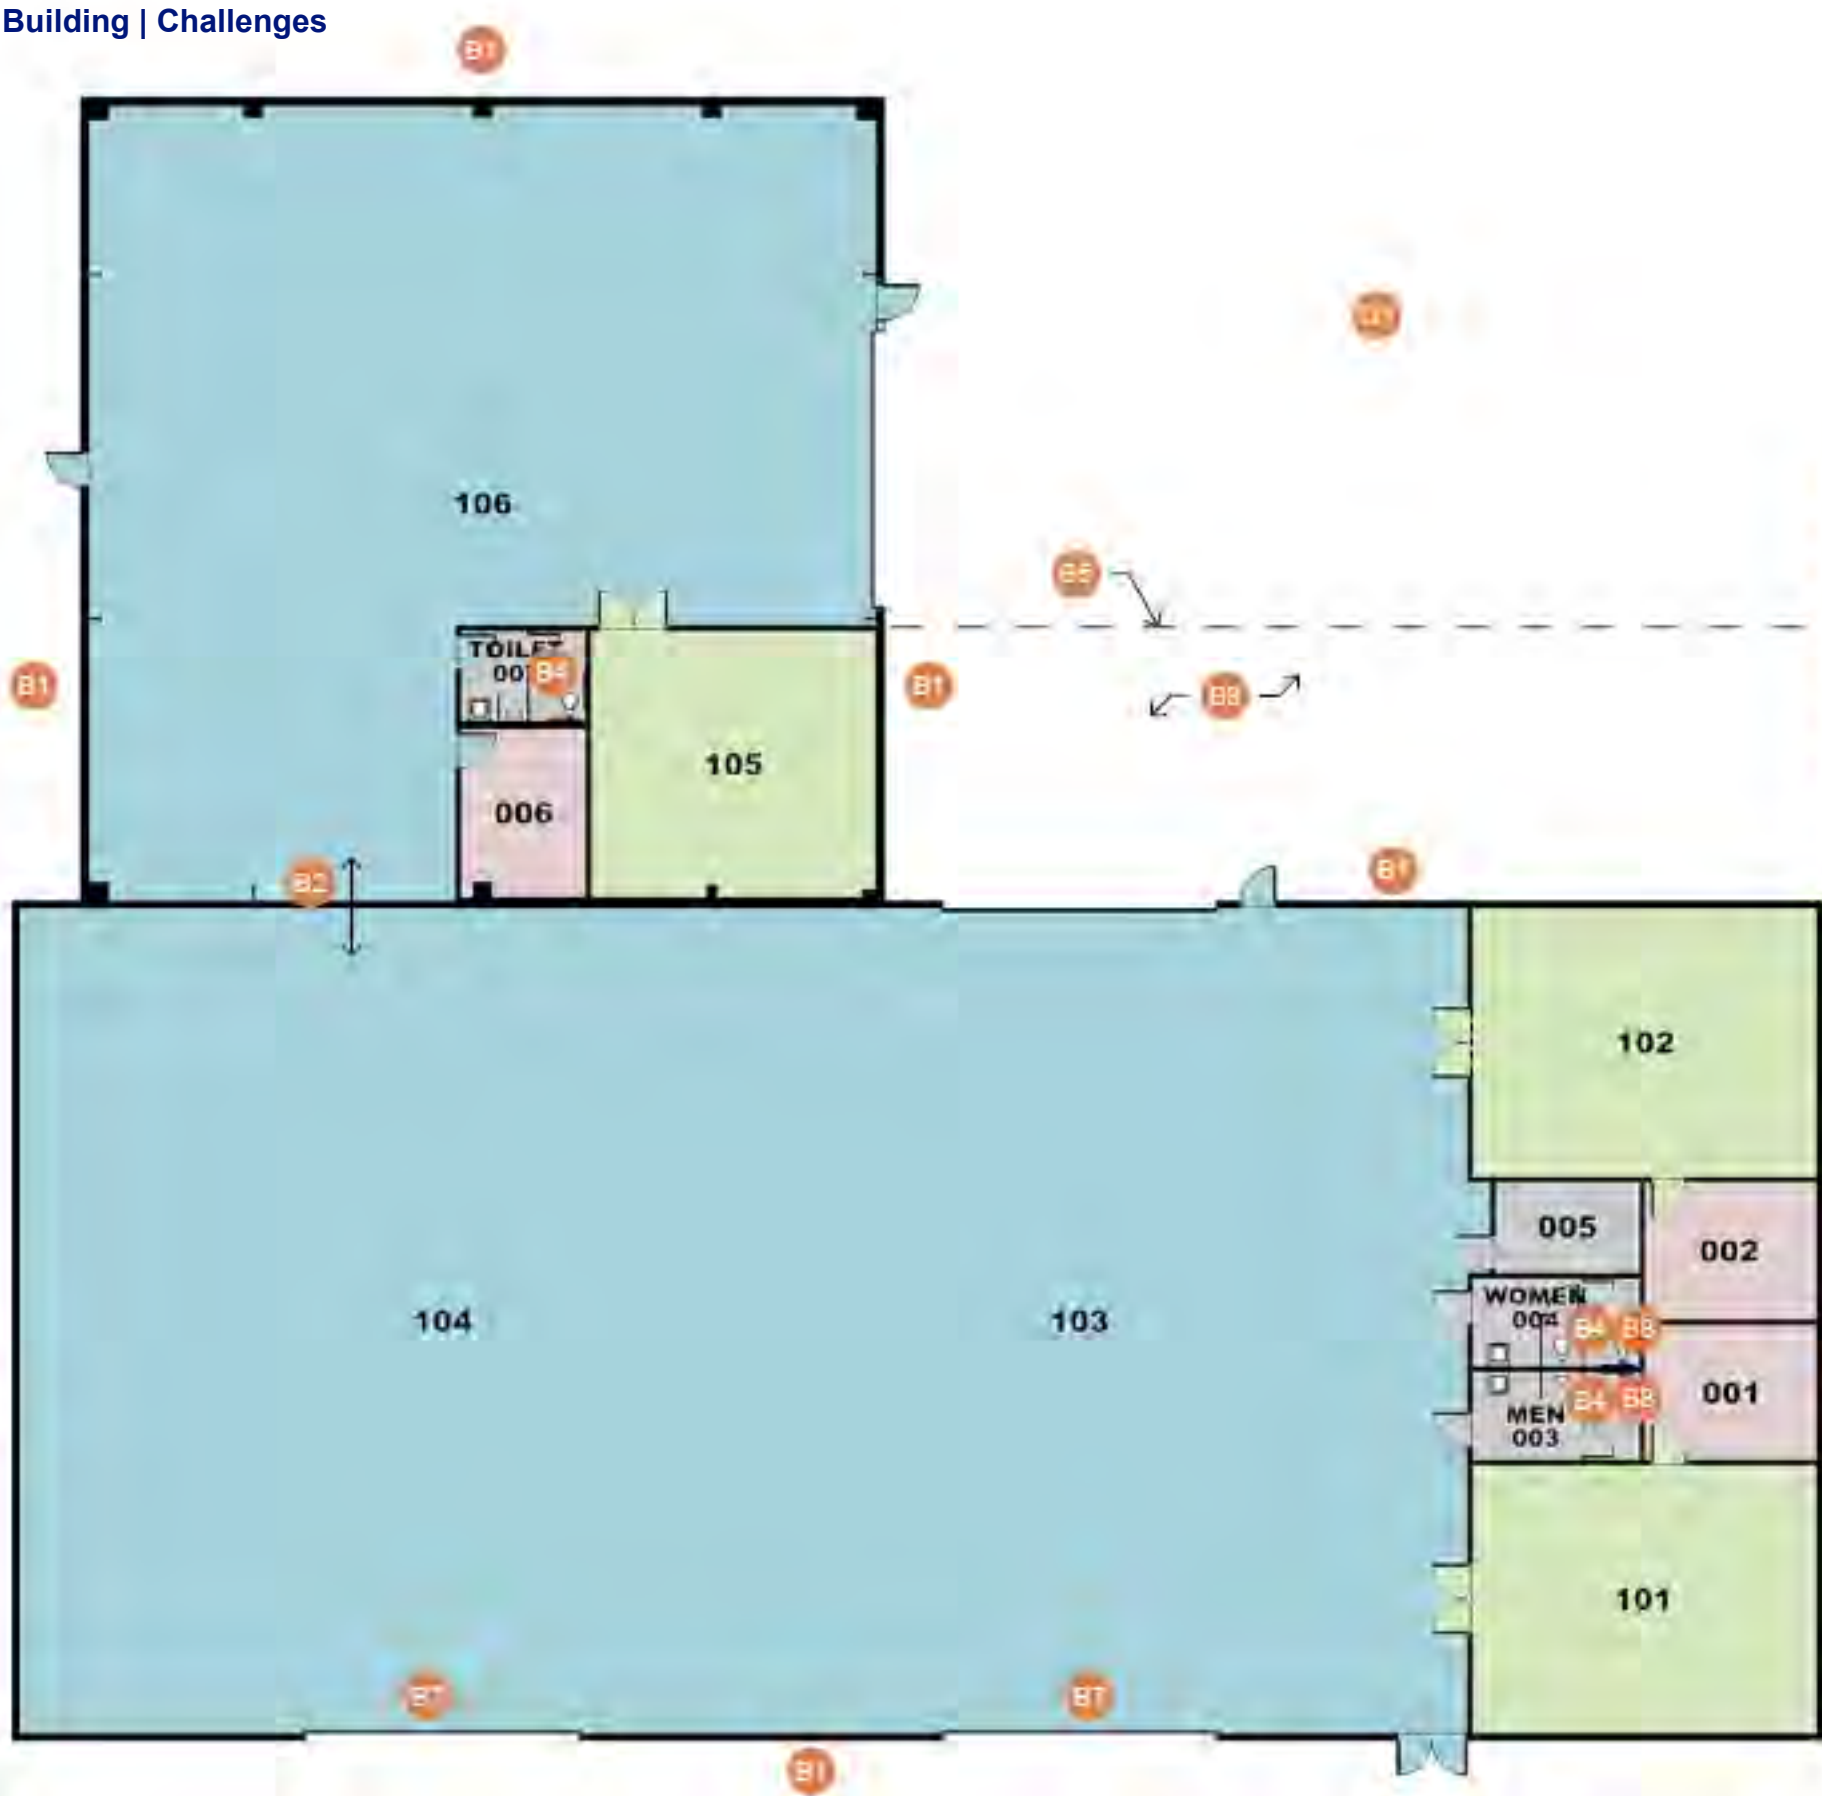
5.8.2 Ag-Tech Building | Challenges

General Challenges

1. No student lounge area
2. Need storage for heavy components
3. Additional storage needed
4. Exhaust has stained the interior finishes of the high bay spaces
5. Guttering around all of the building leaks

- B1 Gutter leaks
- B2 No connection between building areas
- B3 No protected area for exterior storage
- B4 Restrooms are unsightly and need improvement
- B5 Wash bay drain gets plugged up
- B6 Exterior needs paint or new metal
- B7 Garage doors need to be replaced
- B8 Mold issue in bathrooms 003 and 004

- O1 Exterior lawn needs a concrete pad for John Deere signage

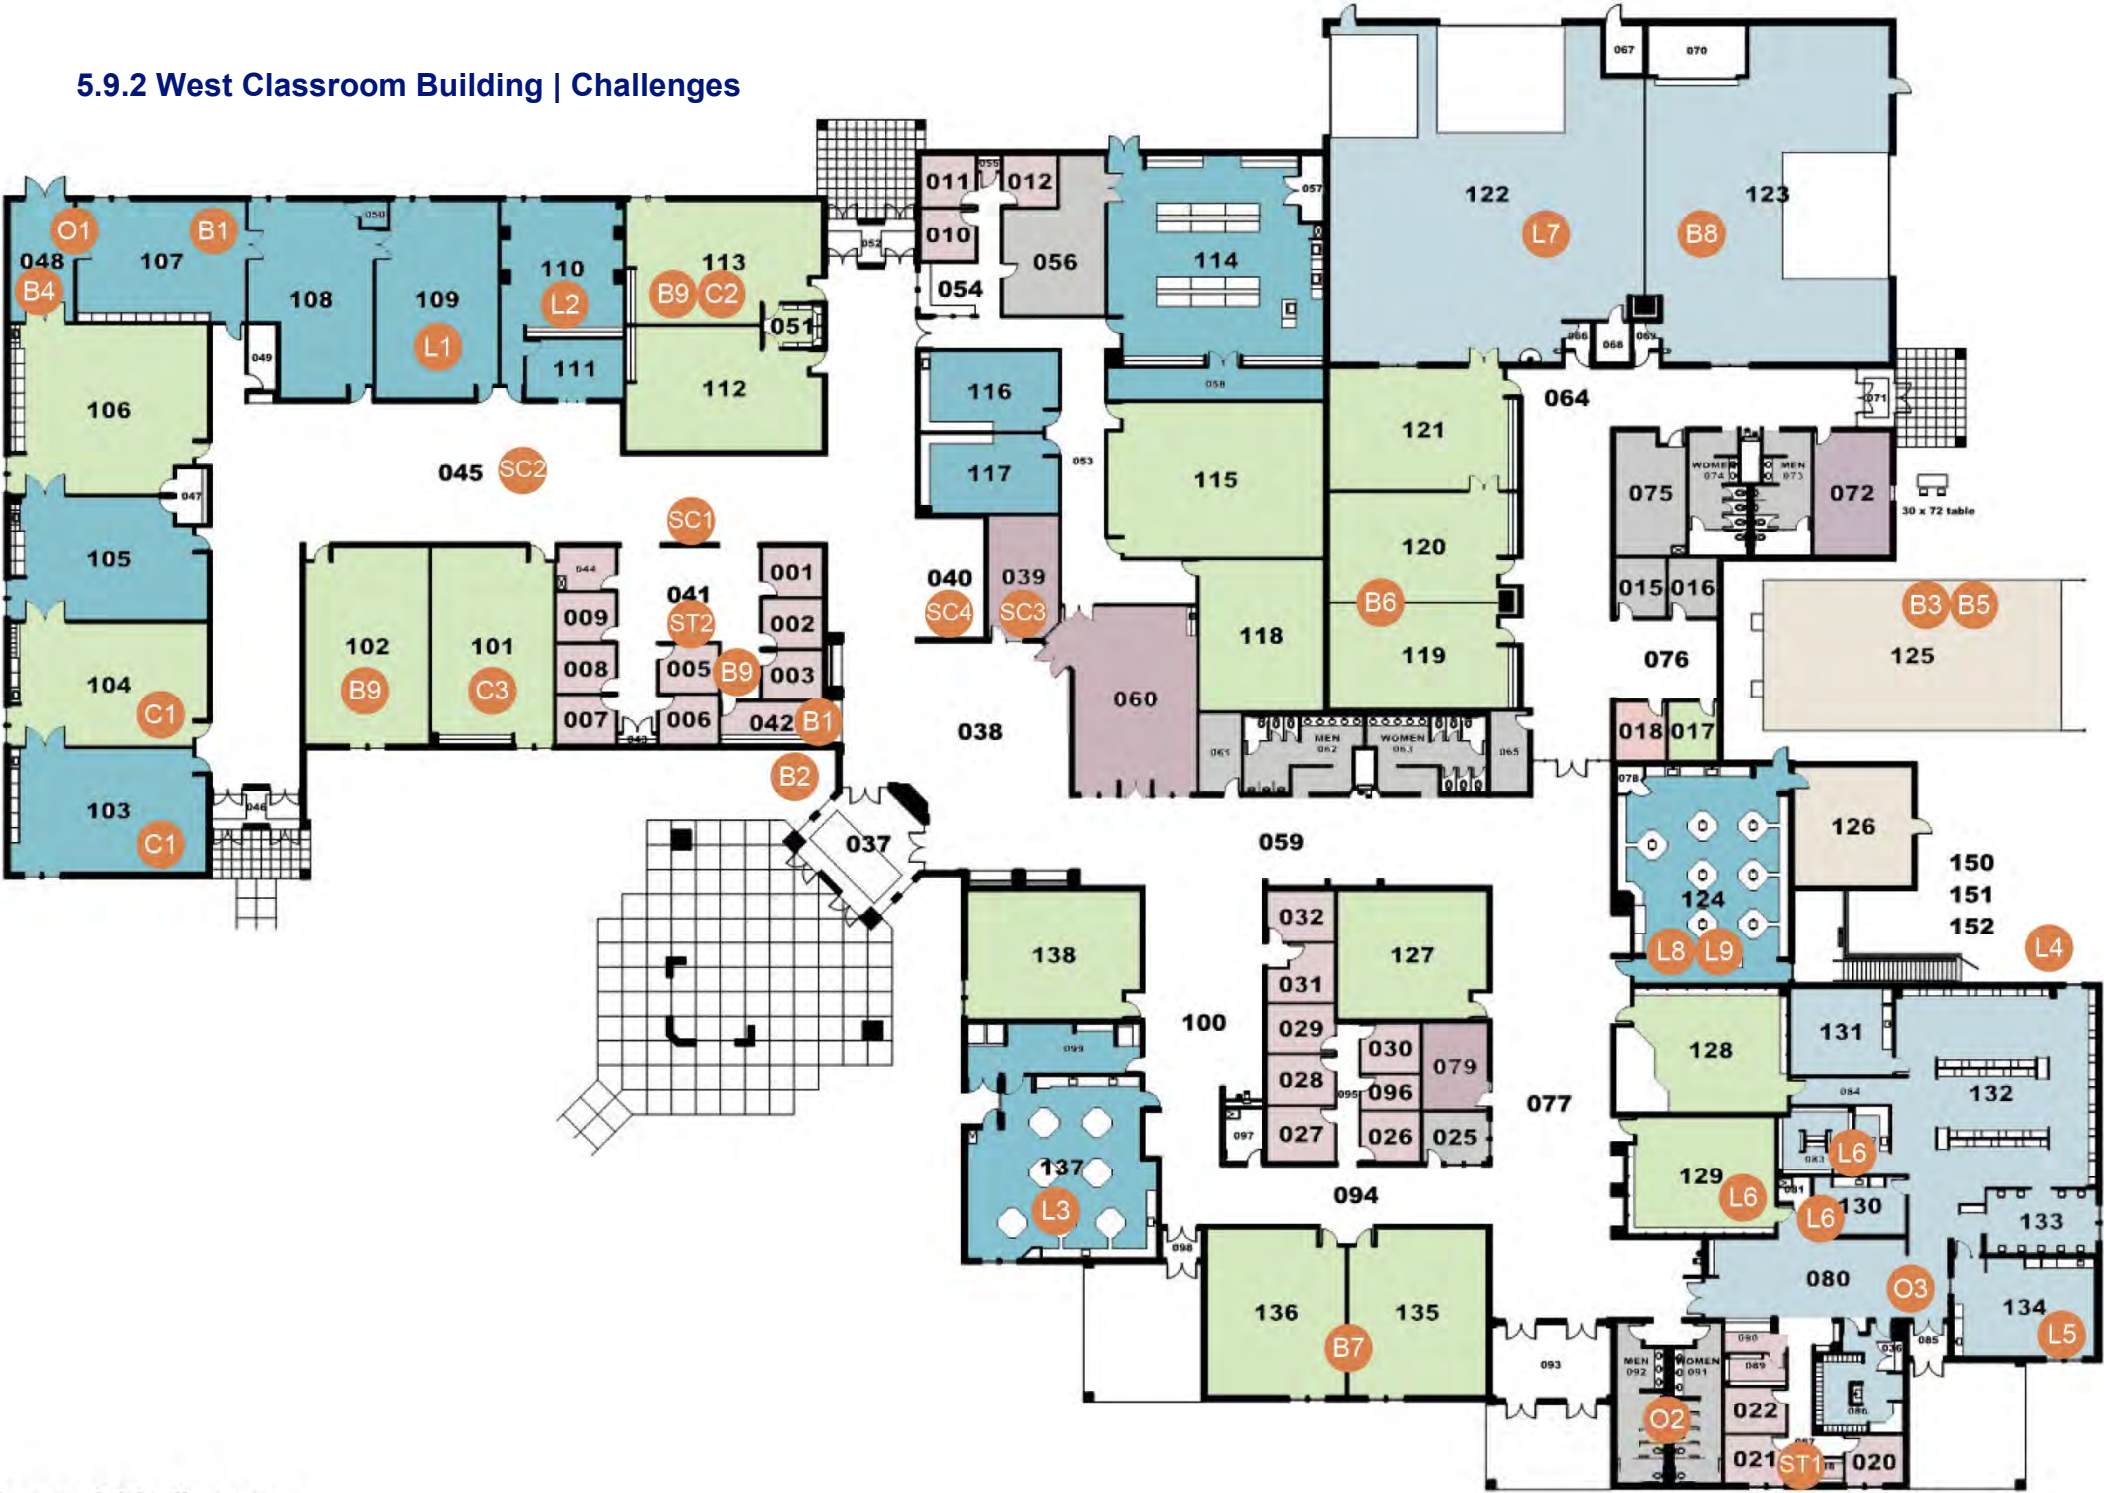
5.9.2 West Classroom Building | Challenges

General Challenges

1. Diesel tech and kubota tech looking for additional space

10. Both Greenhouses(125 and 126) are in need of repair/replacement.

- B1 Need more power options
- B2 Needs sink
- B3 HVAC issues
- B4 Wall and ceiling repairs needed
- B5 Glass panels need to be resealed
- B6 Divider wall in 119/120 works but is aging
- B7 Roof leaking
- B8 Air conditioning needed
- B9 Needs lighting control improvements

- O1 Wall could be demolished for one room
- O2 Aesthetic and functional upgrades needed
- O3 Labs are too visible as the public enters the waiting area

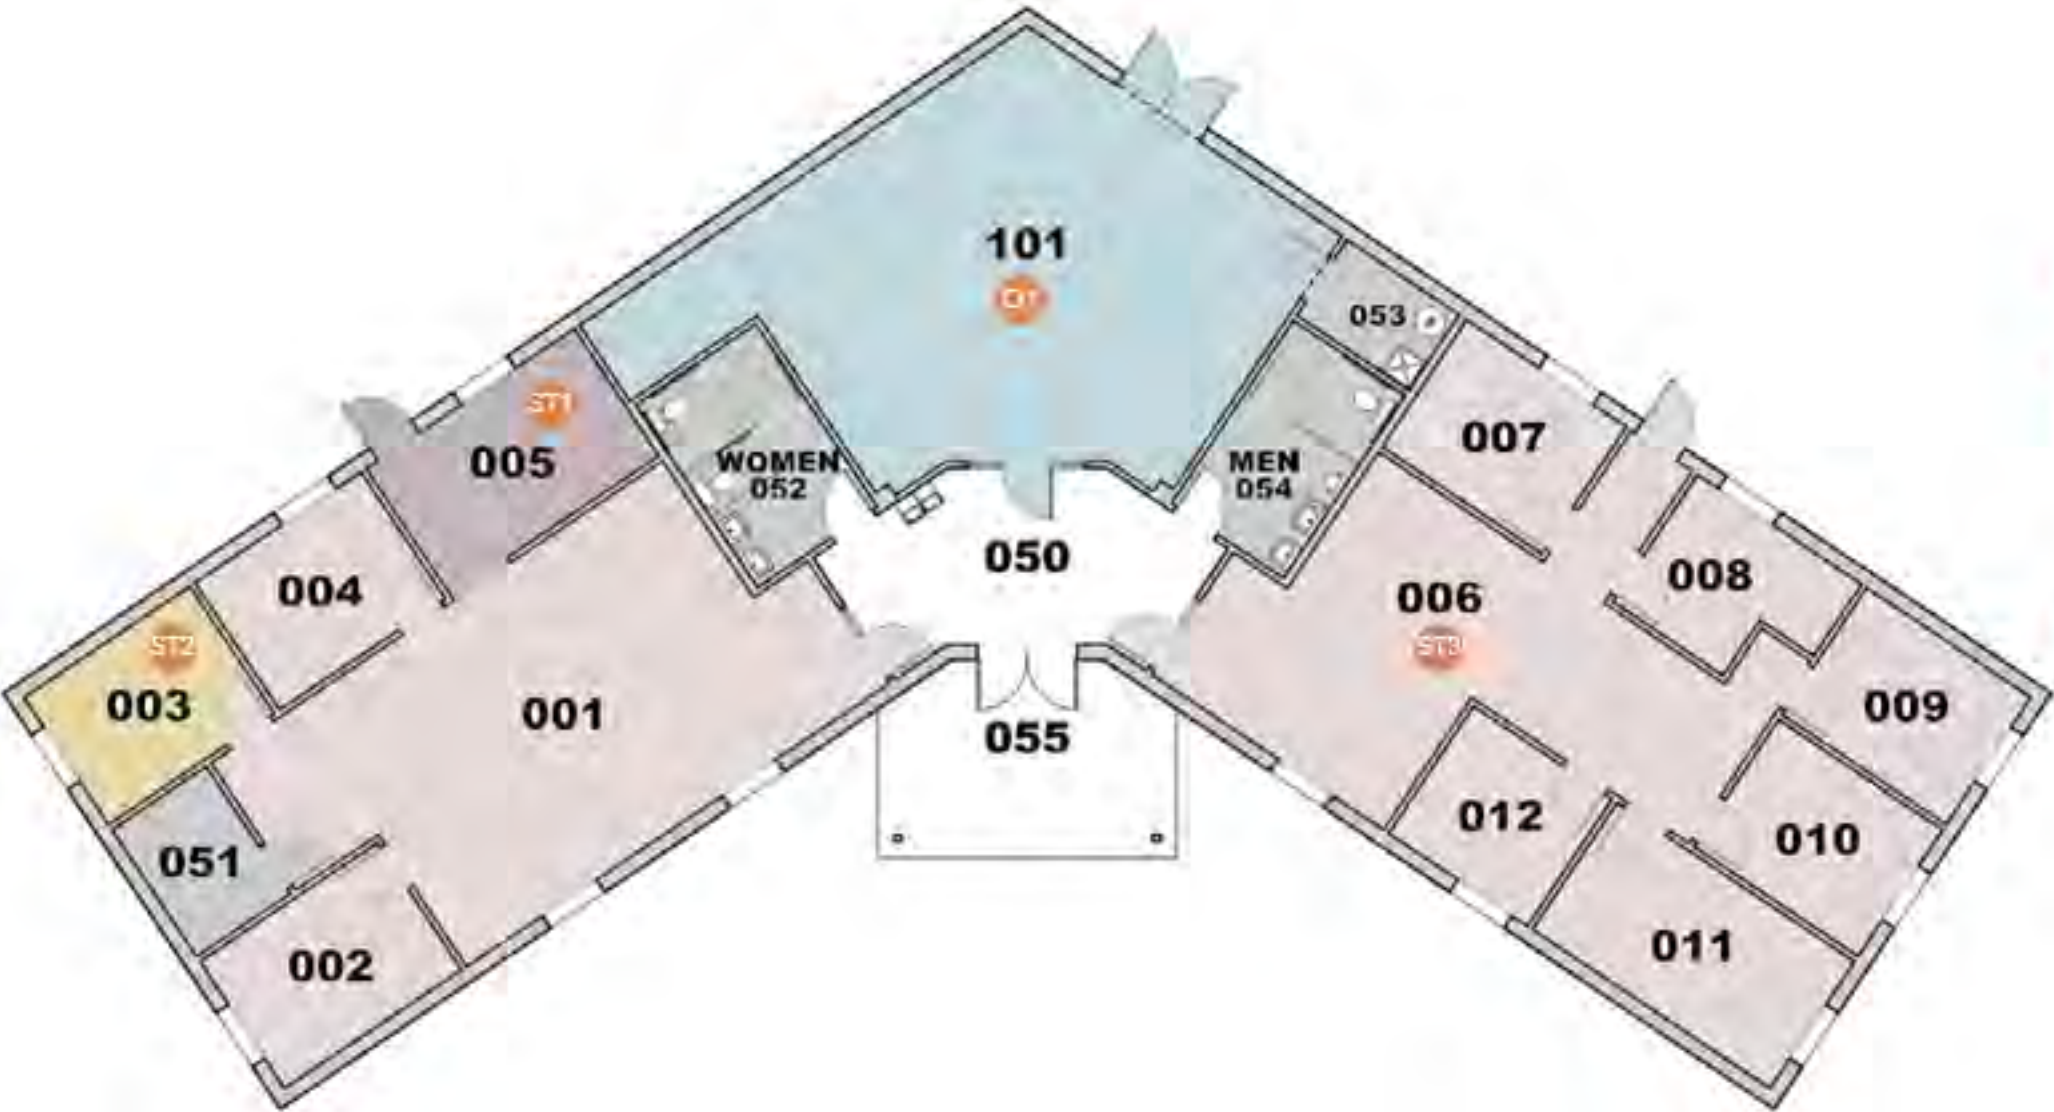
5.10.2 Lensink Hall | Challenges

General Challenges

- 1. Restrooms feel too small
- 2. Additional office space, meeting rooms, true media studio, and landing spots for interns all needed
- 3. Entry should be more gracious for public guests, retirees, and potential new employees
- 4. MPR side does not have a break room

- O1 Original space not utilized as designed
